Agreement No.: NTE 08/2016
Independent Environmental Checker for Development of Anderson Road Quarry Site
– Site Formation and Associated Infrastructure Works
Monthly Environmental Monitoring and Audit Report (October 2018)

CEDD SERVICE CONTRACT NO. NTE/07/2016 ENVIRONMENTAL TEAM FOR DEVELOPMENT OF ANDERSON ROAD QUARRY SITE – SITE FORMATION AND ASSOCIATED INFRASTRUCTURE WORKS

MONTHLY ENVIRONMENTAL MONITORING AND AUDIT REPORT (OCTOBER 2018)

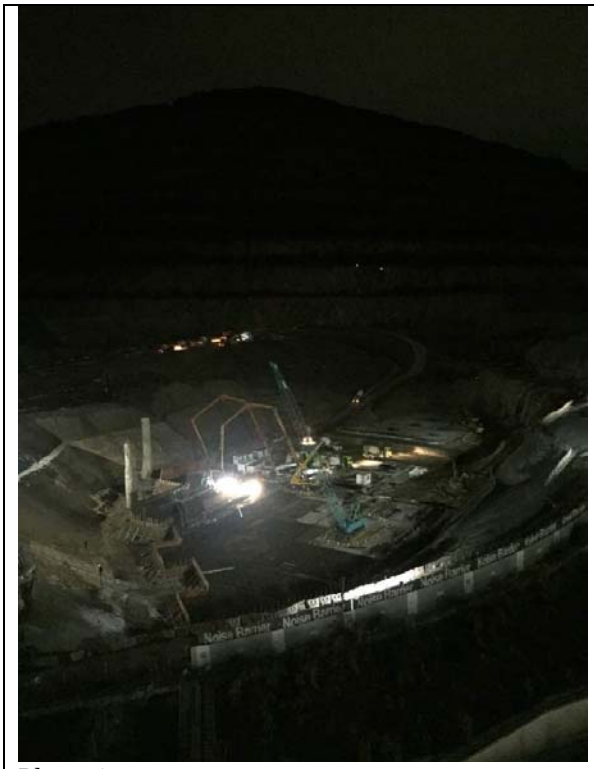
Photo 1
The photo provided by the complainant.

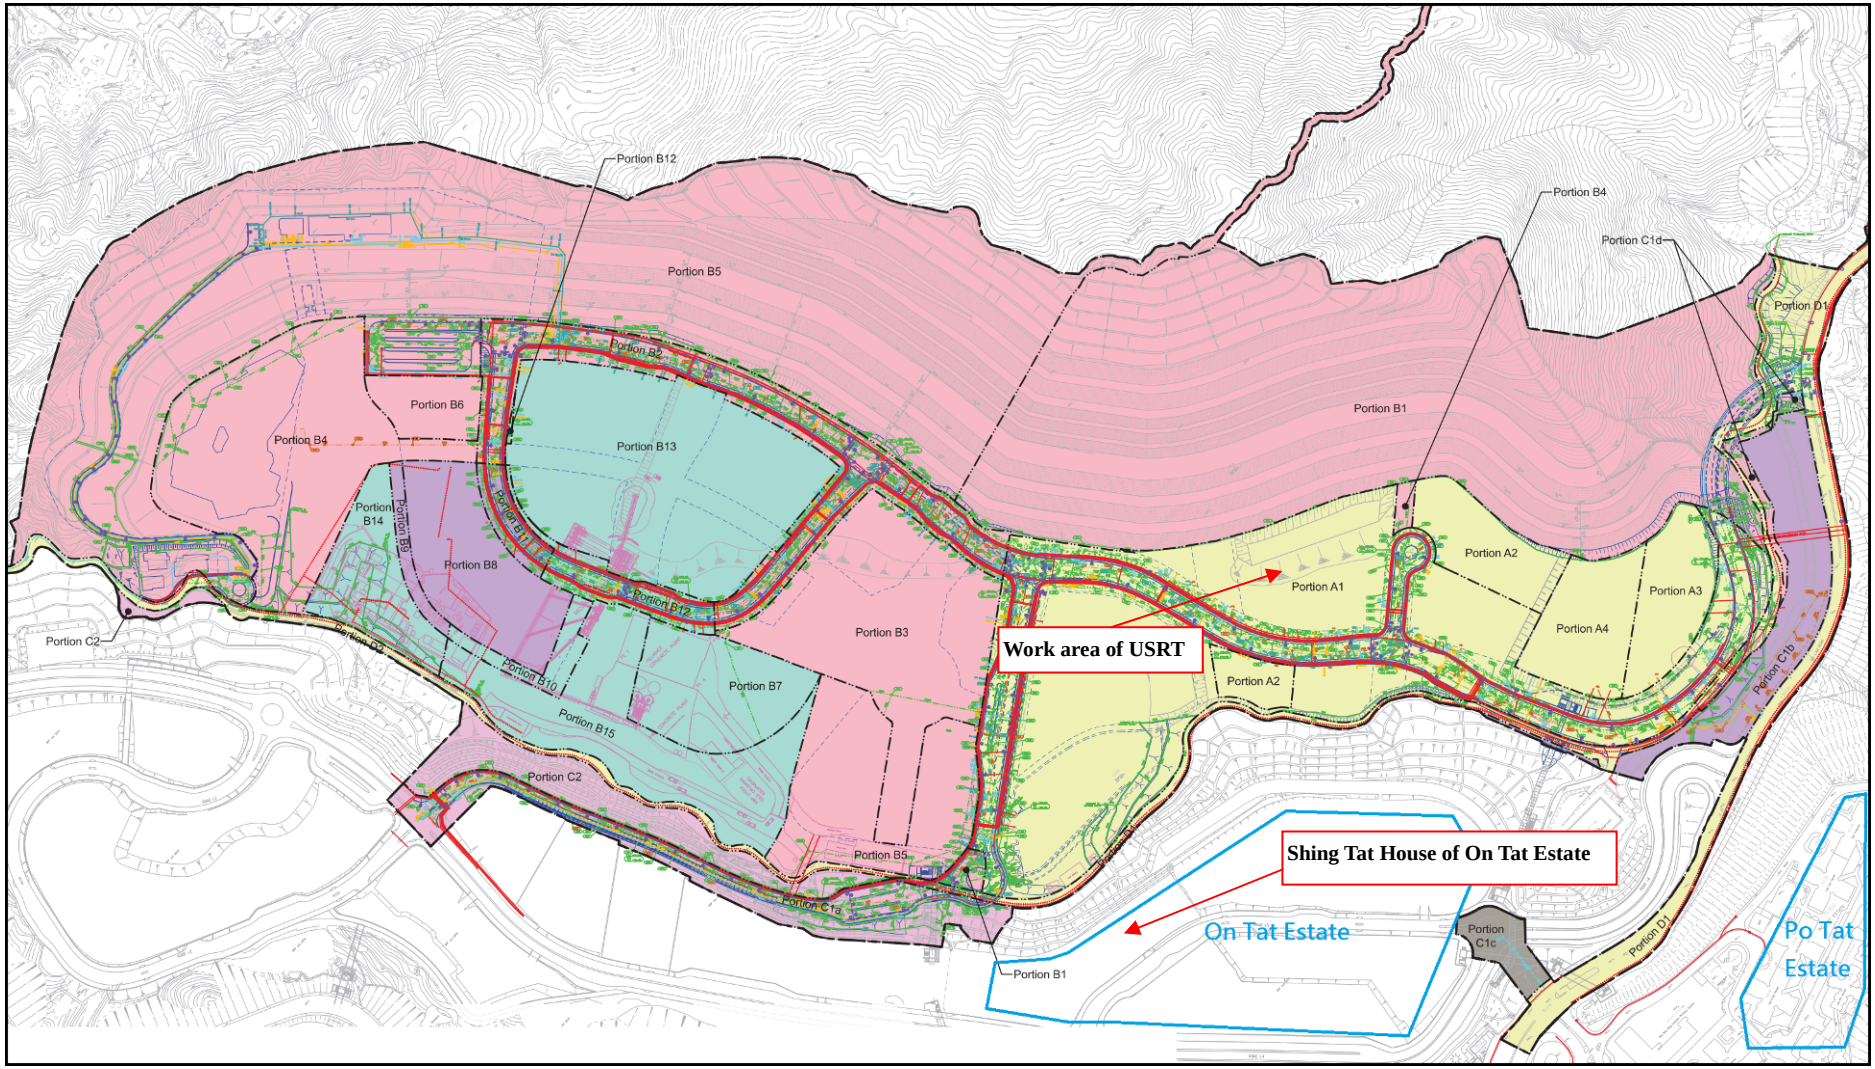
Figure 1 The Layout of NE/2016/01 and the Complaint Location

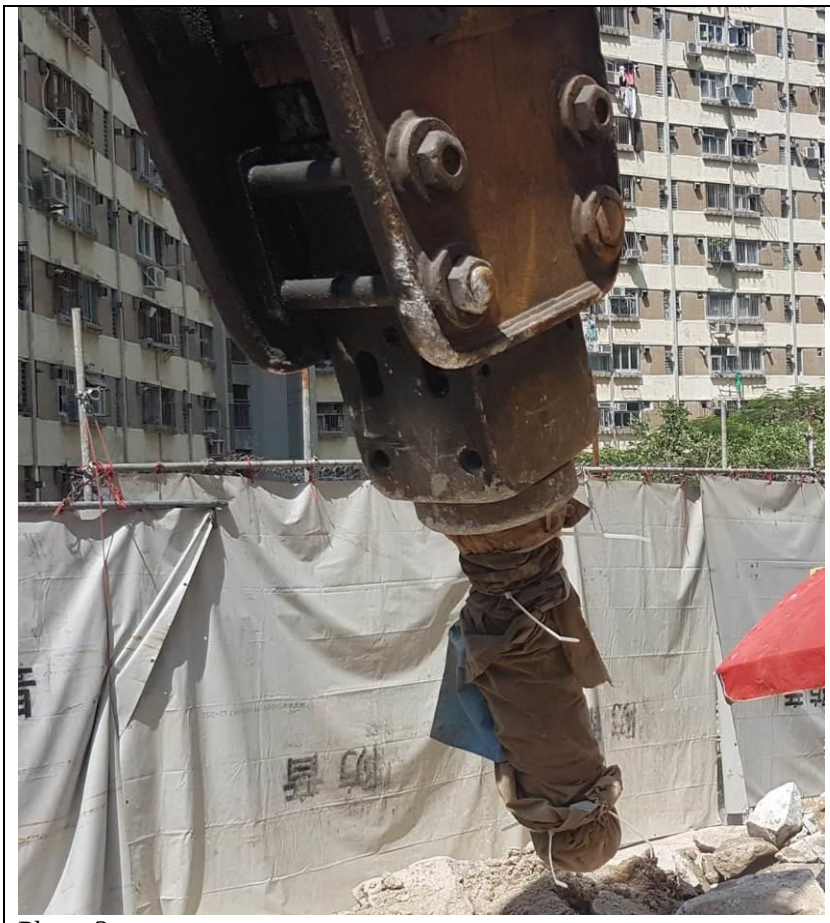
Photo 3

Only one excavator mounted breaker was deployed for the breaking works as good site practice and the breaker was wrapped with acoustic materials to alleviate the noise level generated from the breaking work.

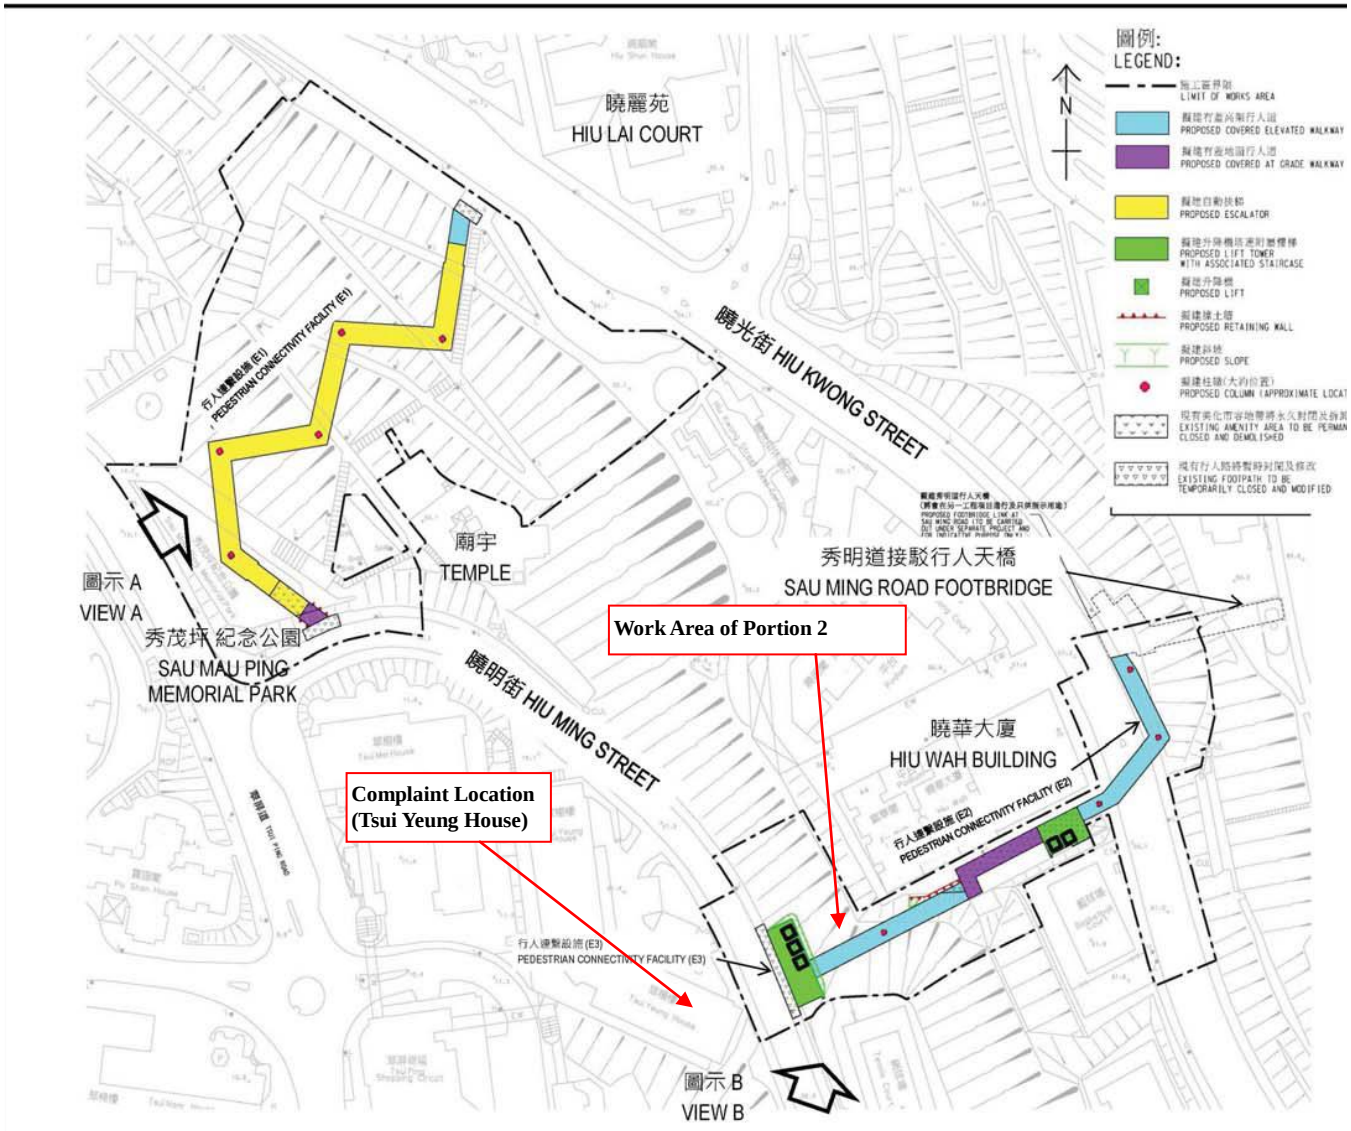
Figure 1 The Layout of Portion 2 of NE/2016/05 and the Complaint Location
