Agreement No.: NTE 08/2016

Independent Environmental Checker for Development of Anderson Road Quarry Site –
Site Formation and Associated Infrastructure Works

Monthly Environmental Monitoring and Audit Report (January 2019)

MONTHLY ENVIRONMENTAL MONITORING AND AUDIT
REPORT (JANUARY 2019)

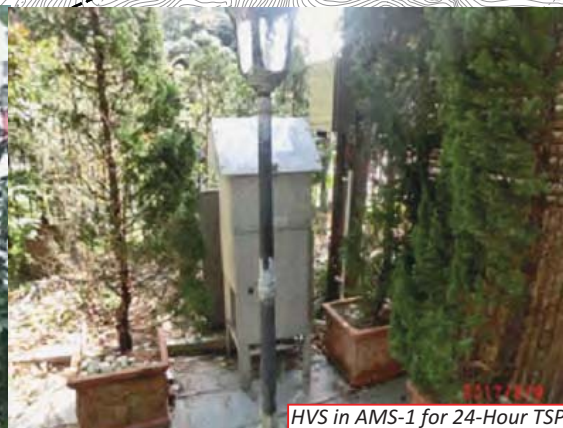
HVS in AMS-1 for 24-Hour TSP

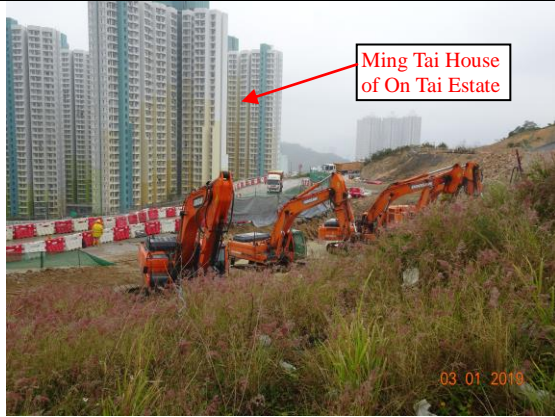
Photo 1

During site inspection on 3 January 2019, excavation and breaking works were carried out for the proposed Pumping Station opposite to the location of complainant - On Tai Estate

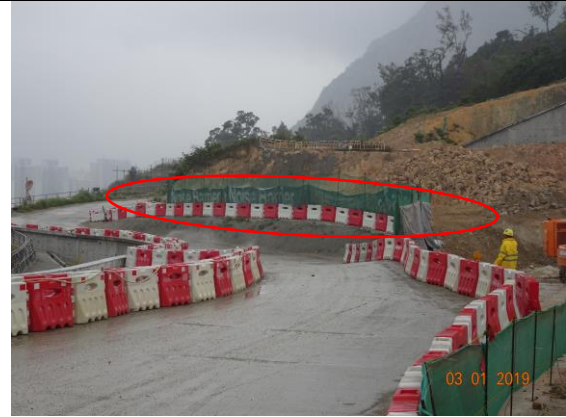
Photo 2

During site inspection on 3 January 2019, it was observed that noise mitigation measures including temporary noise barrier and acoustic mat were implemented on site.

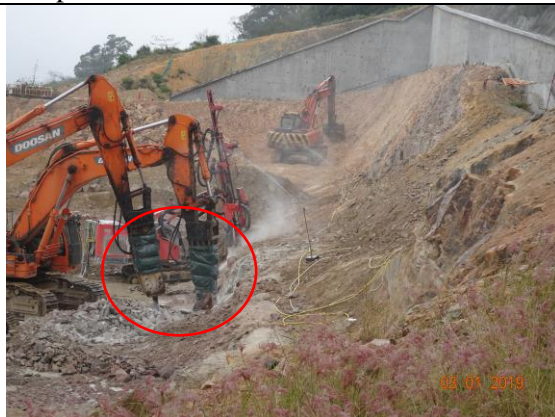
Photo 3

During site inspection on 3 January 2019, it was observed that noise mitigation measures such as breaker head wrapped by acoustic materials were implemented on site.

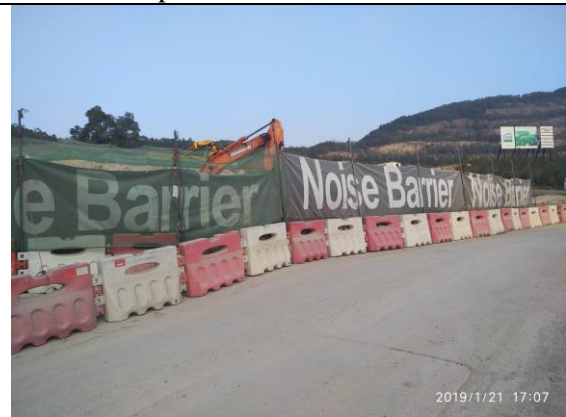
Photo 4

During the recent site inspection on 15 January 2019, it was observed that noise barrier was extended and fully enclosed the works area.

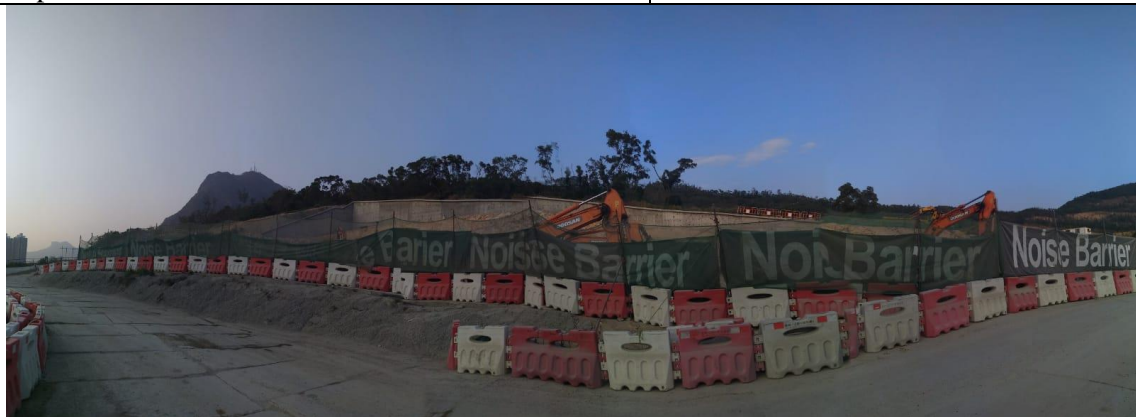
Photo 5

During the recent site inspection on 15 January 2019, it was observed that noise barrier was extended and fully enclosed the works area.

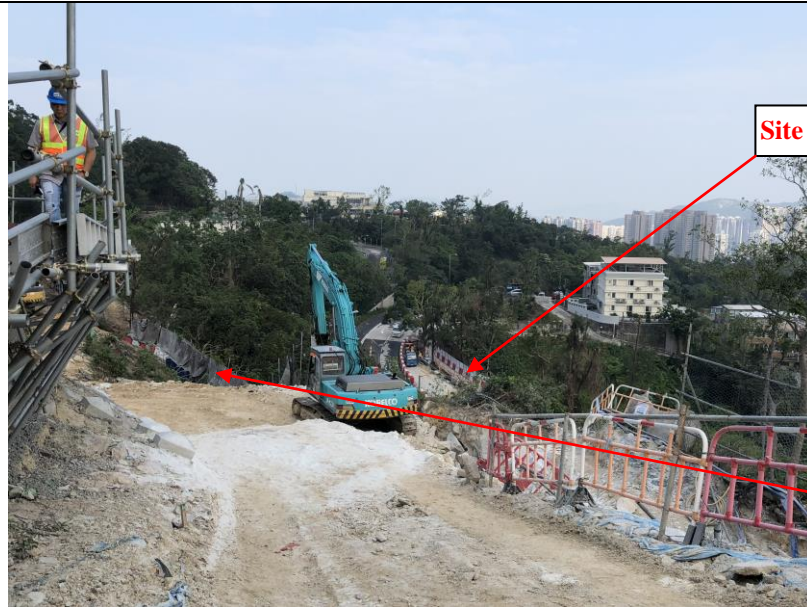
Photo 1

Site hoarding

Acoustic barrier

Joint site inspection among the RE, Contractor and ET was carried out on 20 and 27 November 2018 for the complaint investigation. It was observed that acoustic barrier and site hoarding were in place along the works area of East Portal.

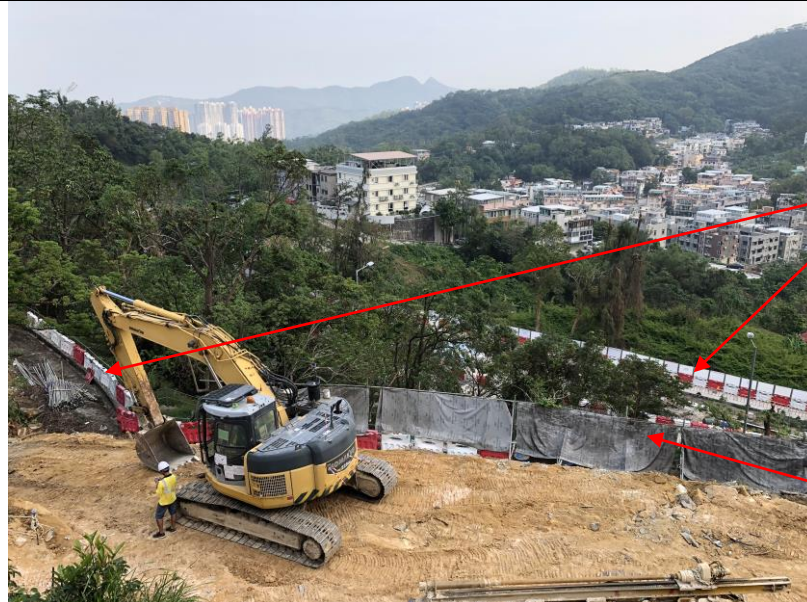
Photo 2

Site hoarding

Acoustic barrier

Joint site inspection among the RE, Contractor and ET was carried out on 20 and 27 November 2018 for the complaint investigation. It was observed that acoustic barrier and site hoarding were in place along the works area of East Portal.
