Independent Environmental Checker for Development of Anderson Road Quarry Site –
Site Formation and Associated Infrastructure Works

Monthly Environmental Monitoring and Audit Report (March 2019)

**ENVIRONMENTAL TEAM FOR DEVELOPMENT OF
ANDERSON ROAD QUARRY SITE – SITE FORMATION
AND ASSOCIATED INFRASTRUCTURE WORKS**

**MONTHLY ENVIRONMENTAL MONITORING AND AUDIT
REPORT (MARCH 2019)**

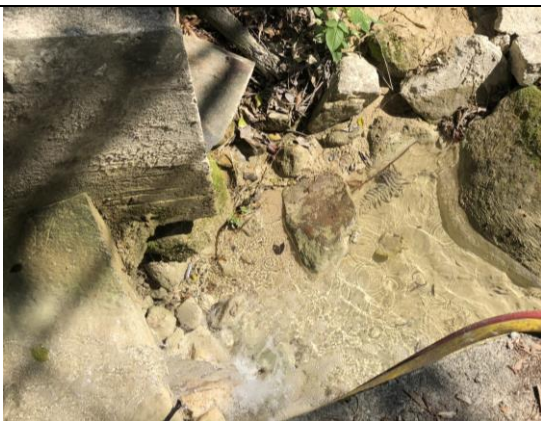
Photo 5

Joint site inspection on 29 January 2019, it was observed that the flowing water in the concerned catchpit and channel was clear.

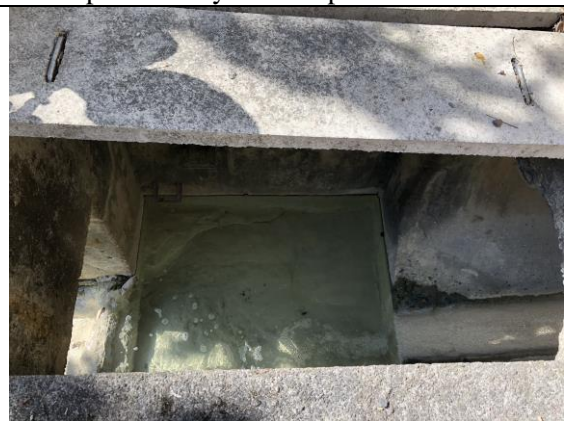
Photo 6

However, accumulation of silt was found at the bed of the catchpit.

Follow up site inspection was conducted on 14 and 21 February 2019. It was observed that the silt in the catchpit was cleaned.

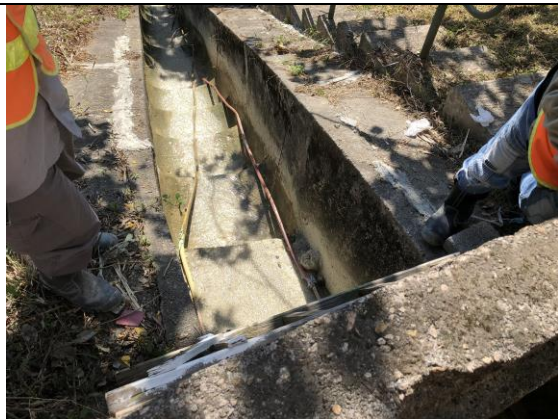
Photo 7

It was observed that the flowing water in the concerned U-channel was clear and no mud and silt were observed.

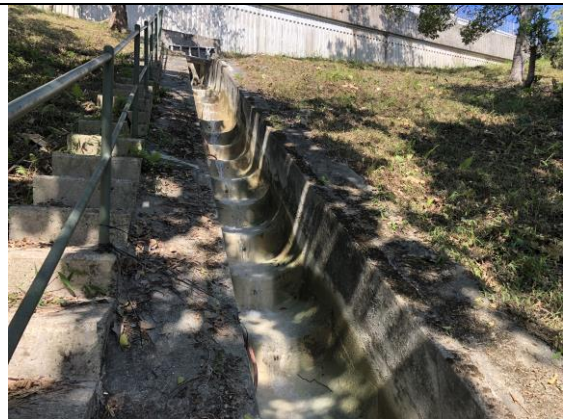
Photo 8

It was observed that the flowing water in the concerned U-channel was clear and no mud and silt were observed.

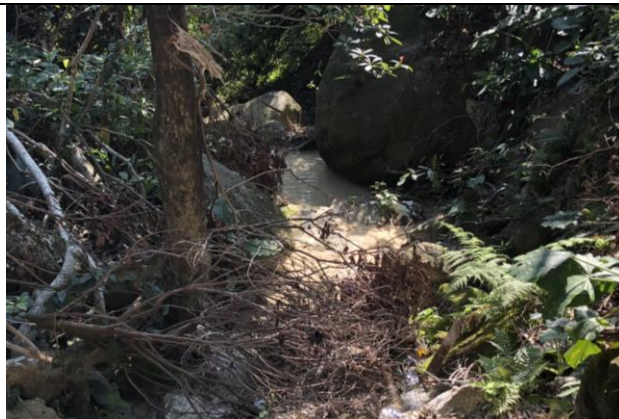
Photo 9

At further downstream, the natural section of the stream was covered by mud and silt.

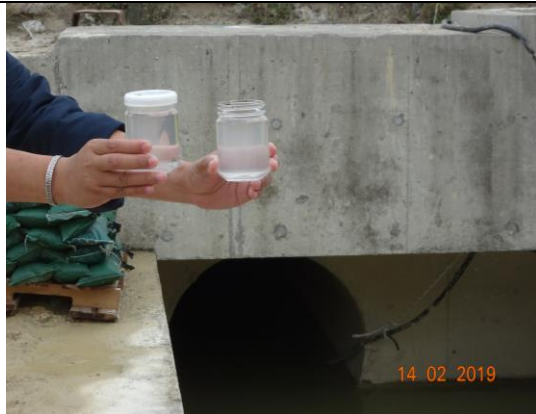
Photo 11

Inspection was conducted on the wastewater on 14 February 2019 and it was observed that the effluent quality was visually clear.

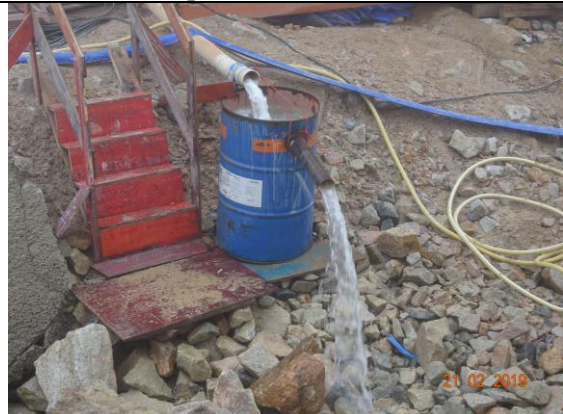
Photo 12

Inspection was conducted on the wastewater on 21 February 2019 and it was observed that the effluent quality was visually clear.

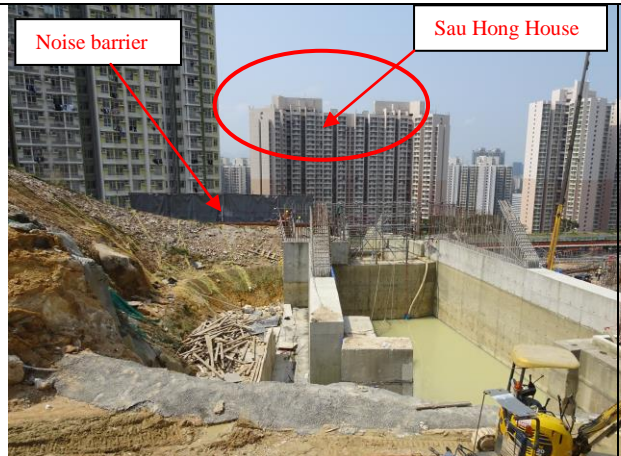
Photo 1

During joint site inspection carried out on 26 February 2019, it was observed that construction of permanent Retaining Wall and temporary drain was conducted near System A which opposite to the complaint location - Sau Hong House. As noise mitigation measures, erection of acoustic mat as temporary noise barrier was installed to screen the works area.

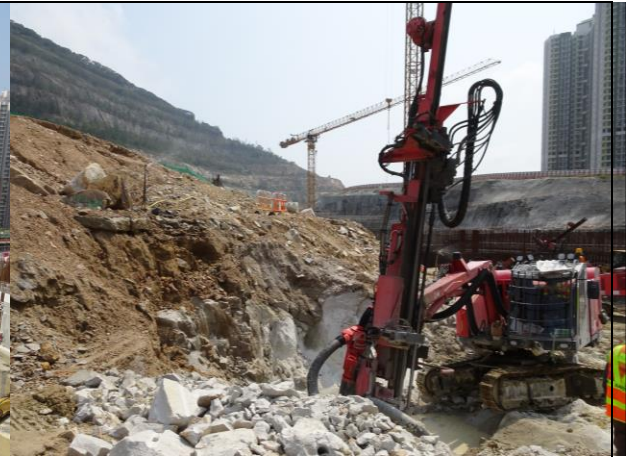
Photo 2

Alternative quiet work method such as drilling on hard rock before the breaking work was applied to reduce the duration of breaking activities.

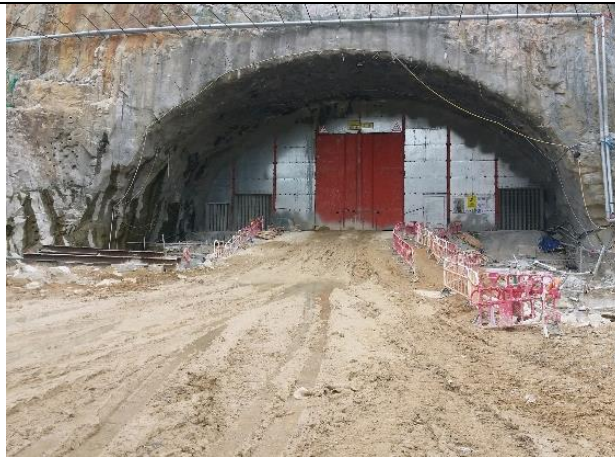
Photo 3

As noise mitigation measures, acoustic door was closed and no Powered Mechanical Equipment (PME) would be operated and mobilized outside the tunnel area to comply with the CNP requirement.

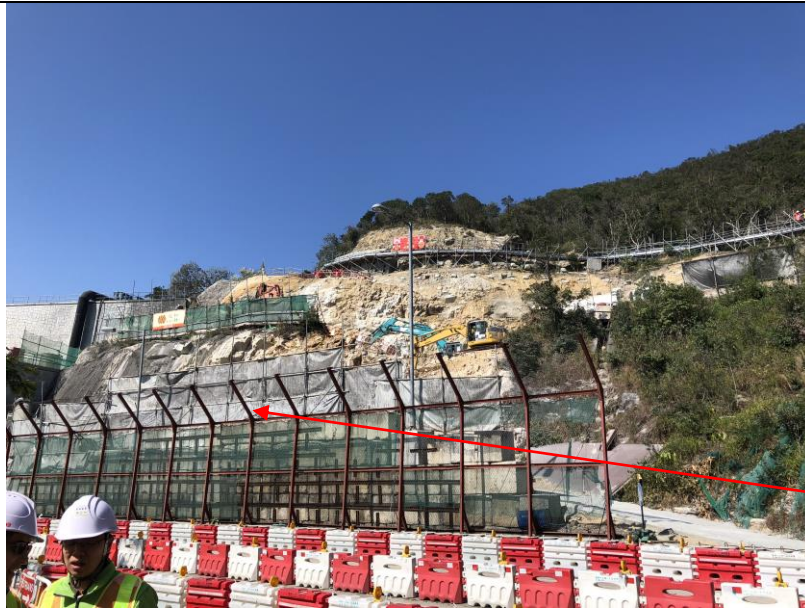
Photo 1

Acoustic barrier

Joint site inspections among the RE, CWSTVJV and ET were carried out on 26 February 2019. It was observed that as noise mitigation measures, acoustic barriers were erected along the works area.

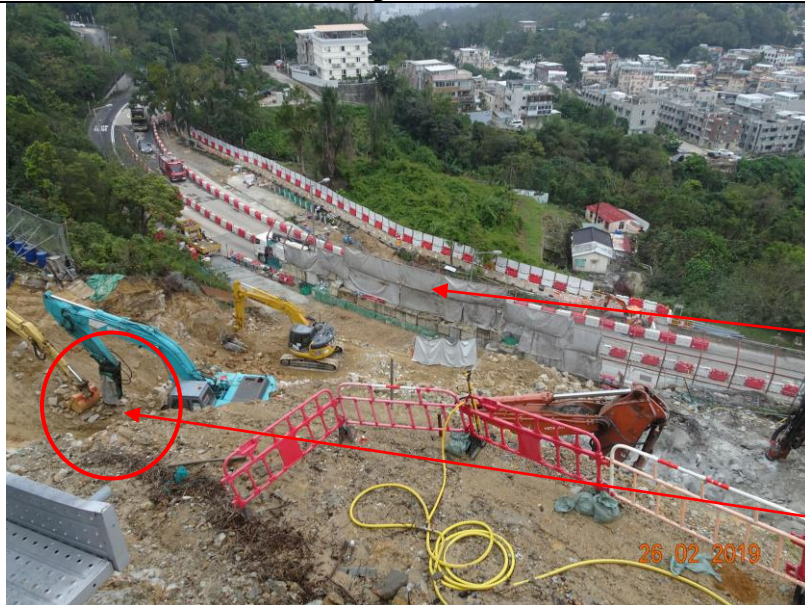
Acoustic barrier

Breaker head were wrapped with acoustic material

Joint site inspections among the RE, CWSTVJV and ET were carried out on 26 February 2019. It was observed that as noise mitigation measures, acoustic barriers were erected along the works area and breaker head were wrapped with acoustic material.

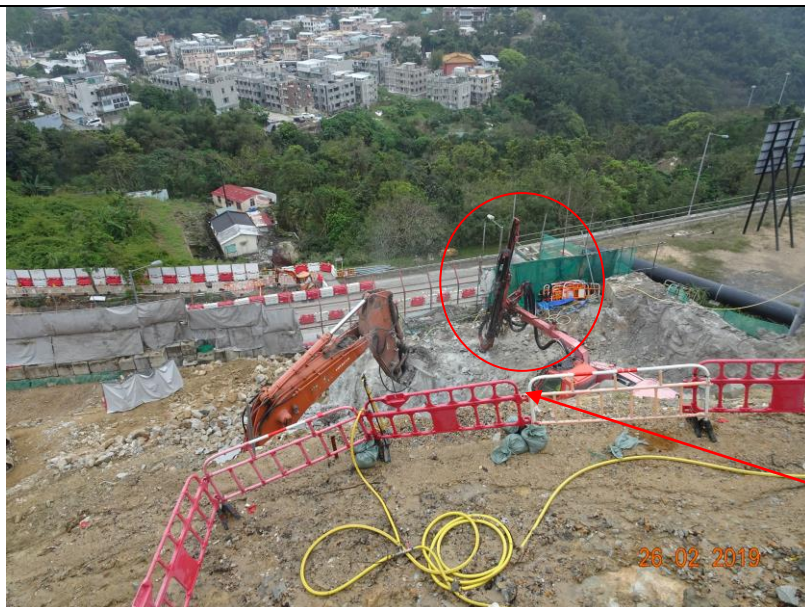
Photo 3

Driller

As advised by CWSTVJV, alternative quiet work method was adopted such as drilling the hard rock before the breaking work to reduce the breaking duration.

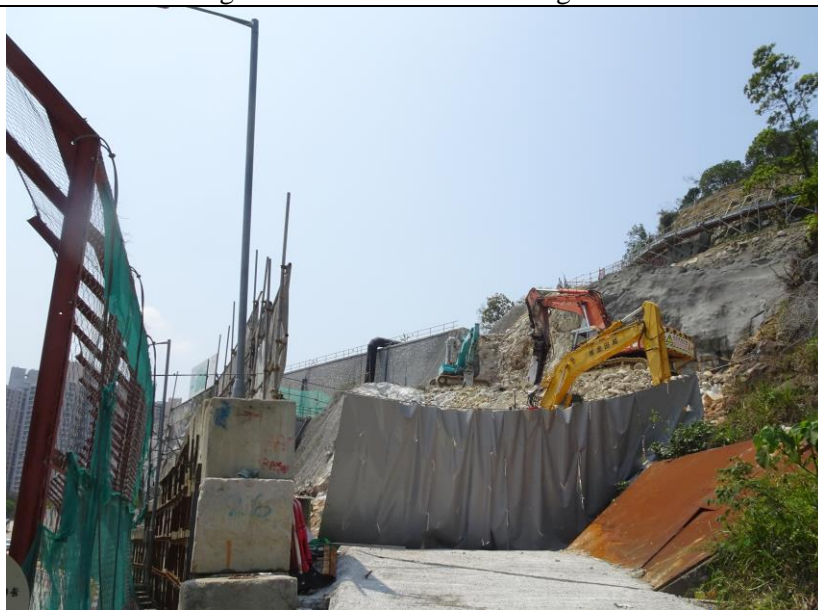
Photo 4

Additional noise barrier was added in response to Mrs Wong's request.

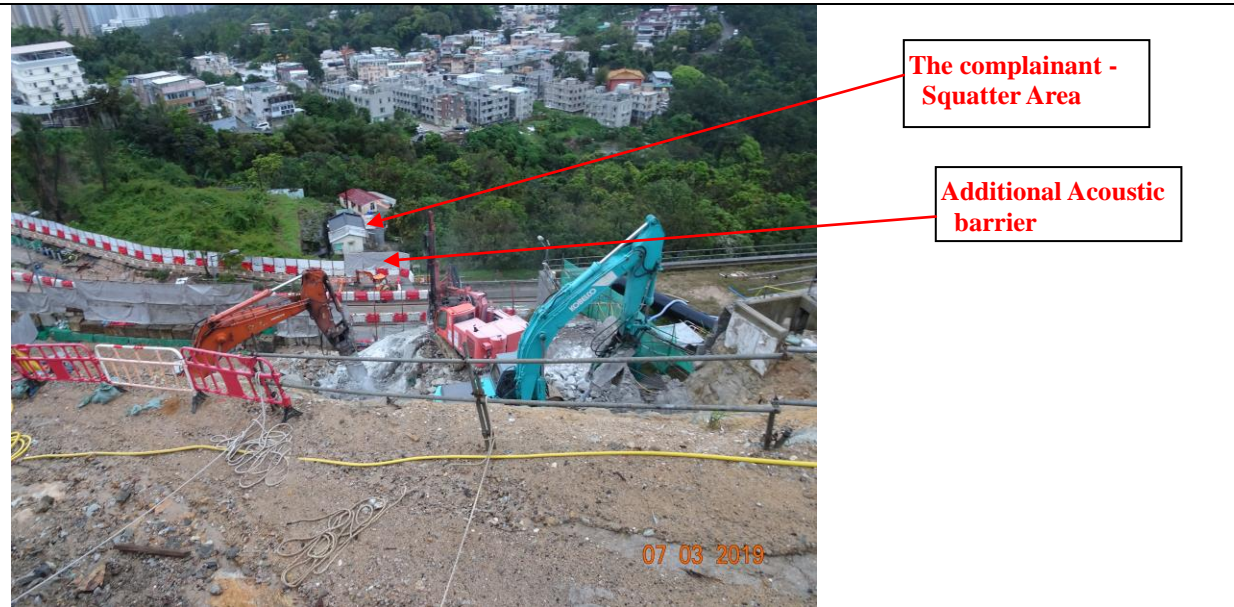
Photo 1

Joint site inspections among the RE, CWSTVJV and ET were carried out on 7 March 2019. It was observed additional acoustic mat has been erected in front of the Squatter Area to minimize the noise impact.

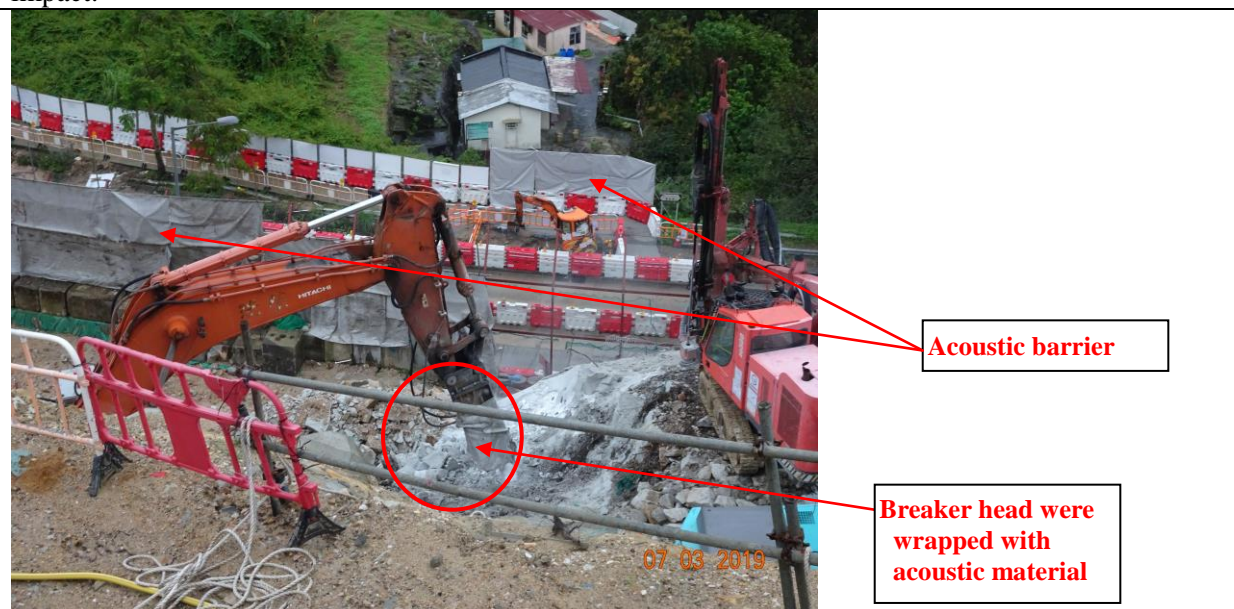
Photo 2

Joint site inspections among the RE, CWSTVJV and ET were carried out on 26 February 2019. It was observed that as noise mitigation measures, acoustic barriers were erected along the works area and breaker head were wrapped with acoustic material.
