Service Contract No: EDO/01/2017
Environmental Team for
Development of Anderson Road Quarry Site
Road Improvement Works
Monthly EM&A Report (March 2020)

**ENVIRONMENTAL TEAM FOR
DEVELOPMENT OF
ANDERSON ROAD QUARRY SITE -
ROAD IMPROVEMENT WORKS**

MONTHLY ENVIRONMENTAL MONITORING & AUDIT REPORT

MARCH 2020

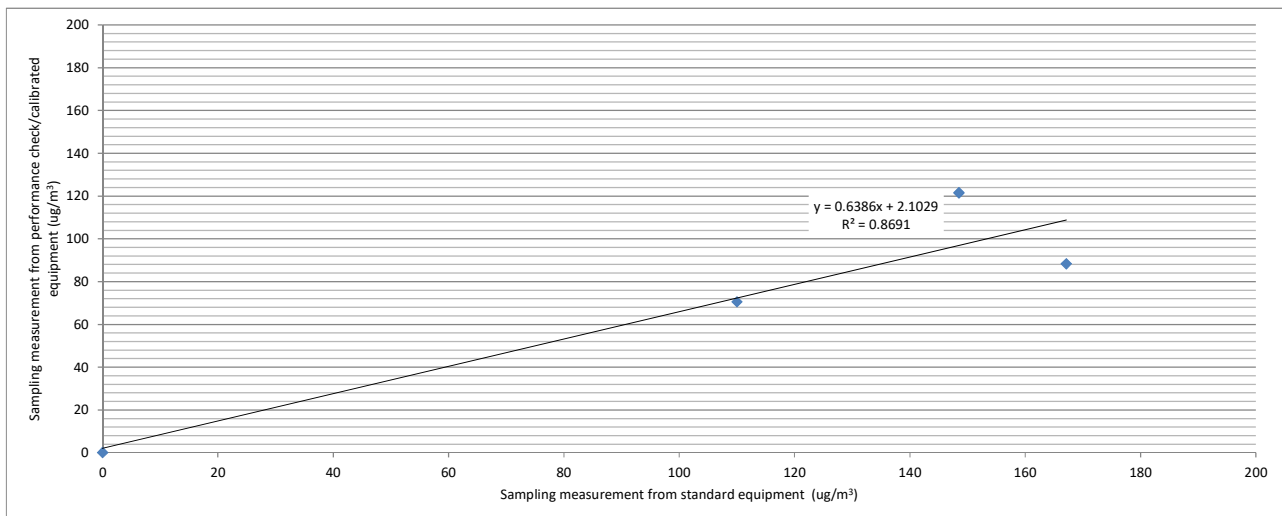
Linear Regression of Y on X

Slope (K- factor) : 1.4000
Correlation Coefficient : 0.9323
Validity of Performance Check / Calibration Record : 29/9/2020

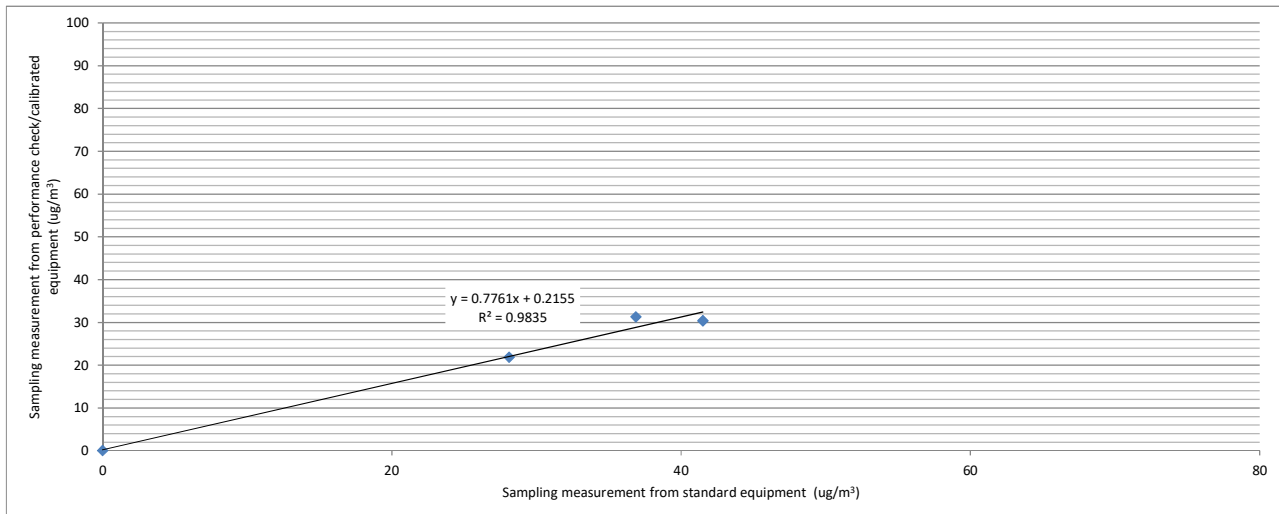
Linear Regression of Y on X

Slope (K- factor) : 1.3000
 Correlation Coefficient : 0.9917
 Validity of Performance Check / Calibration Record : 19/6/2020

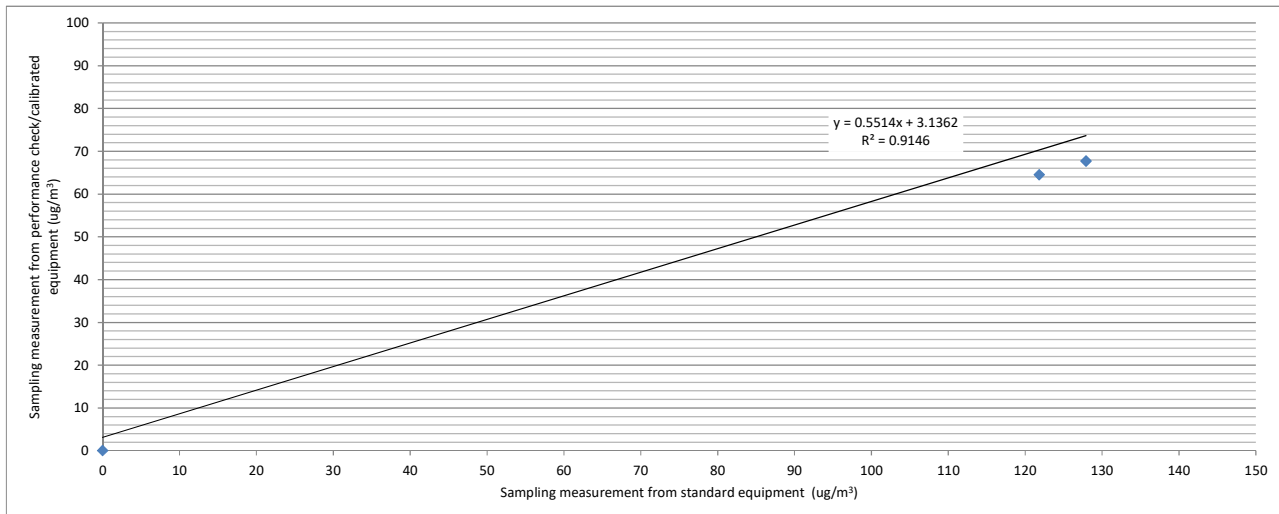
Linear Regression of Y on X

Slope (K- factor) : 1.7000
Correlation Coefficient : 0.9563
Validity of Performance Check / Calibration Record : 5/11/2020

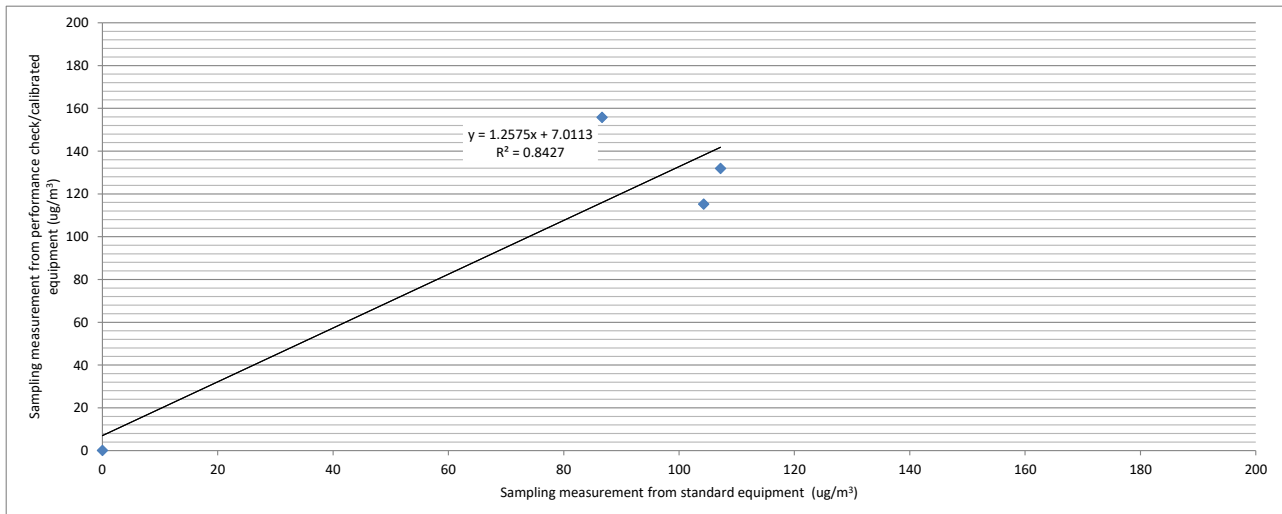
Linear Regression of Y on X

Slope (K- factor) : 0.7000
Correlation Coefficient : 0.9180
Validity of Performance Check / Calibration Record : 2/1/2021

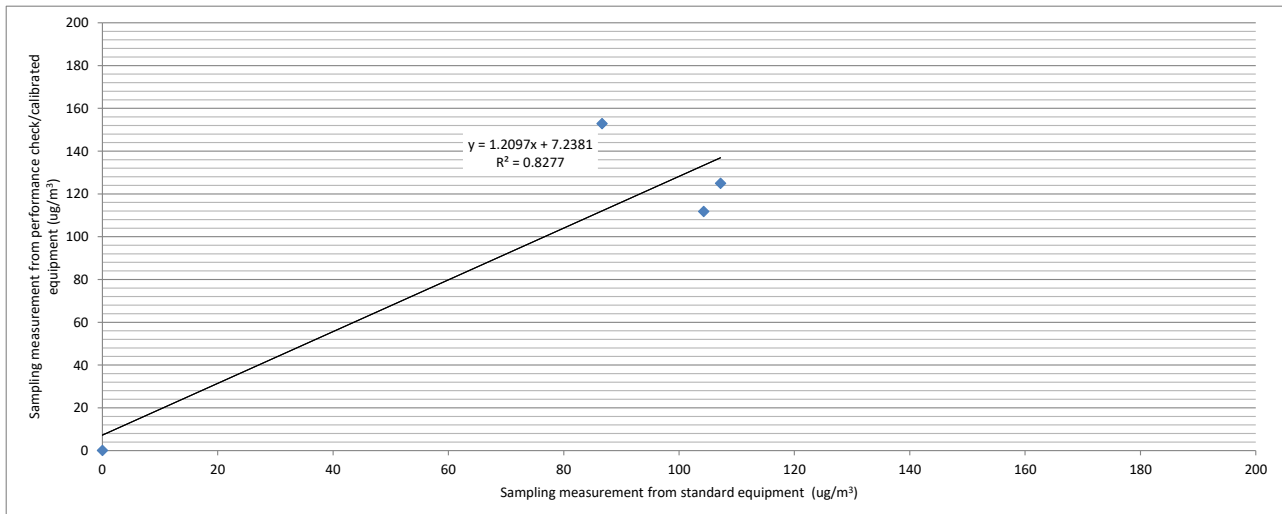
Linear Regression of Y on X

Slope (K- factor) : 0.7000
Correlation Coefficient : 0.9098
Validity of Performance Check / Calibration Record : 2/1/2021

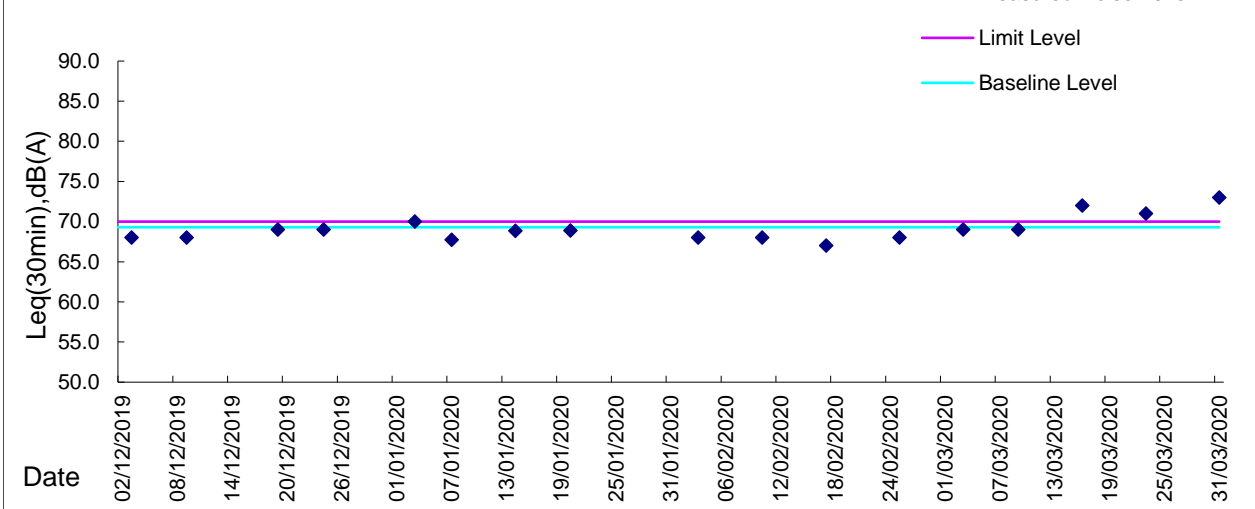
NMC-01 - G/F, Kei Shun Special School

Day Time (0700 - 1900hrs on normal weekdays)
