Service Contract No: EDO/01/2017
Environmental Team for
Development of Anderson Road Quarry Site
Road Improvement Works
Monthly EM&A Report (October 2019)

**ENVIRONMENTAL TEAM FOR
DEVELOPMENT OF
ANDERSON ROAD QUARRY SITE -
ROAD IMPROVEMENT WORKS**

MONTHLY ENVIRONMENTAL MONITORING & AUDIT REPORT

OCTOBER 2019

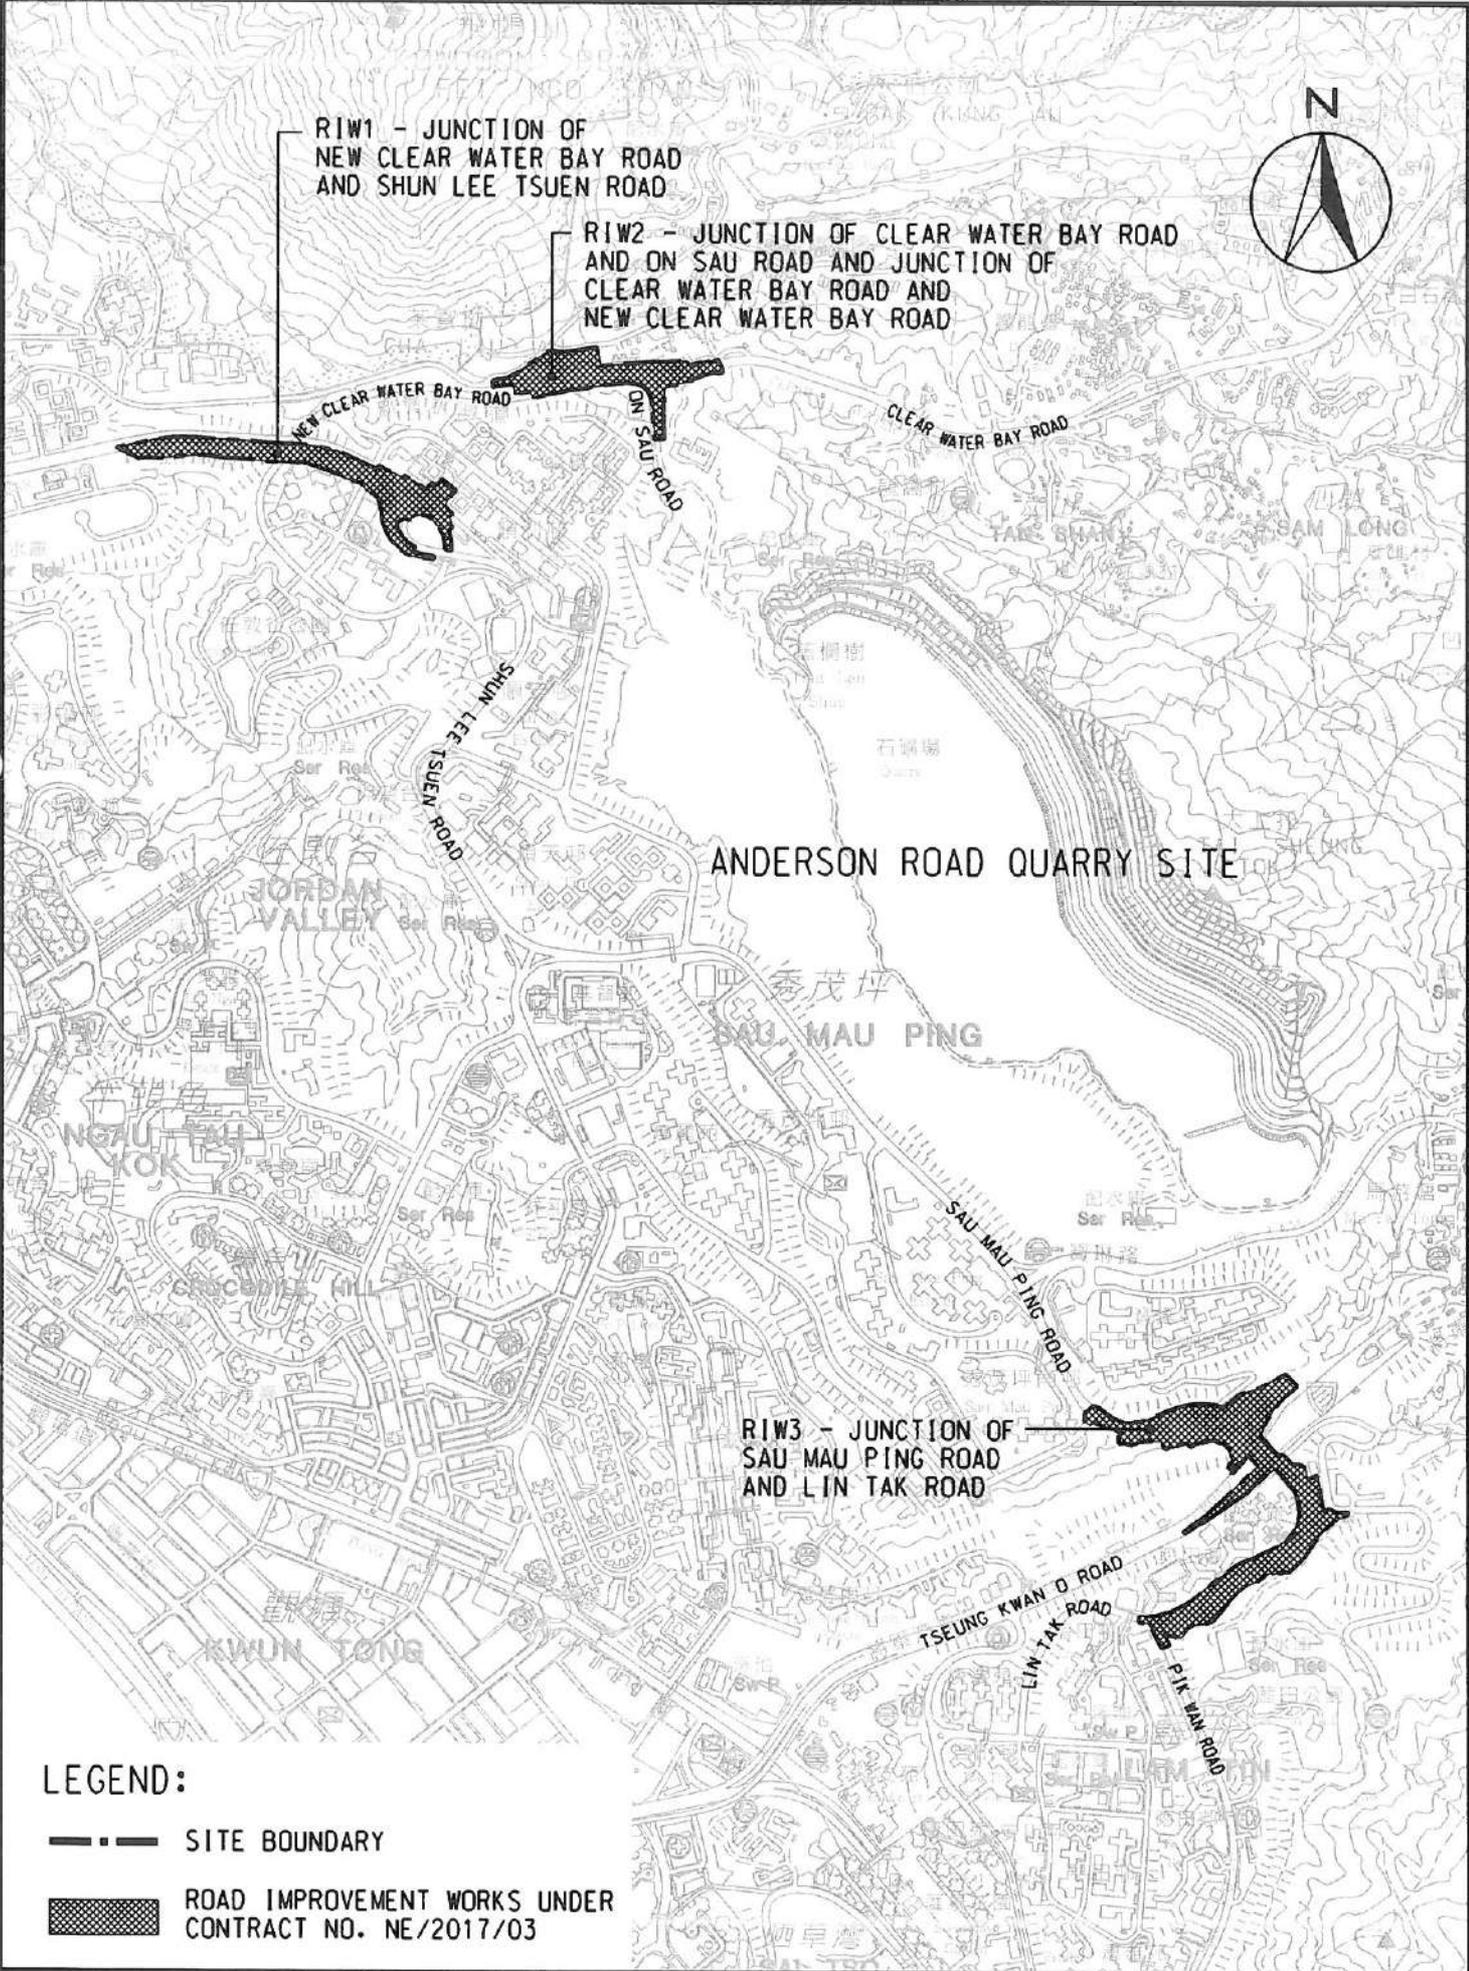
Figure 2.1

GENERAL LAYOUT PLAN OF ROAD IMPROVEMENT WORKS UNDER CONTRACT NO. NE/2017/03

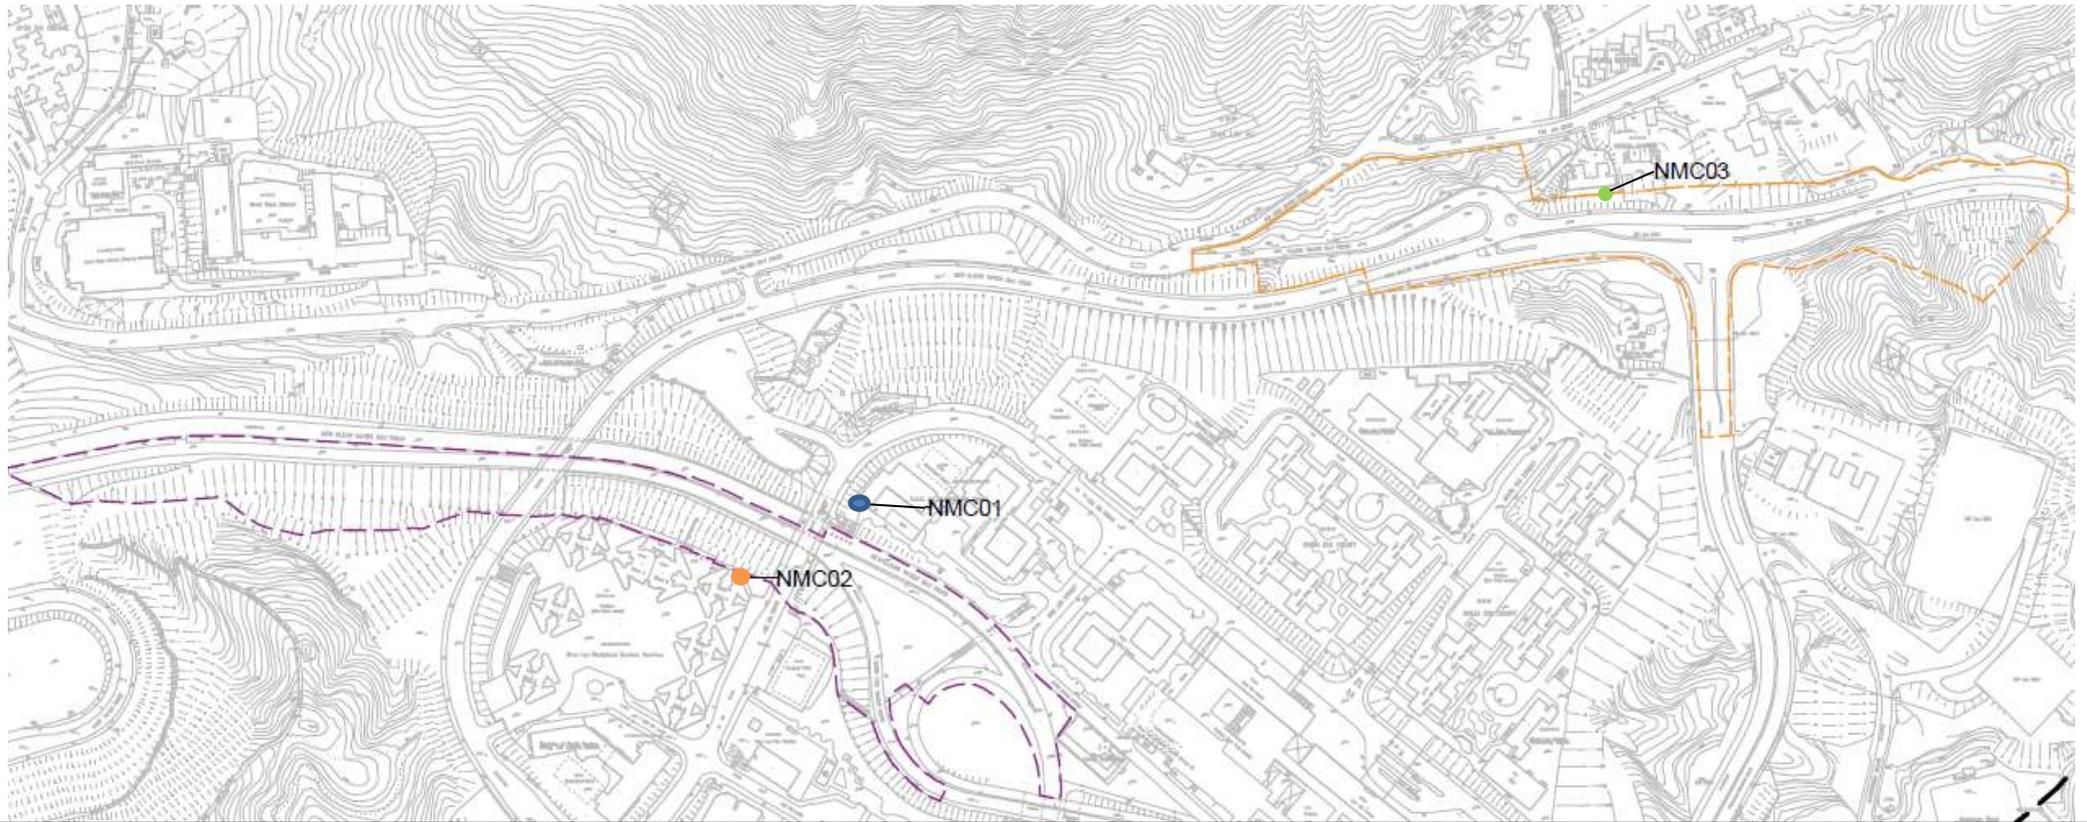
Figure 4.1
 Location of Noise Monitoring Station
 (Construction Phase)
 (for Road Improvement Work 1 & 2)

Monitoring Location ID	Description
<i>Noise Monitoring Station (Construction Phase)</i>	
NMC01	Kei Shun Special School
NMC02	Shun Lee Disciplined Services Quarters Block 6
NMC03	Sienna Garden Block 6

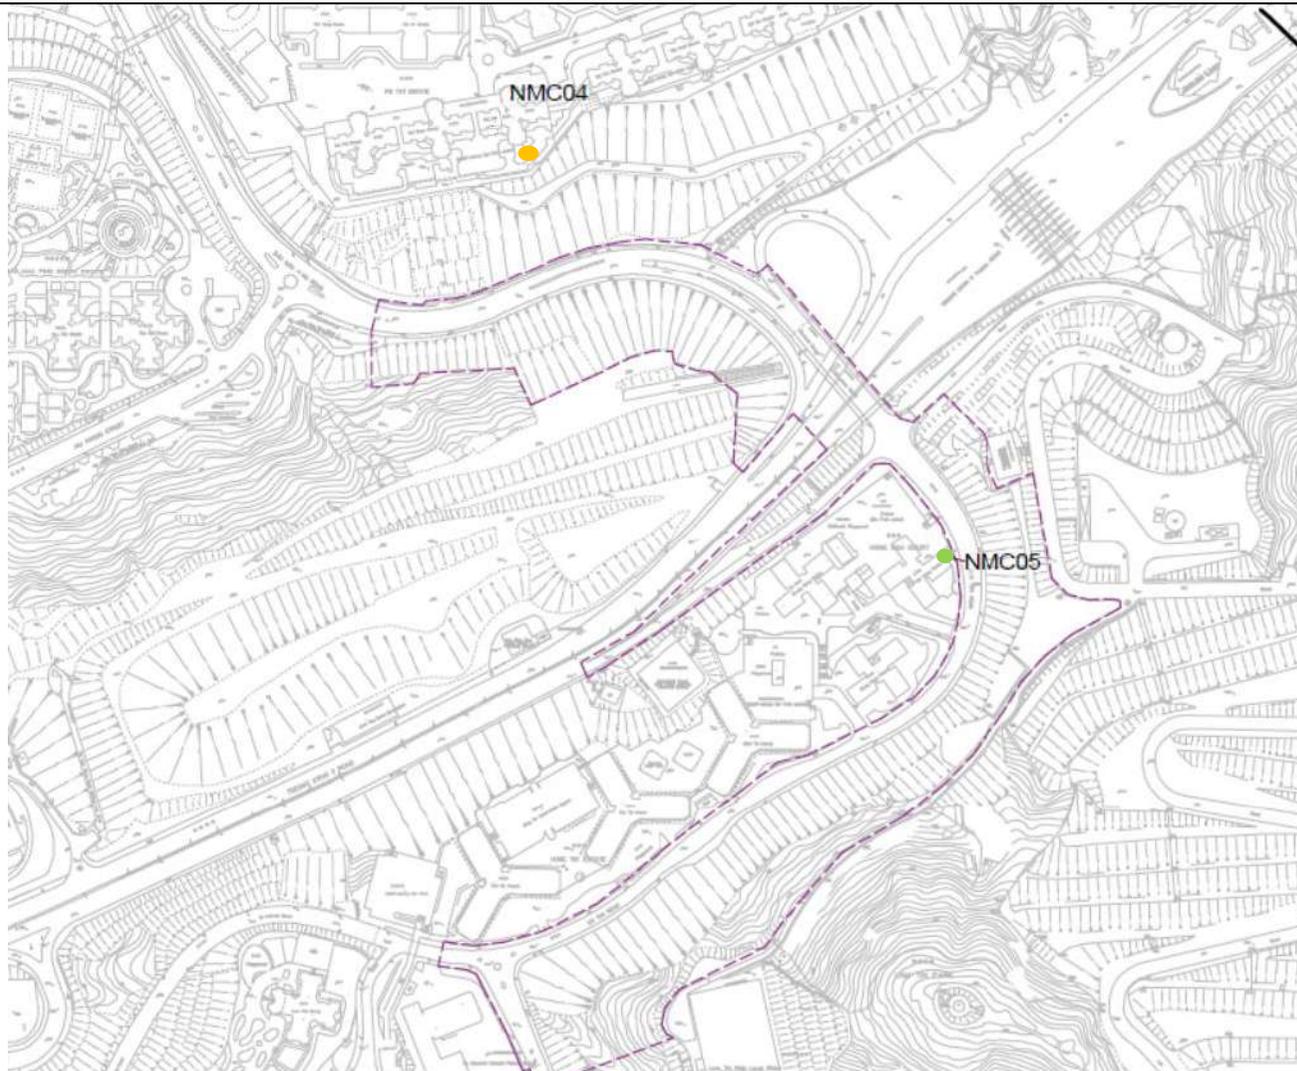
Figure 4.2
 Location of Noise Monitoring Station
 (Construction Phase)
 (for Road Improvement Work 3)

Monitoring Location ID	Description
NMC04	Po Tat Estate Tat Kai House
NMC05	Hong Wah Court Block B Yee Hong House

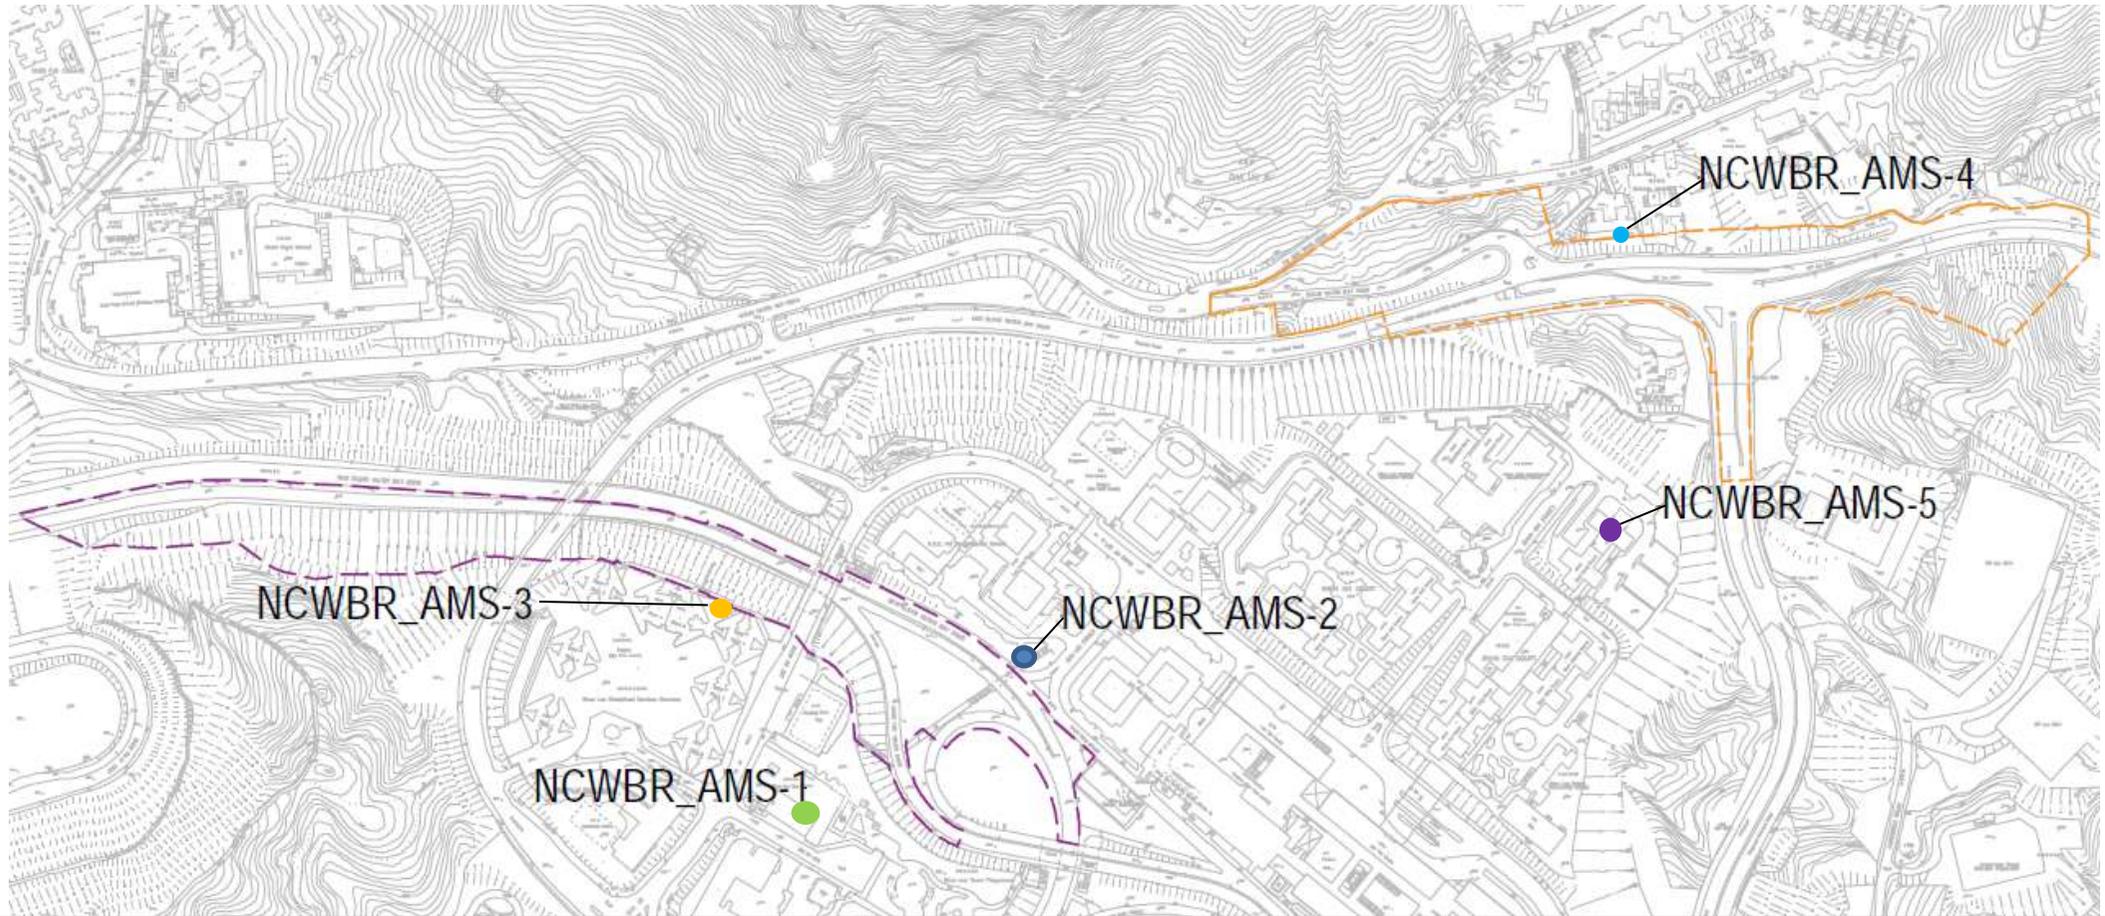
Figure 4.3
 Location of Air Quality Monitoring Station
 (for Road Improvement Work 1 & 2)

Monitoring Station ID	EIA ID	Location
NCWBR RIW		
NCWBR_AMS-1	ASLF-1	Shun Lee Fire Station
NCWBR_AMS-2	ASLE-21	Shun Lee Estate Lee Hang House
NCWBR_AMS-3	ASLD-10	Shun Lee Disciplined Services Quarters (Block 6)
NCWBR_AMS-4	AFNS-3	Sienna Garden
NCWBR_AMS-5	ASCC-05	Shun Chi Court Shun Fung House

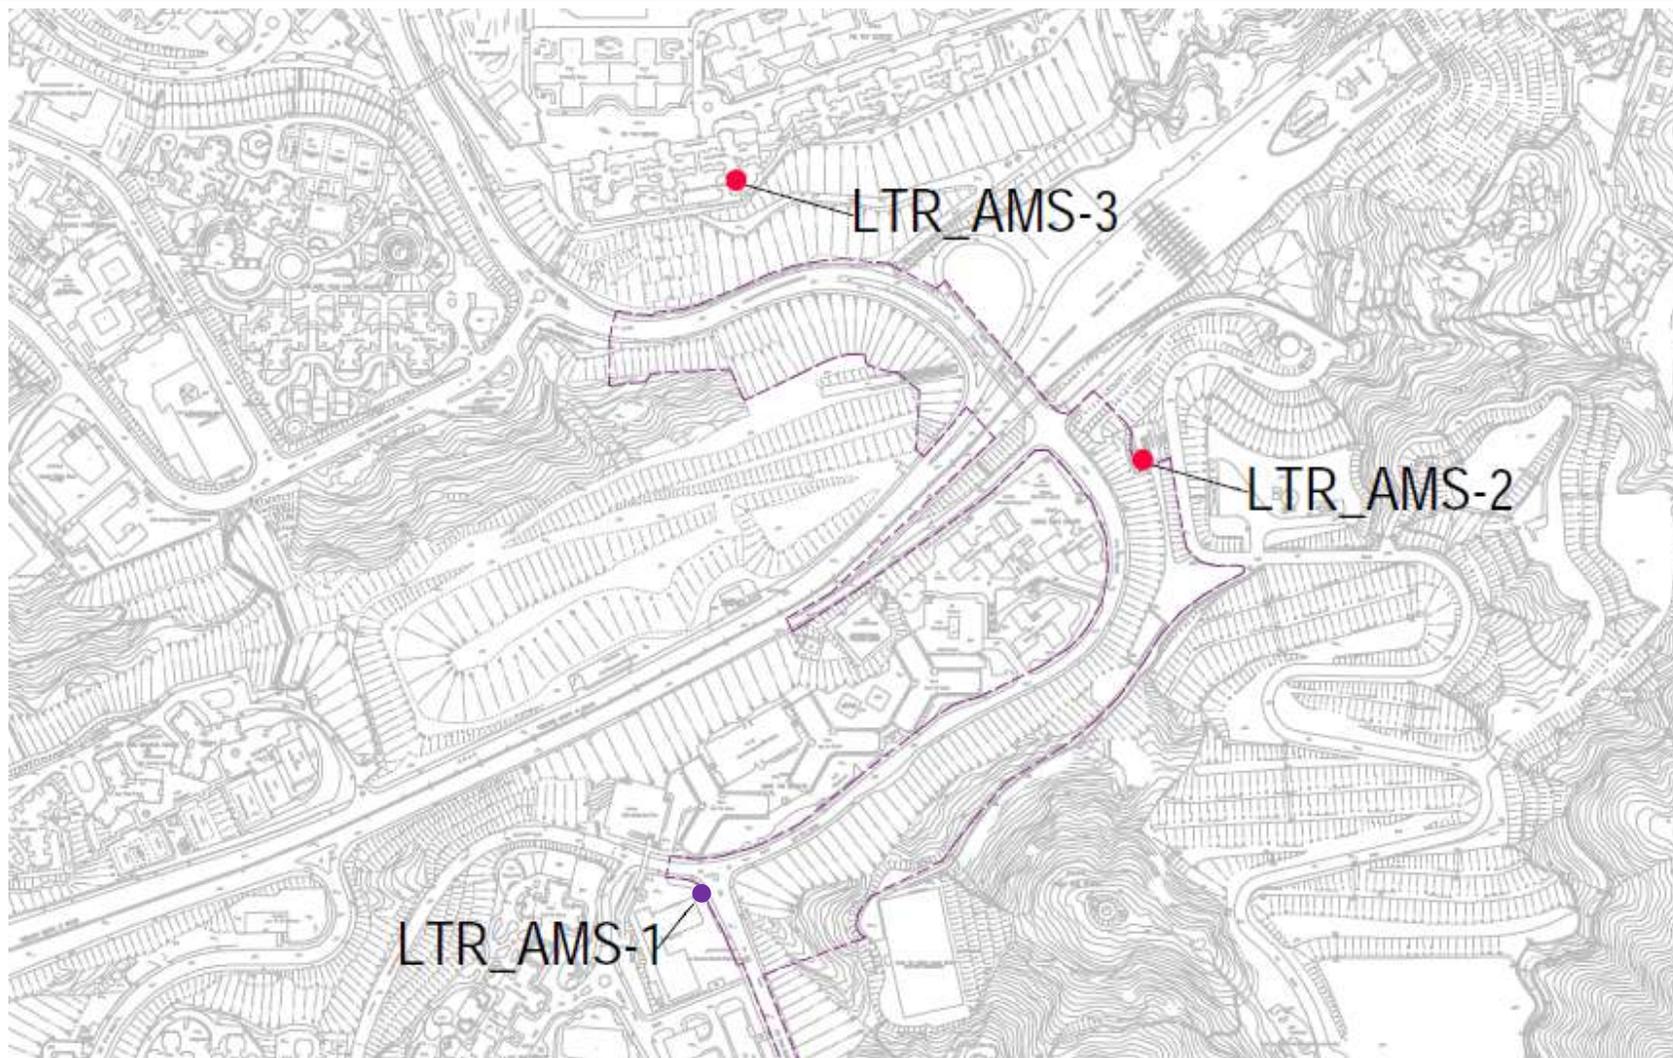
Figure 4.4
Location of Air Quality Monitoring Station
(for Road Improvement Work 3)

Monitoring Station ID	EIA ID	Location
LTR RIW		
LTR_AMS-1	ASECP-2	St Edward's Catholic Primary School
LTR_AMS-2	AEPD-01	Environmental Protection Department's Restored Landfill Site Office
LTR_AMS-3	APTE-14	Po Tat Estate Tat Kai House

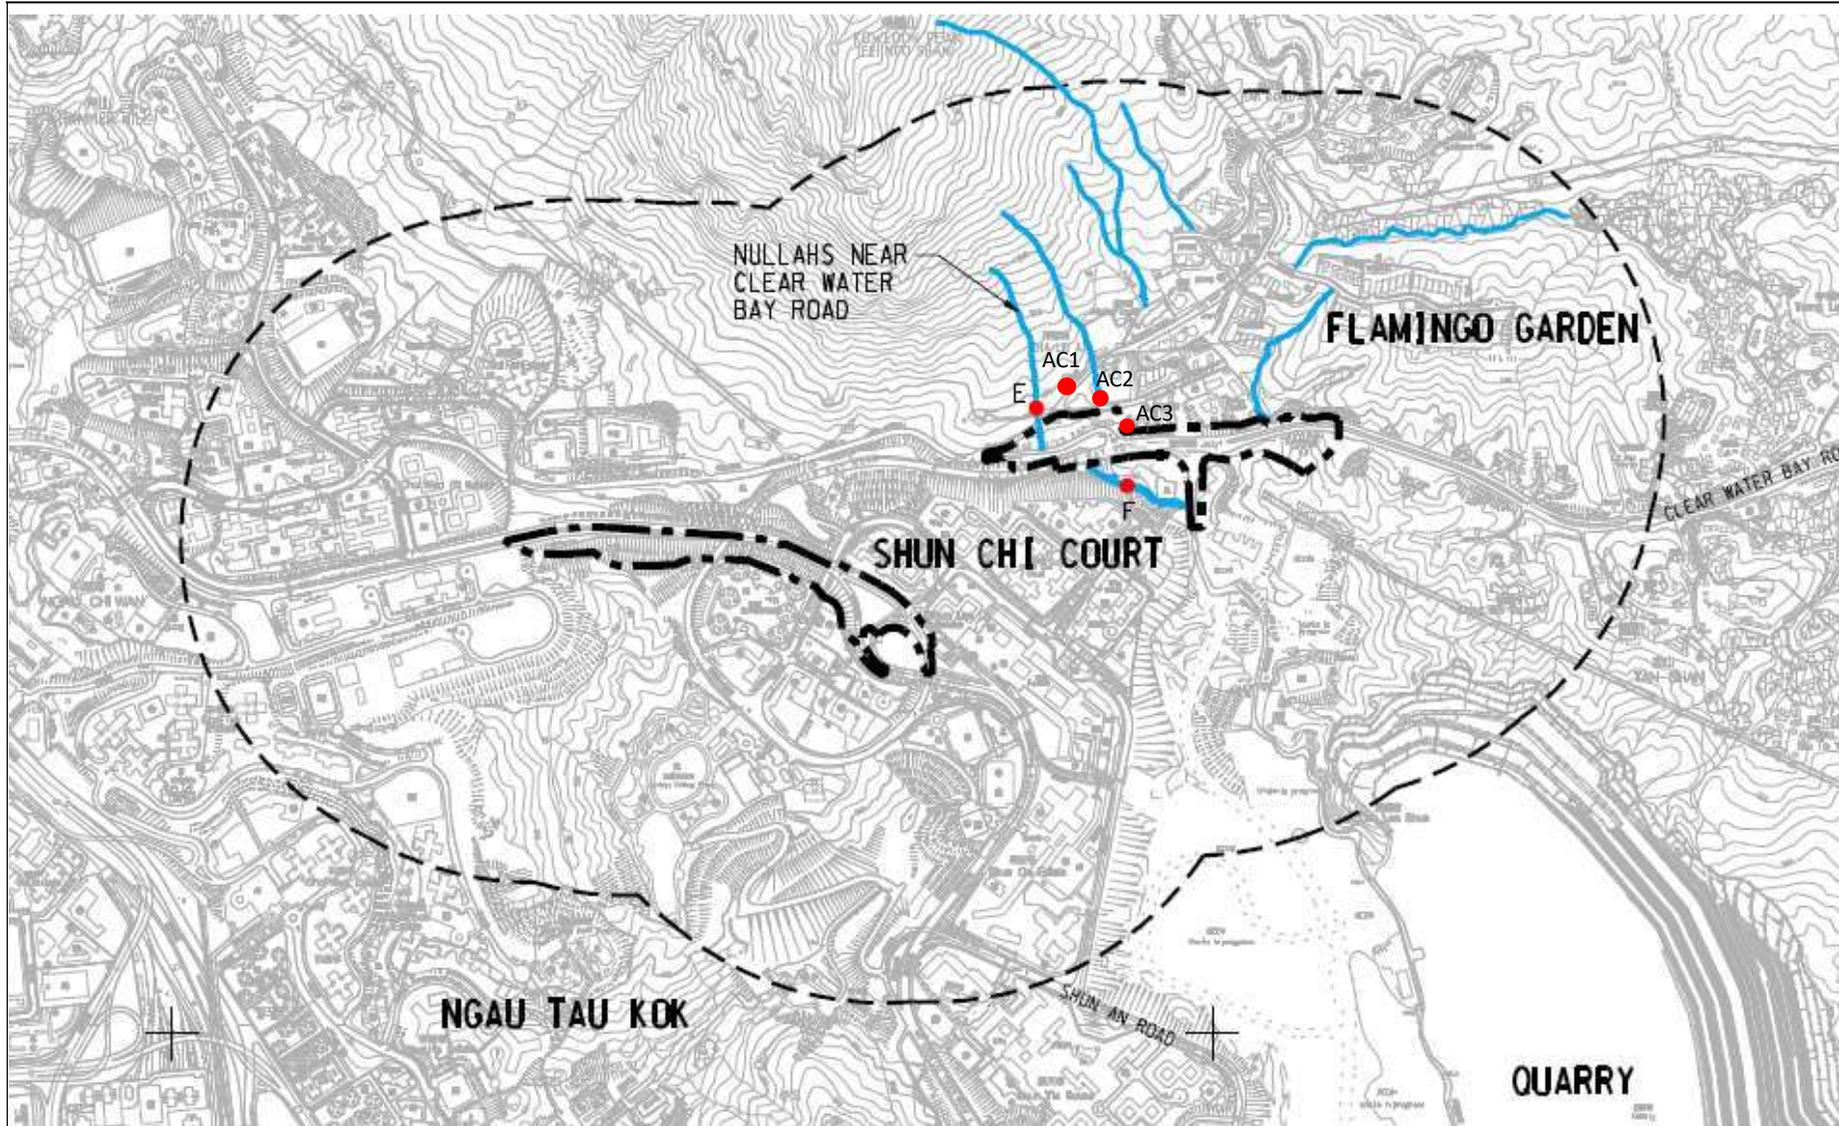
Figure 4.5
Location of Water Quality Monitoring Station
(for Road Improvement Work 1 & 2)

Inland Water	Stations	Description
Channelized nullah across the Project site	E	Upstream Control Station
	F	Downstream Impact Station
	AC1	Upstream Reference Station
	AC2	Upstream Reference Station
	AC3	Upstream Reference Station

It is recommended that upstream monitoring station (monitoring station E, AC1, AC2, AC3 and H) would be taken as control reference for exceedance investigation only. Action and limit level would not be establish using the baseline data.

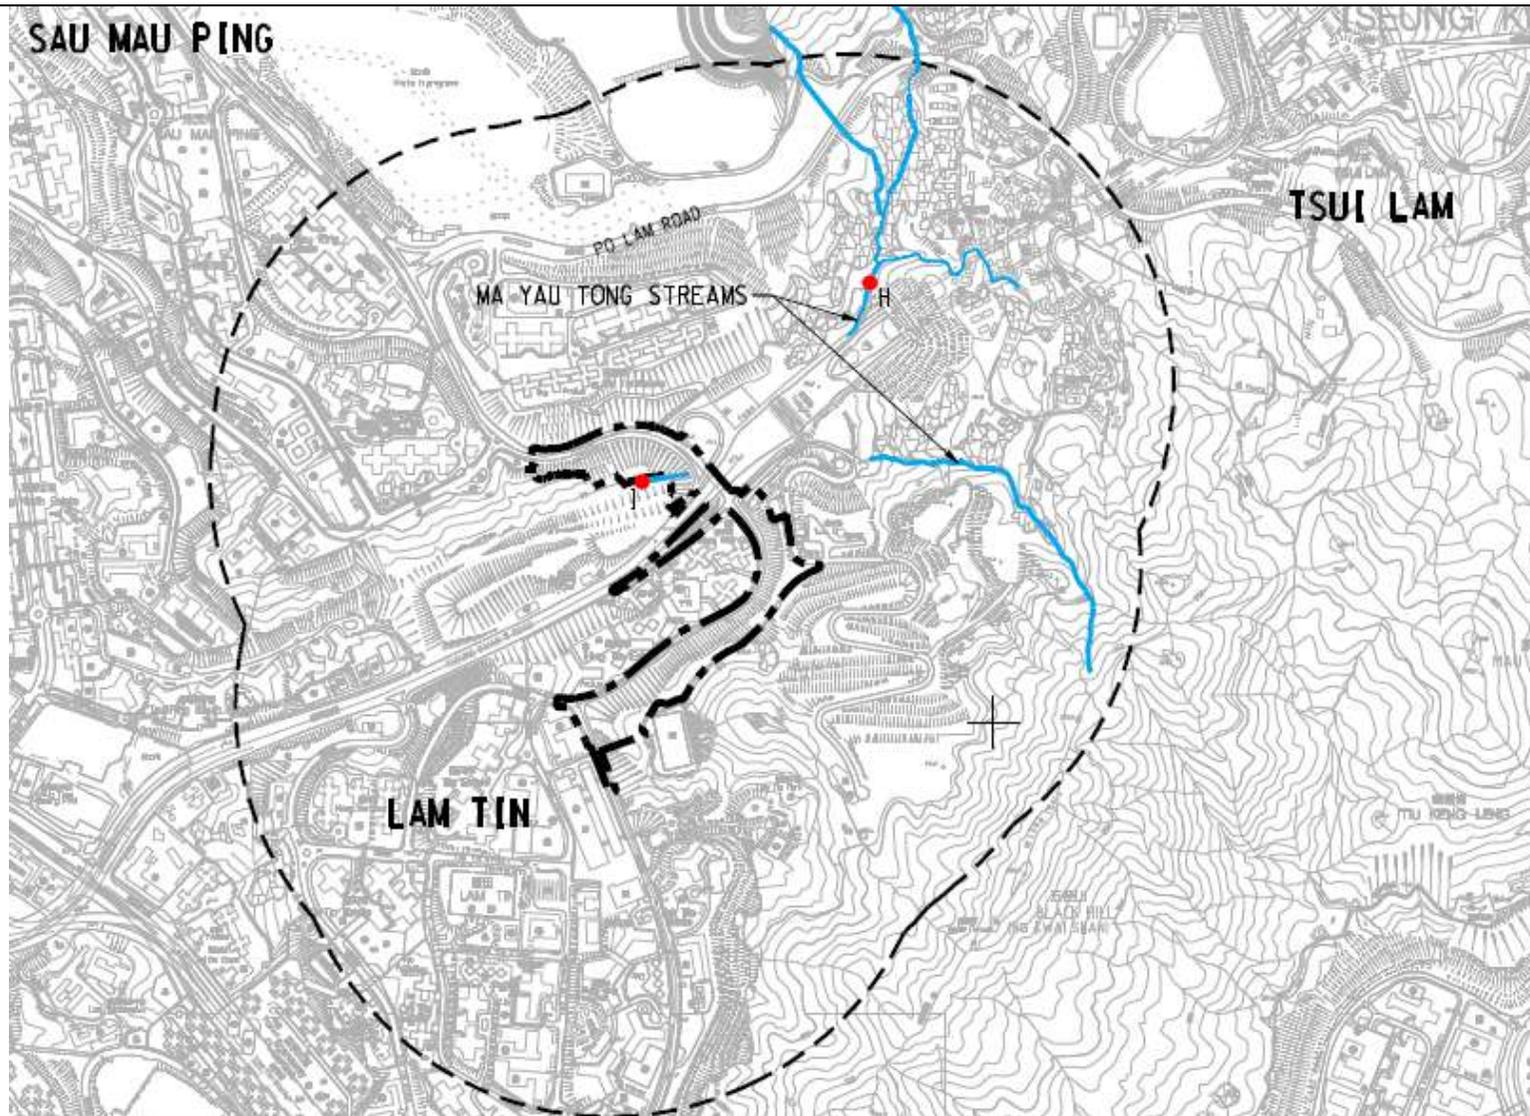
Figure 4.6
Location of Water Quality Monitoring Station
(for Road Improvement Work 3)

Inland Water	Stations	Description
Ma Yau Tong Stream	H	Upstream Control Station
	I	Downstream Impact Station

It is recommended that upstream monitoring station (monitoring station E and H) would be taken as control reference for exceedance investigation only. Action and limit level would not be establish using the baseline data.

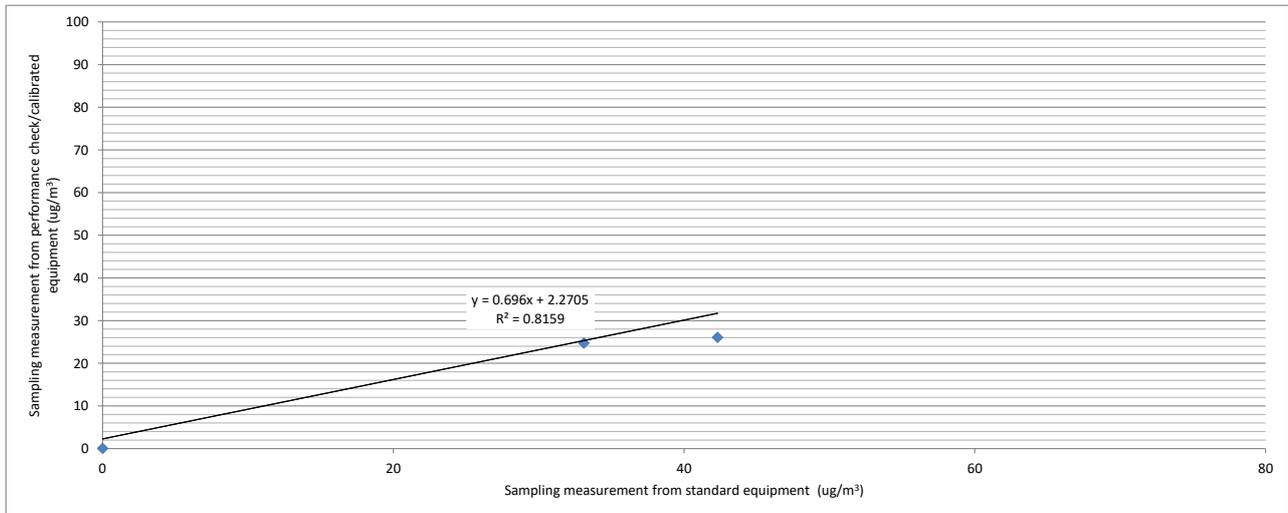
Linear Regression of Y on X

Slope (K- factor) : 1.2000
Correlation Coefficient : 0.9033
Validity of Performance Check / Calibration Record : 28/8/2020

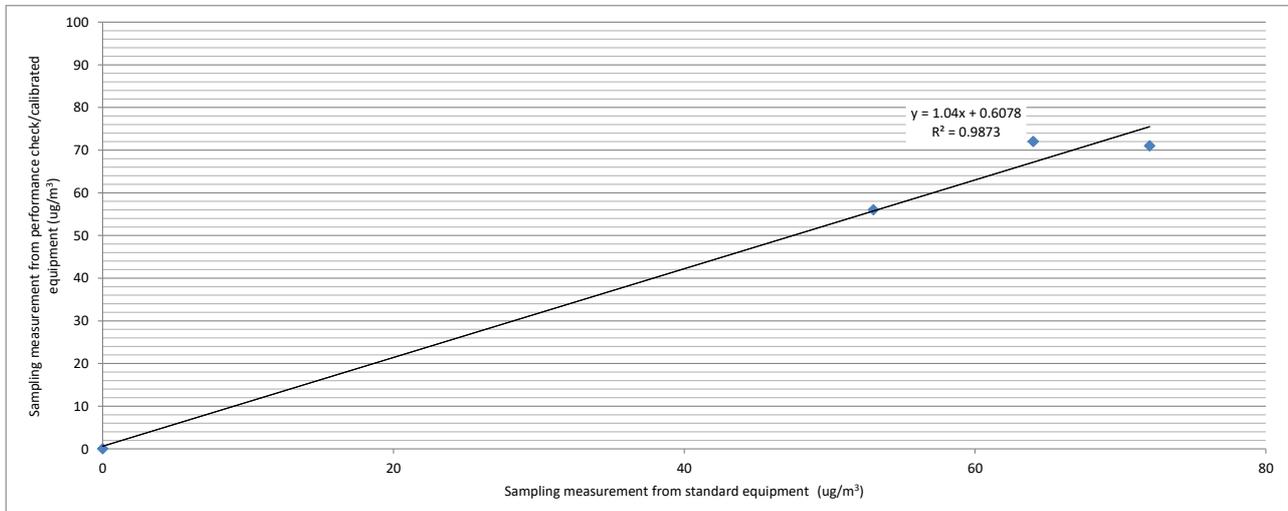
Linear Regression of Y on X

Slope (K- factor) : 1.0000
Correlation Coefficient : 0.9936
Validity of Performance Check / Calibration Record : 13/3/2020

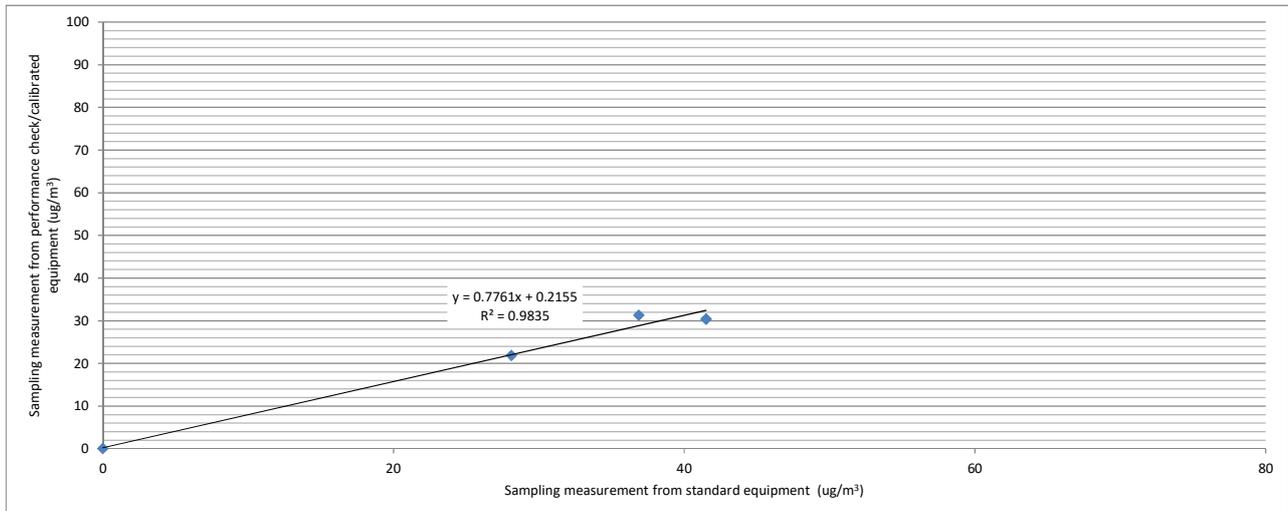
Linear Regression of Y on X

Slope (K- factor) : 1.3000
 Correlation Coefficient : 0.9917
 Validity of Performance Check / Calibration Record : 19/6/2020

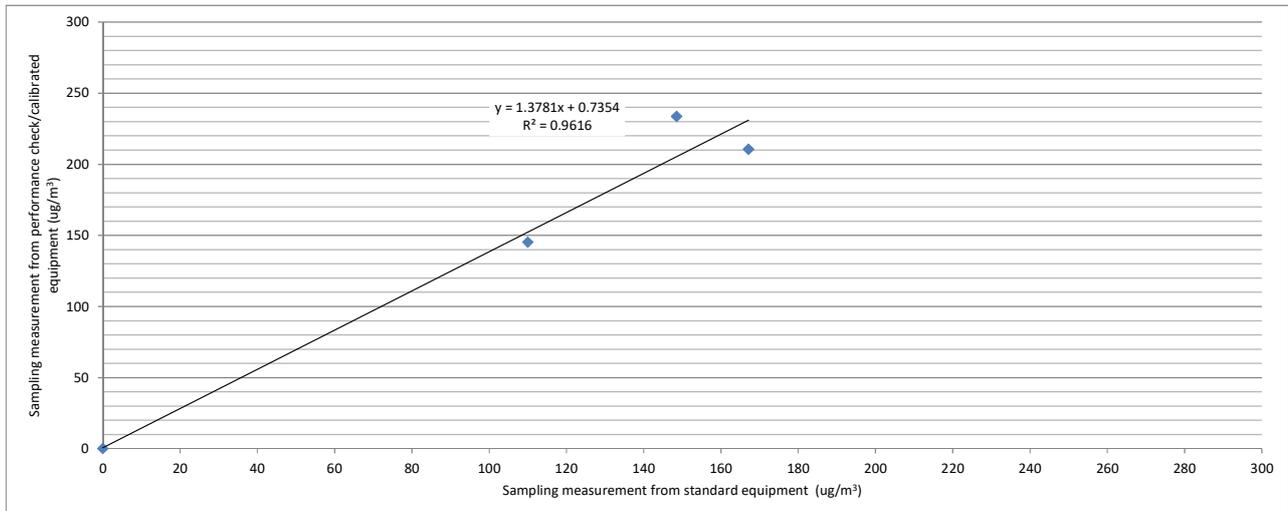
Linear Regression of Y on X

Slope (K- factor) : 0.7000
Correlation Coefficient : 0.9806
Validity of Performance Check / Calibration Record : 29/9/2020

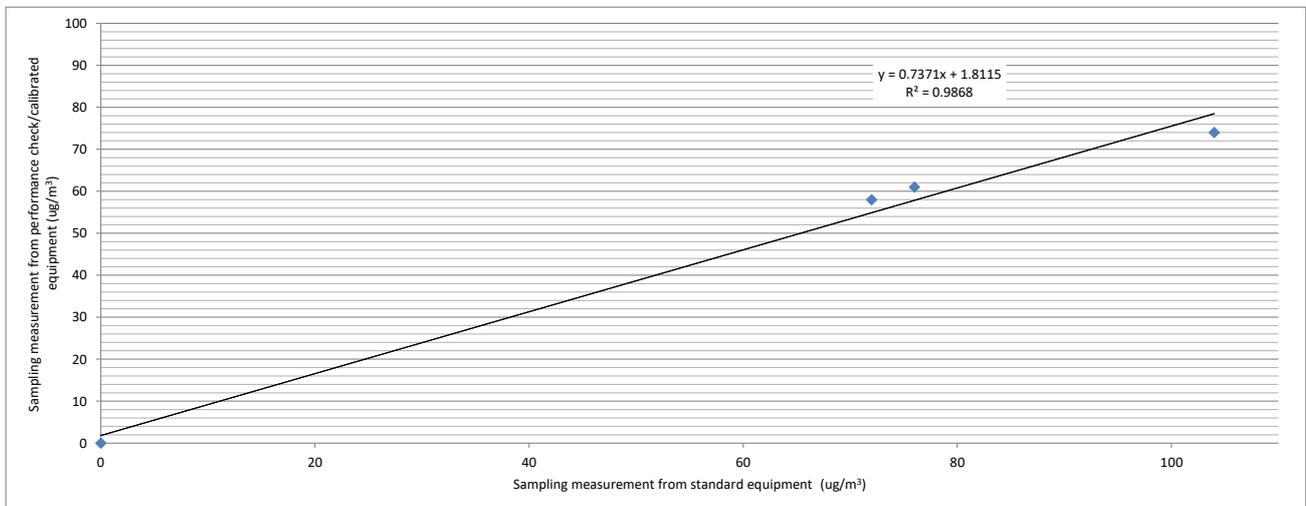
Linear Regression of Y on X

Slope (K- factor) : 1.4000
 Correlation Coefficient : 0.9934
 Validity of Performance Check / Calibration Record : 13/3/2020

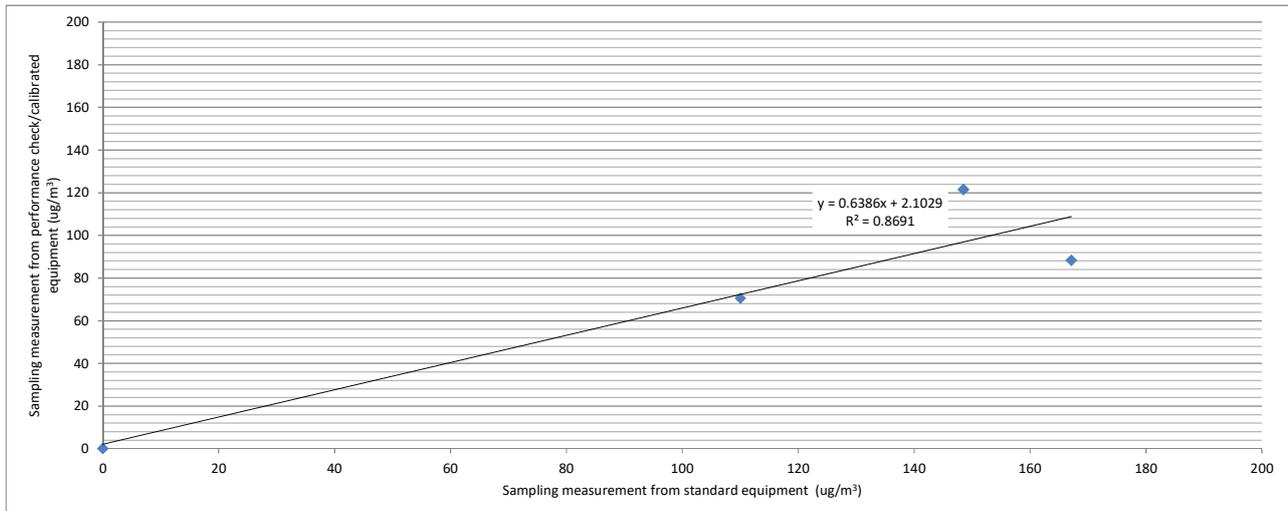
Linear Regression of Y on X

Slope (K- factor) : 1.4000
Correlation Coefficient : 0.9323
Validity of Performance Check / Calibration Record : 29/9/2020

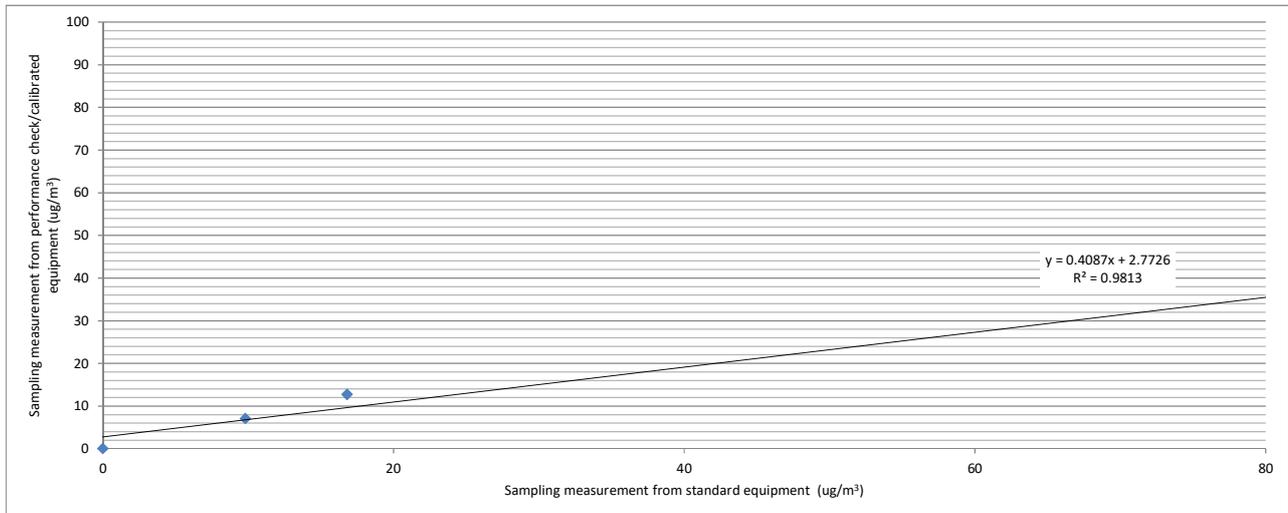
Linear Regression of Y on X

Slope (K- factor) : 2.5000
Correlation Coefficient : 0.9906
Validity of Performance Check / Calibration Record : 28/7/2020

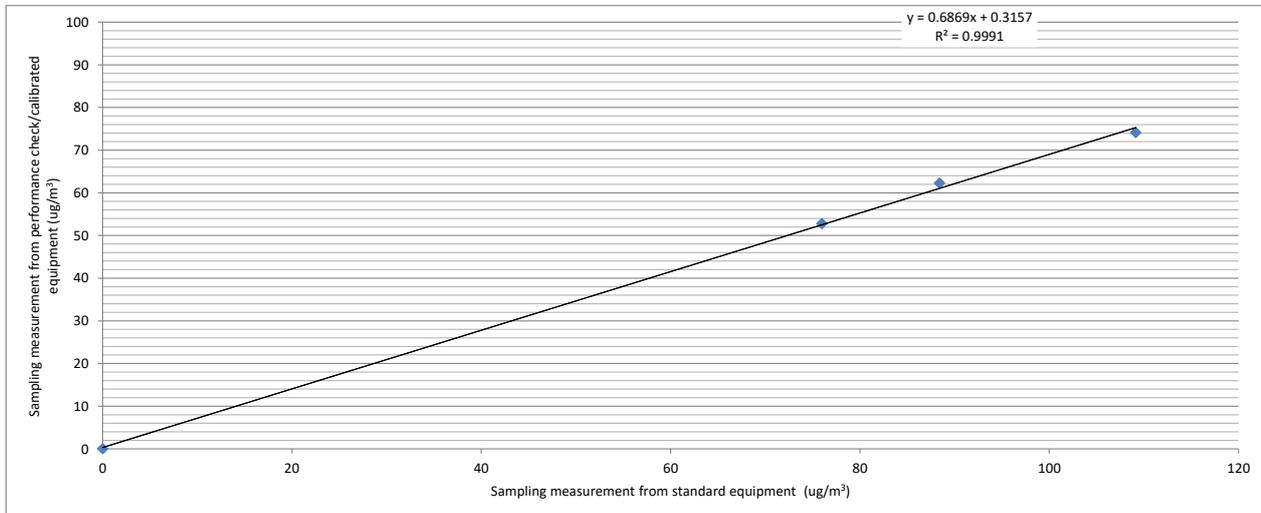
Linear Regression of Y on X

Slope (K- factor) : 1.5000
Correlation Coefficient : 0.9995
Validity of Performance Check / Calibration Record : 10/1/2020

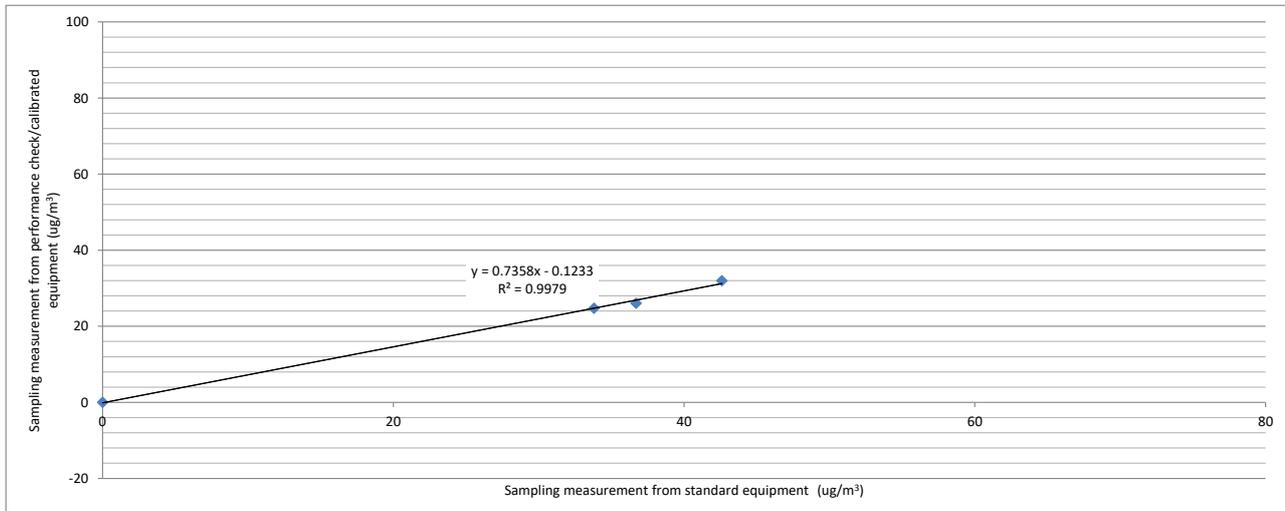
Linear Regression of Y on X

Slope (K- factor) : 1.4000
 Correlation Coefficient : 0.9989
 Validity of Performance Check / Calibration Record : 7/7/2020

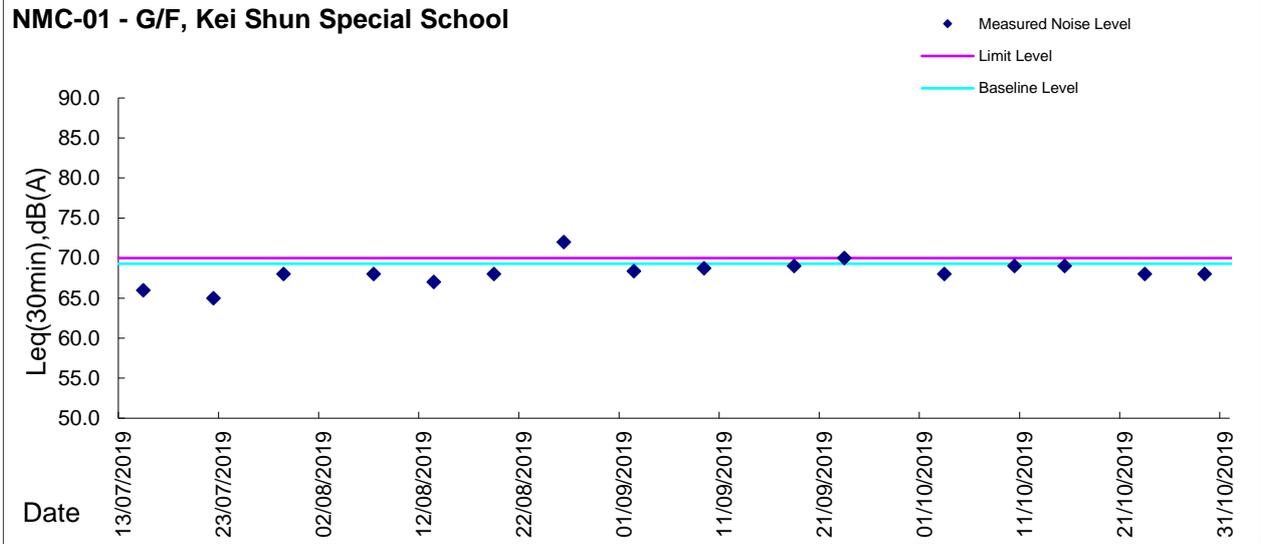
NMC-01 - G/F, Kei Shun Special School

Day Time (0700 - 1900hrs on normal weekdays)
