Service Contract No: EDO/01/2017 Environmental Team for Development of Anderson Road Quarry Site Road Improvement Works Monthly EM&A Report (April 2020)

ENVIRONMENTAL TEAM FOR DEVELOPMENT OF ANDERSON ROAD QUARRY SITE -ROAD IMPROVEMENT WORKS

MONTHLY ENVIRONMENTAL MONITORING & AUDIT REPORT

APRIL 2020

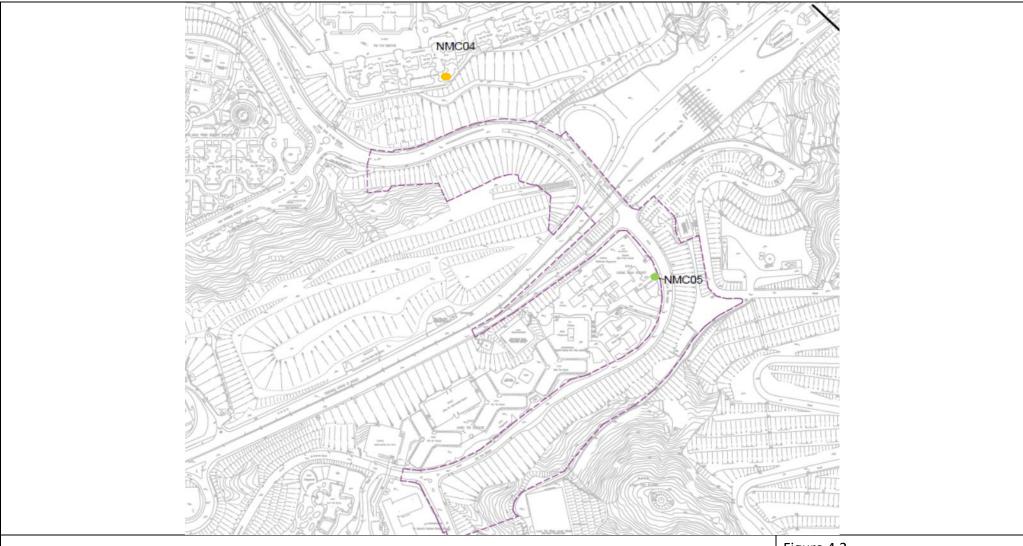
Figure 4.2
Location of Noise Monitoring Station
(Construction Phase)
(for Road Improvement Work 3)

Monitoring Location ID	Description
NMC04	Po Tat Estate Tat Kai House
NMC05	Hong Wah Court Block B Yee Hong House

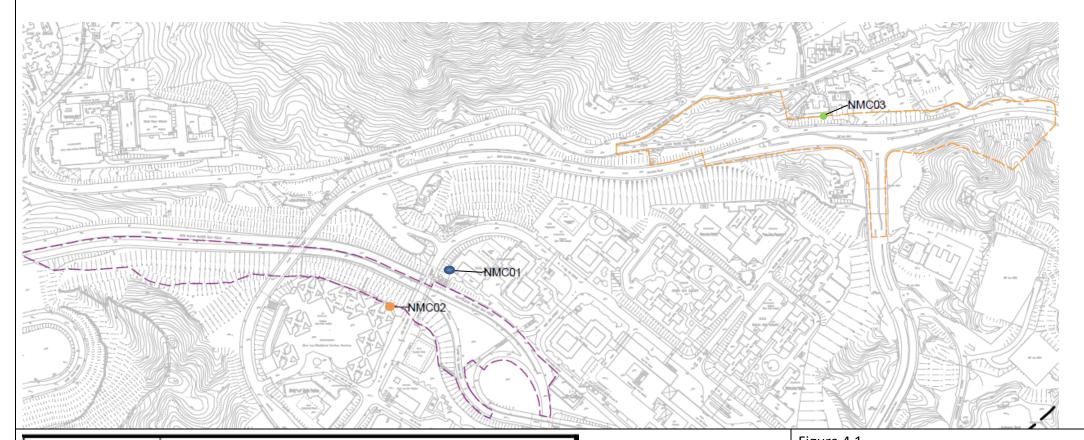
Figure 4.1
Location of Noise Monitoring Station
(Construction Phase)
(for Road Improvement Work 1 & 2)

Monitoring Location ID	Description
Noise Monitoring	Station (Construction Phase)
NMC01	Kei Shun Special School
NMC02	Shun Lee Disciplined Services Quarters Block 6
NMC03	Sienna Garden Block 6

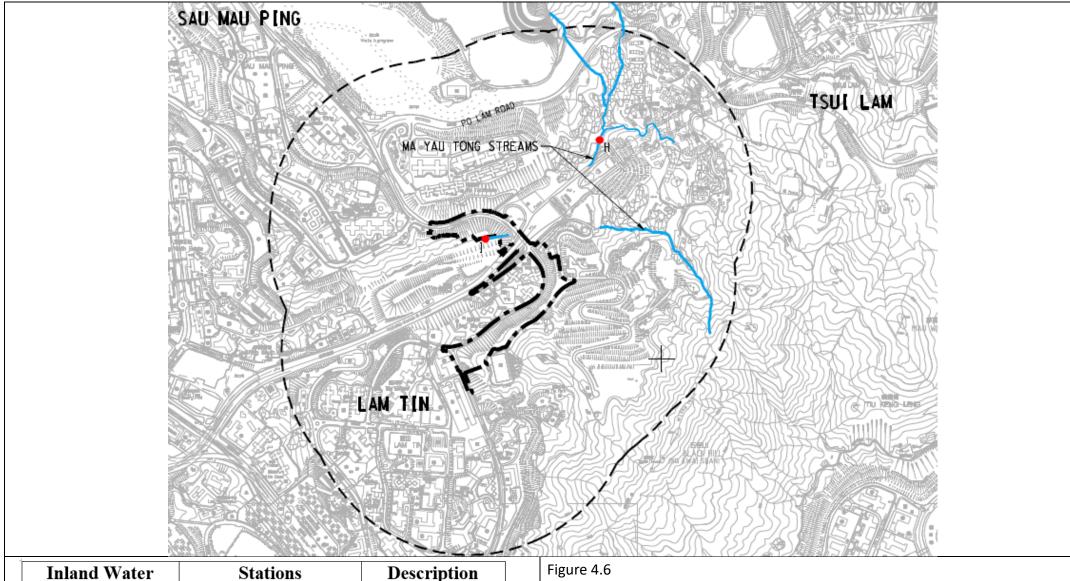
Location of Water Quality Monitoring Station (for Road Improvement Work 3)

Inland Water	Stations	Description
Ma Yau Tong	Н	Upstream
Stream		Control Station
	I	Downstream
		Impact Station

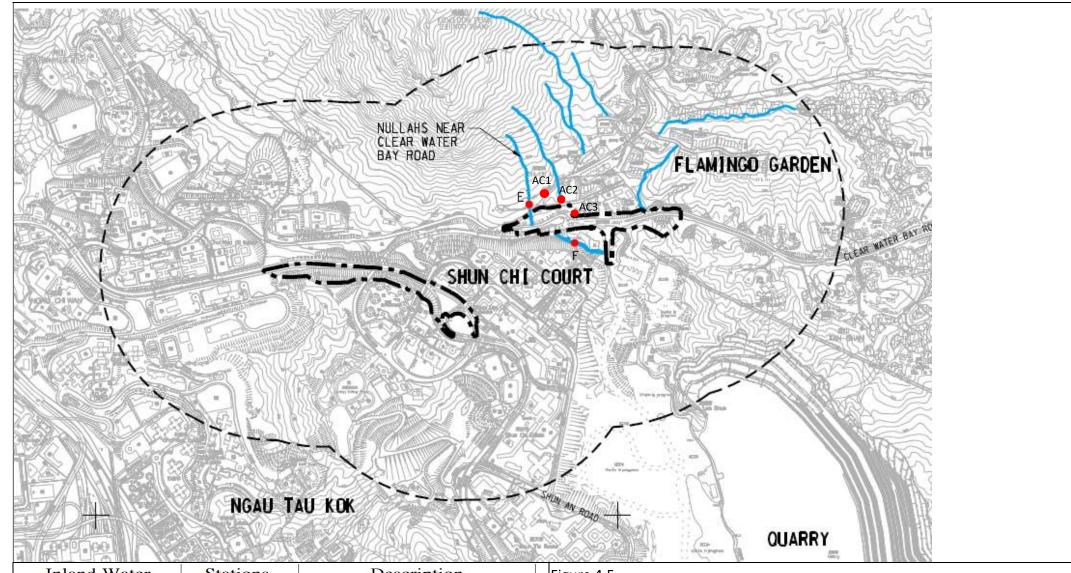
Figure 4.5
Location of Water Quality Monitoring Station
(for Road Improvement Work 1 & 2)

Inland Water	Stations	Description
	Е	Upstream Control Station
Channelized nullah	F	Downstream Impact Station
across the Project	AC1	Upstream Reference Station
site	AC2	Upstream Reference Station
	AC3	Upstream Reference Station

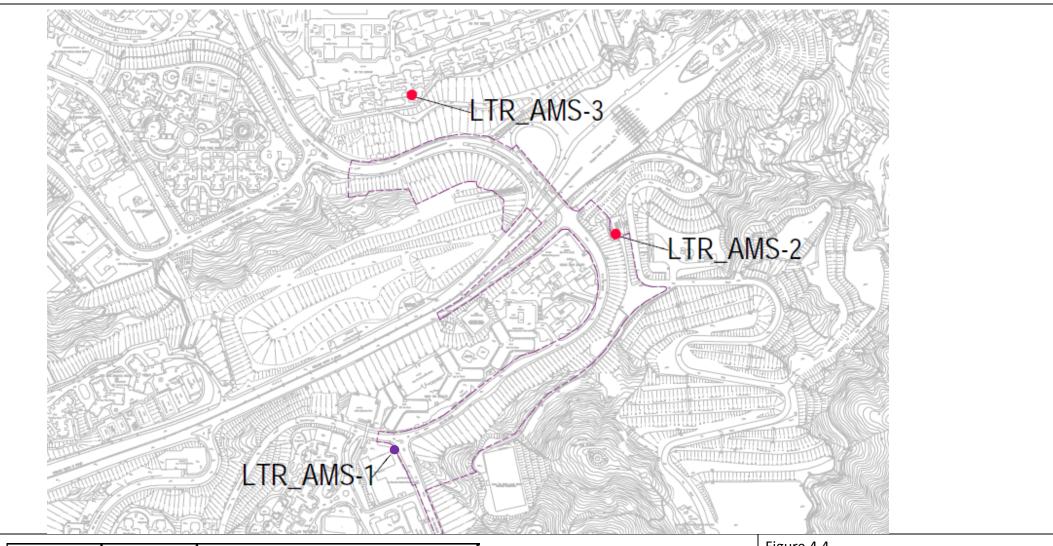
Figure 4.4
Location of Air Quality Monitoring Station
(for Road Improvement Work 3)

Monitoring Station ID	EIA ID	Location				
LTR RIW						
LTR_AMS-1	ASECP-2 St Edward's Catholic Primary School					
LTR_AMS-2	R_AMS-2 AEPD-01 Environmental Protection Departm Restored Landfill Site Office					
LTR_AMS-3	APTE-14	Po Tat Estate Tat Kai House

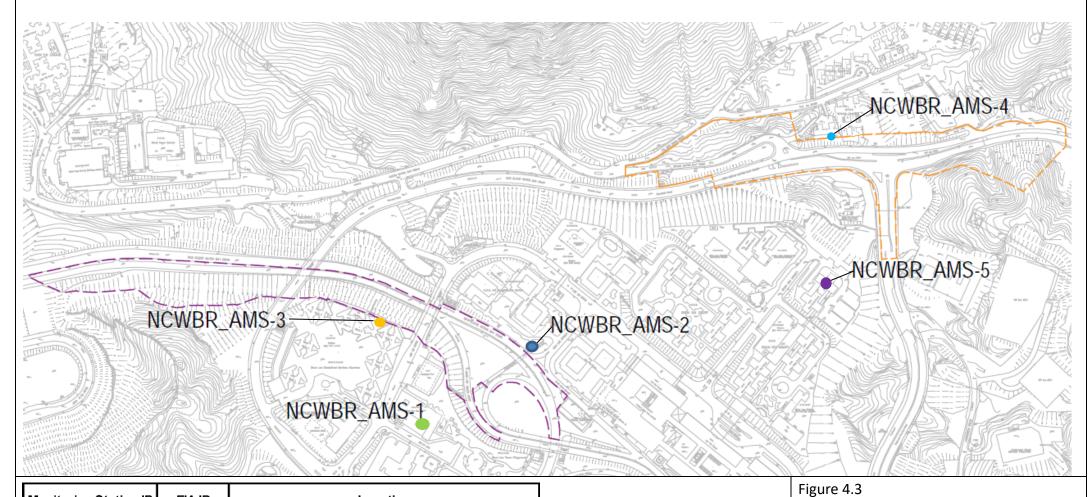
Figure 4.3
Location of Air Quality Monitoring Station
(for Road Improvement Work 1 & 2)

Monitoring Station ID	EIA ID	Location					
NCWBR RIW							
NCWBR_AMS-1	IS-1 ASLF-1 Shun Lee Fire Station						
NCWBR_AMS-2	ASLE-21	Shun Lee Estate Lee Hang House					
NCWBR_AMS-3	ASLD-10	Shun Lee Disciplined Services Quarters (Block 6)					
NCWBR_AMS-4	AFNS-3	Sienna Garden					
NCWBR_AMS-5	ASCC-05	Shun Chi Court Shun Fung House

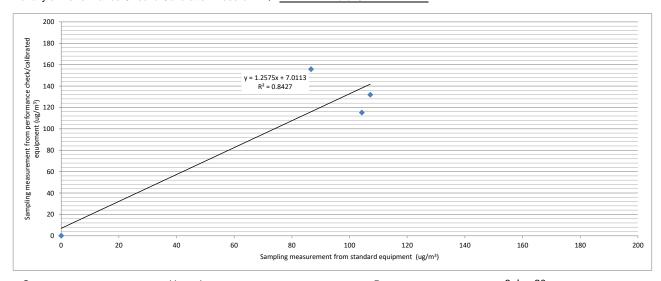
Linear Regression of Y on X

Slope (K- factor) : 0.700
Correlation Coefficient : 0.918
Validity of Performance Check / Calibration Record : 2/1/20
