**ENVIRONMENTAL TEAM FOR  
DEVELOPMENT OF  
ANDERSON ROAD QUARRY SITE -  
ROAD IMPROVEMENT WORKS**

**UNDER ENVIRONMENTAL PERMIT NO. EP-513/2016**

**MONTHLY ENVIRONMENTAL MONITORING & AUDIT REPORT**

**JANUARY 2021**

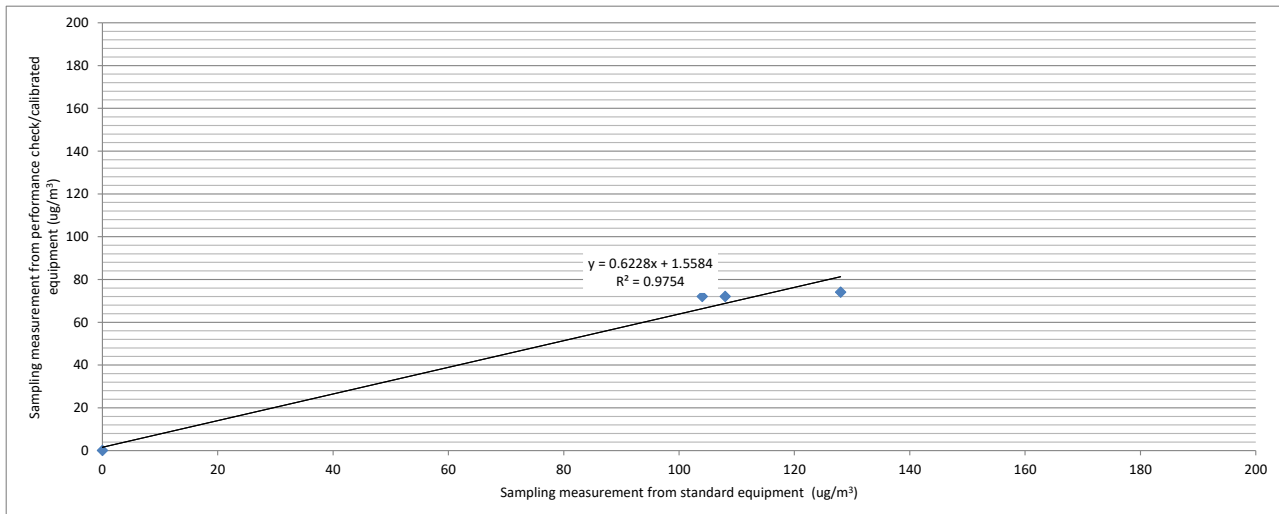
**Linear Regression of Y on X**

Slope (K- factor) : 1.6000  
 Correlation Coefficient : 0.9876  
 Validity of Performance Check / Calibration Record : 17/3/2021

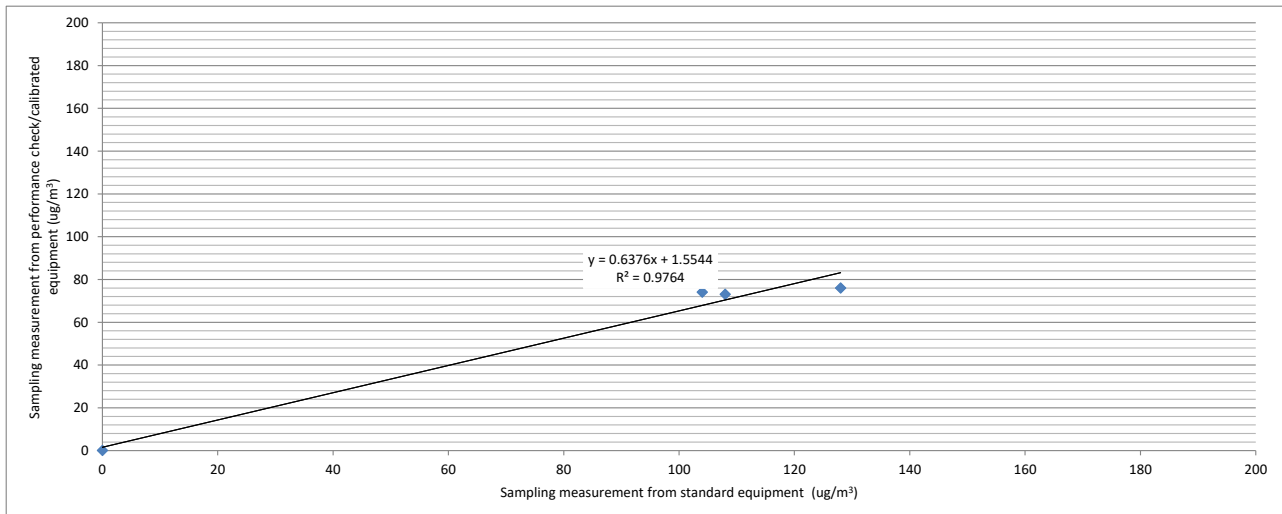
Linear Regression of Y on X

Slope (K- factor) : 1.6000
Correlation Coefficient : 0.9881
Validity of Performance Check / Calibration Record : 17/3/2021

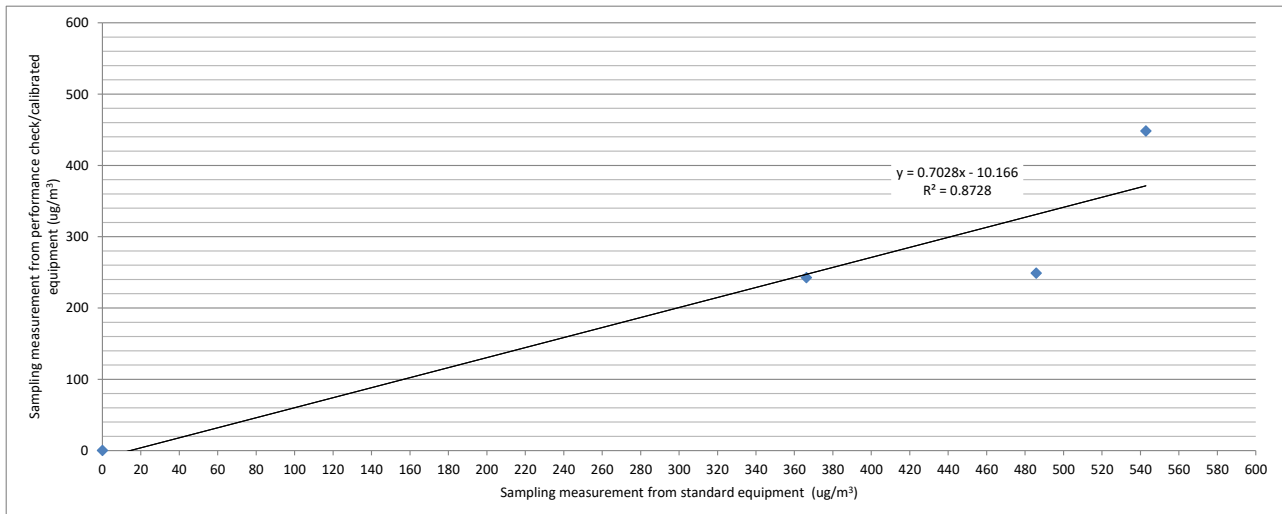
Linear Regression of Y on X

Slope (K- factor) : 1.3000
Correlation Coefficient : 0.9342
Validity of Performance Check / Calibration Record : 16/9/2021

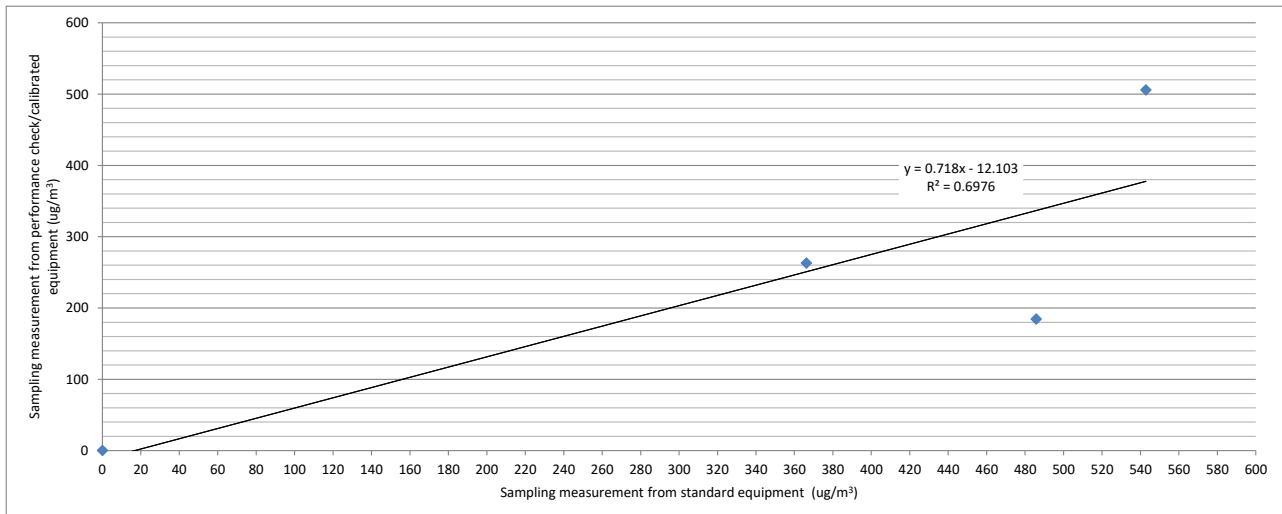
Linear Regression of Y on X

Slope (K- factor) : 1.0000
Correlation Coefficient : 0.8352
Validity of Performance Check / Calibration Record : 16/9/2021

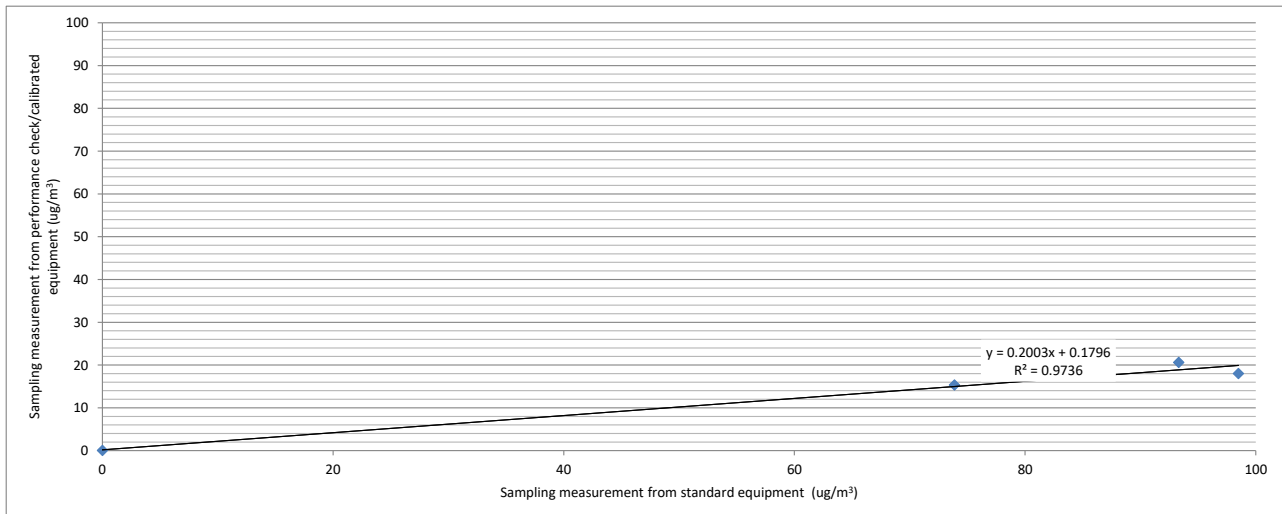
Linear Regression of Y on X

Slope (K- factor) : 4.9000
Correlation Coefficient : 0.9867
Validity of Performance Check / Calibration Record : 27/4/2021

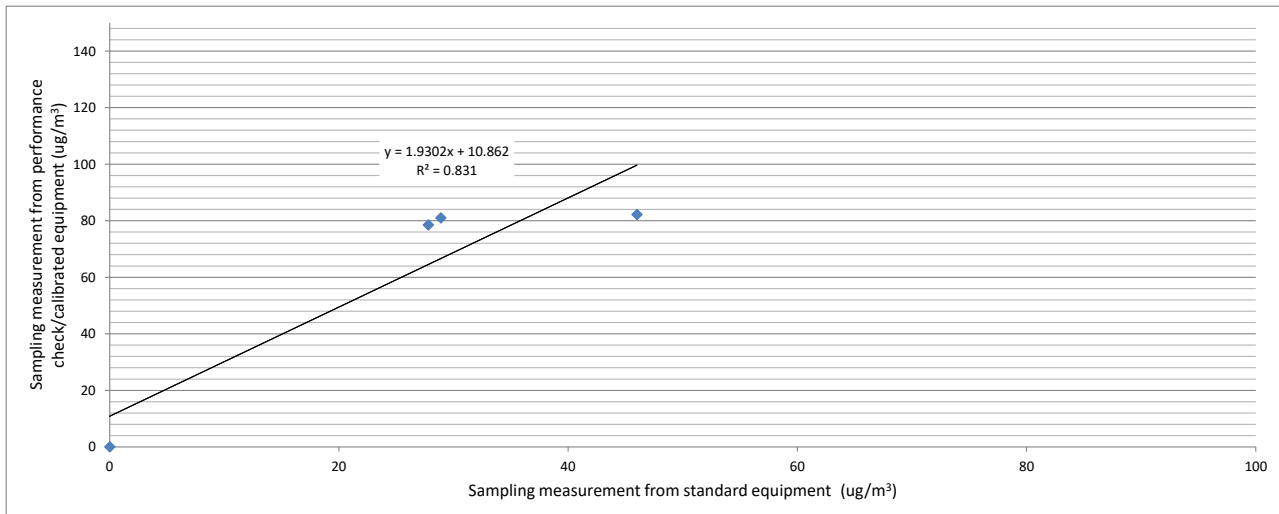
**Linear Regression of Y on X**

Slope (K- factor) : 0.5000  
 Correlation Coefficient : 0.9116  
 Validity of Performance Check / Calibration Record : 3/11/2021

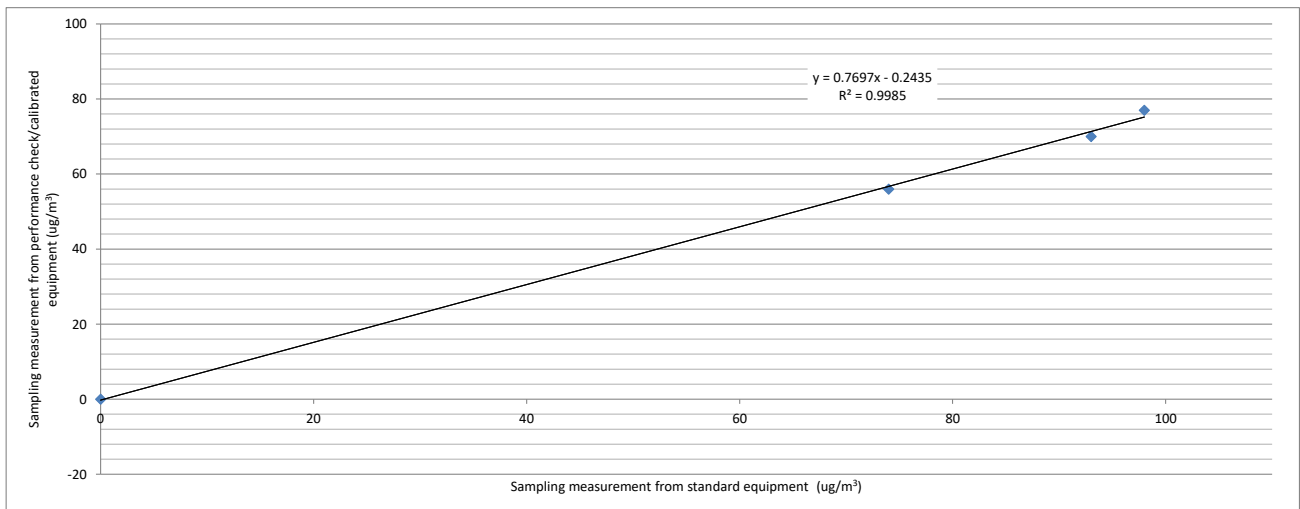
Linear Regression of Y on X

Slope (K- factor) : 1.3000  
 Correlation Coefficient : 0.9992  
 Validity of Performance Check / Calibration Record : 2/5/2021

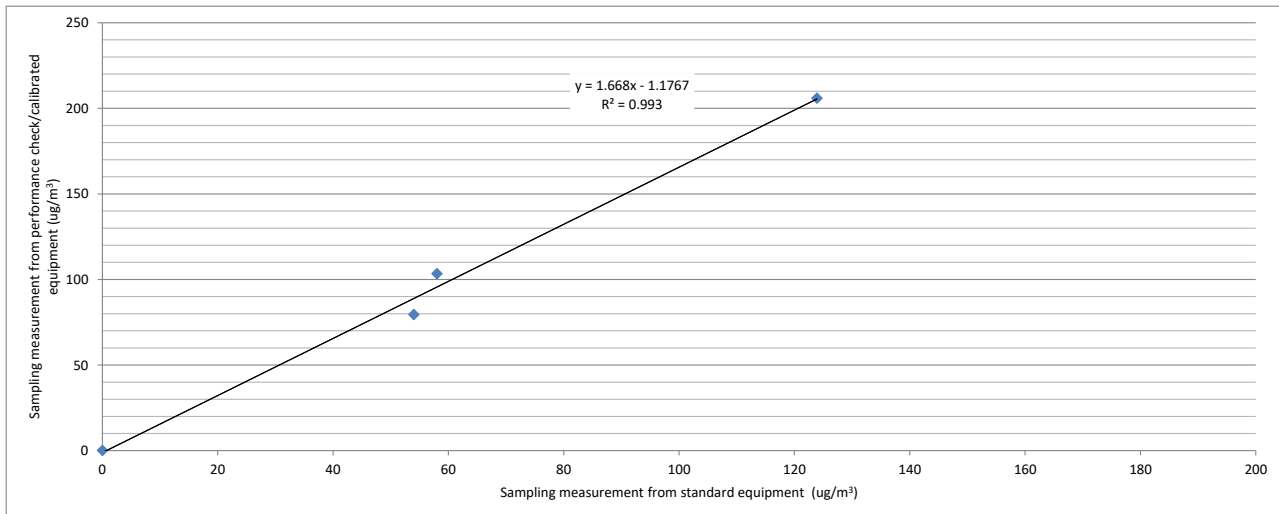
Linear Regression of Y on X

Slope (K- factor) : 0.6000
Correlation Coefficient : 0.9965
Validity of Performance Check / Calibration Record : 27/8/2021
