Service Contract No: EDO/01/2017
Environmental Team for
Development of Anderson Road Quarry Site
Road Improvement Works
Monthly EM&A Report (June 2021)

**ENVIRONMENTAL TEAM FOR
DEVELOPMENT OF
ANDERSON ROAD QUARRY SITE -
ROAD IMPROVEMENT WORKS**

MONTHLY ENVIRONMENTAL MONITORING & AUDIT REPORT

JUNE 2021

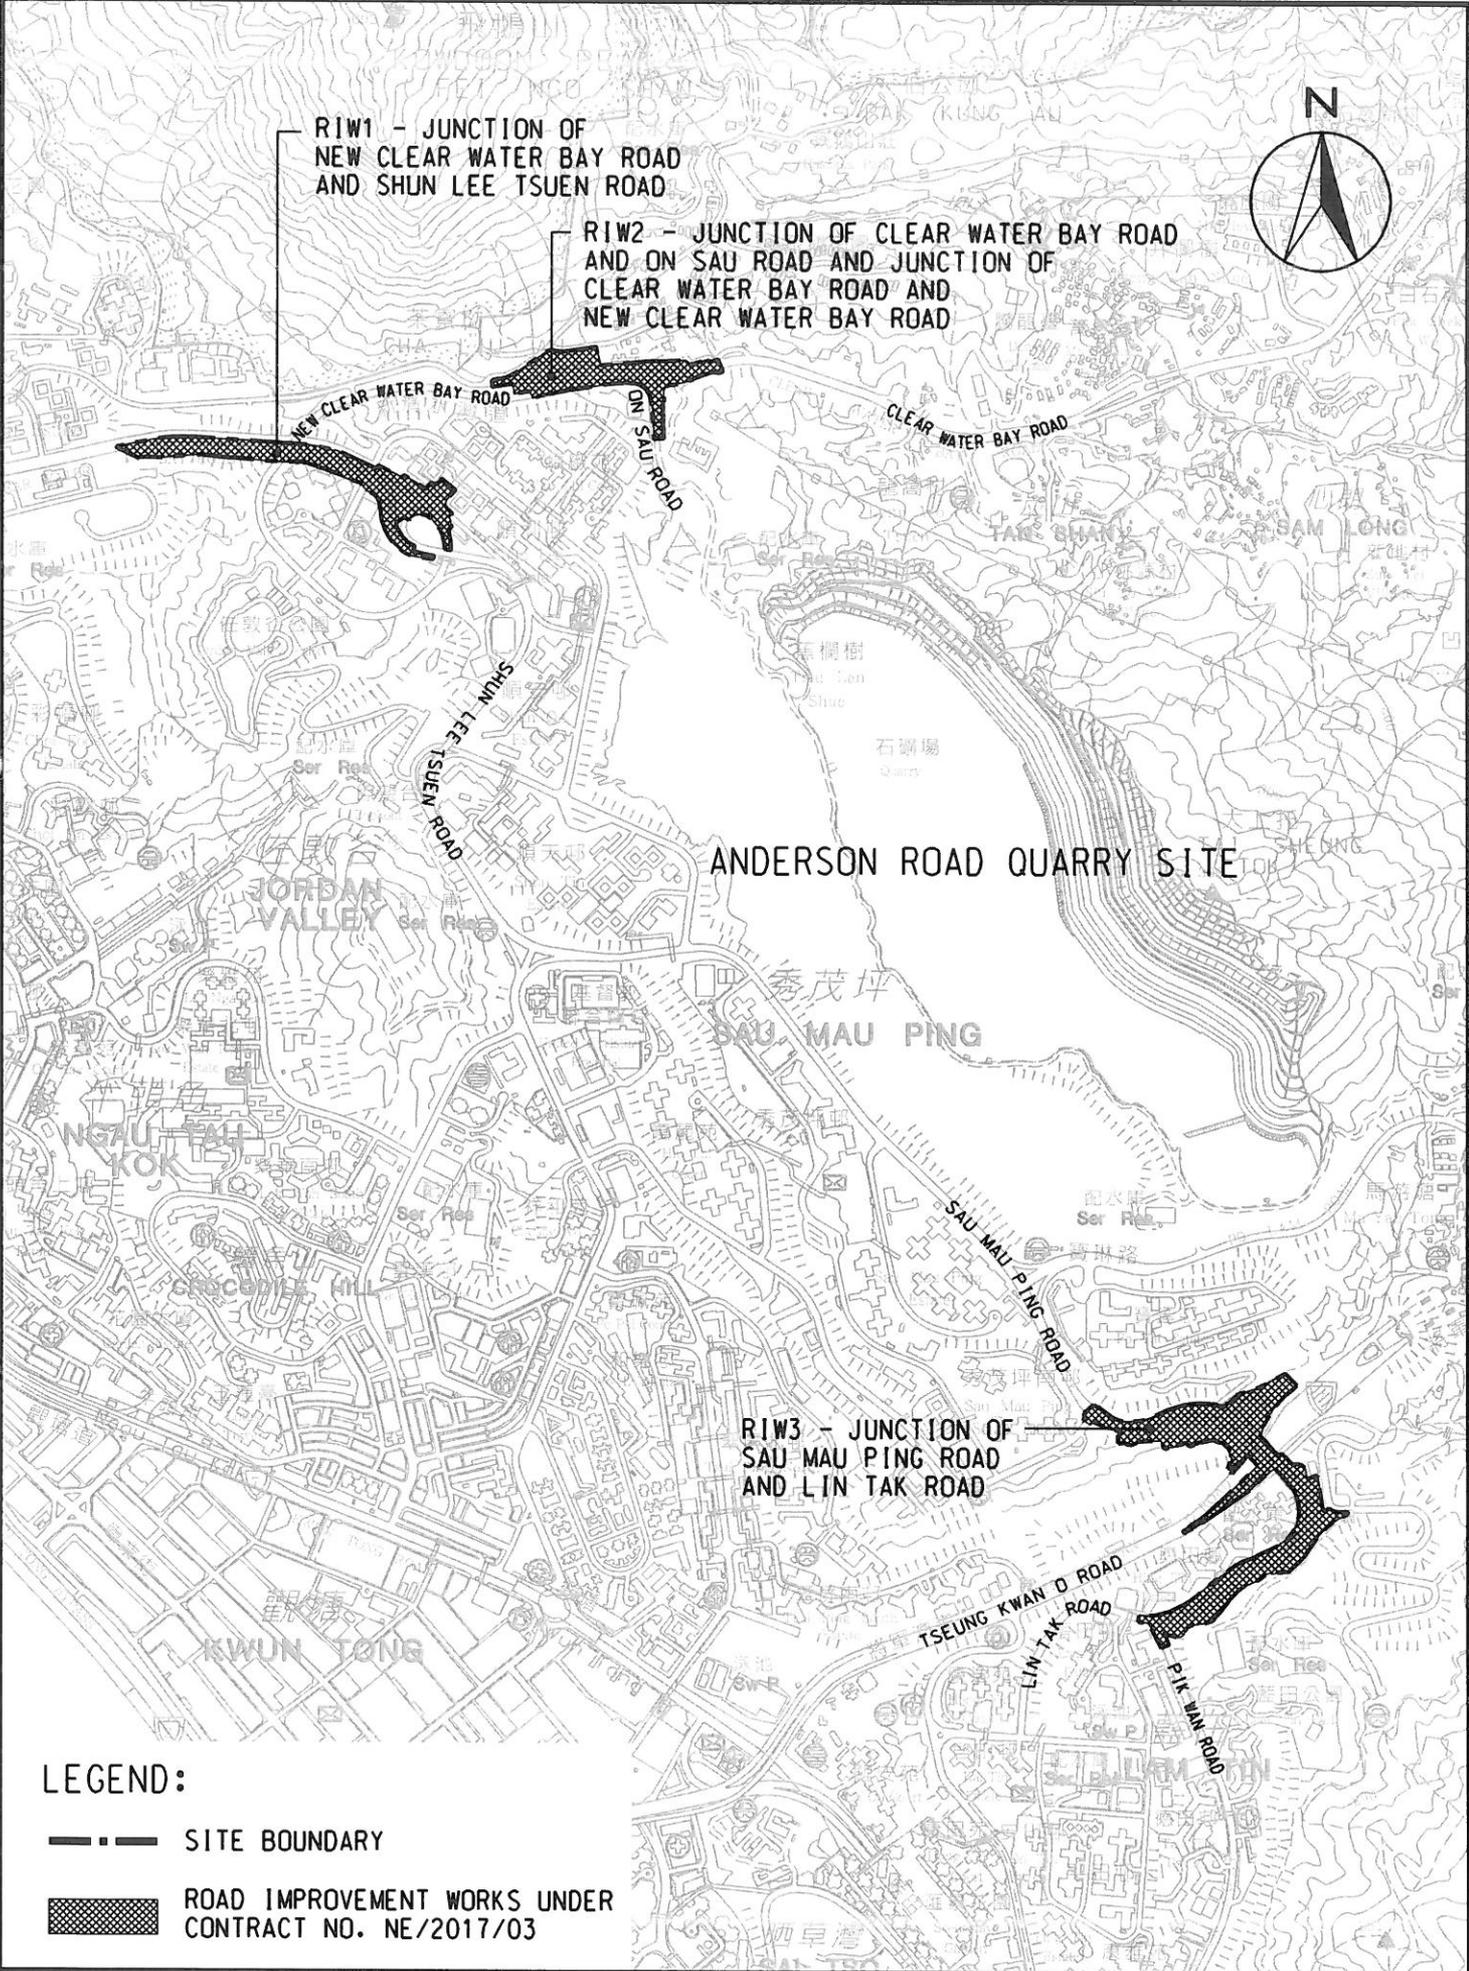
Figure 2.1

Project Layout

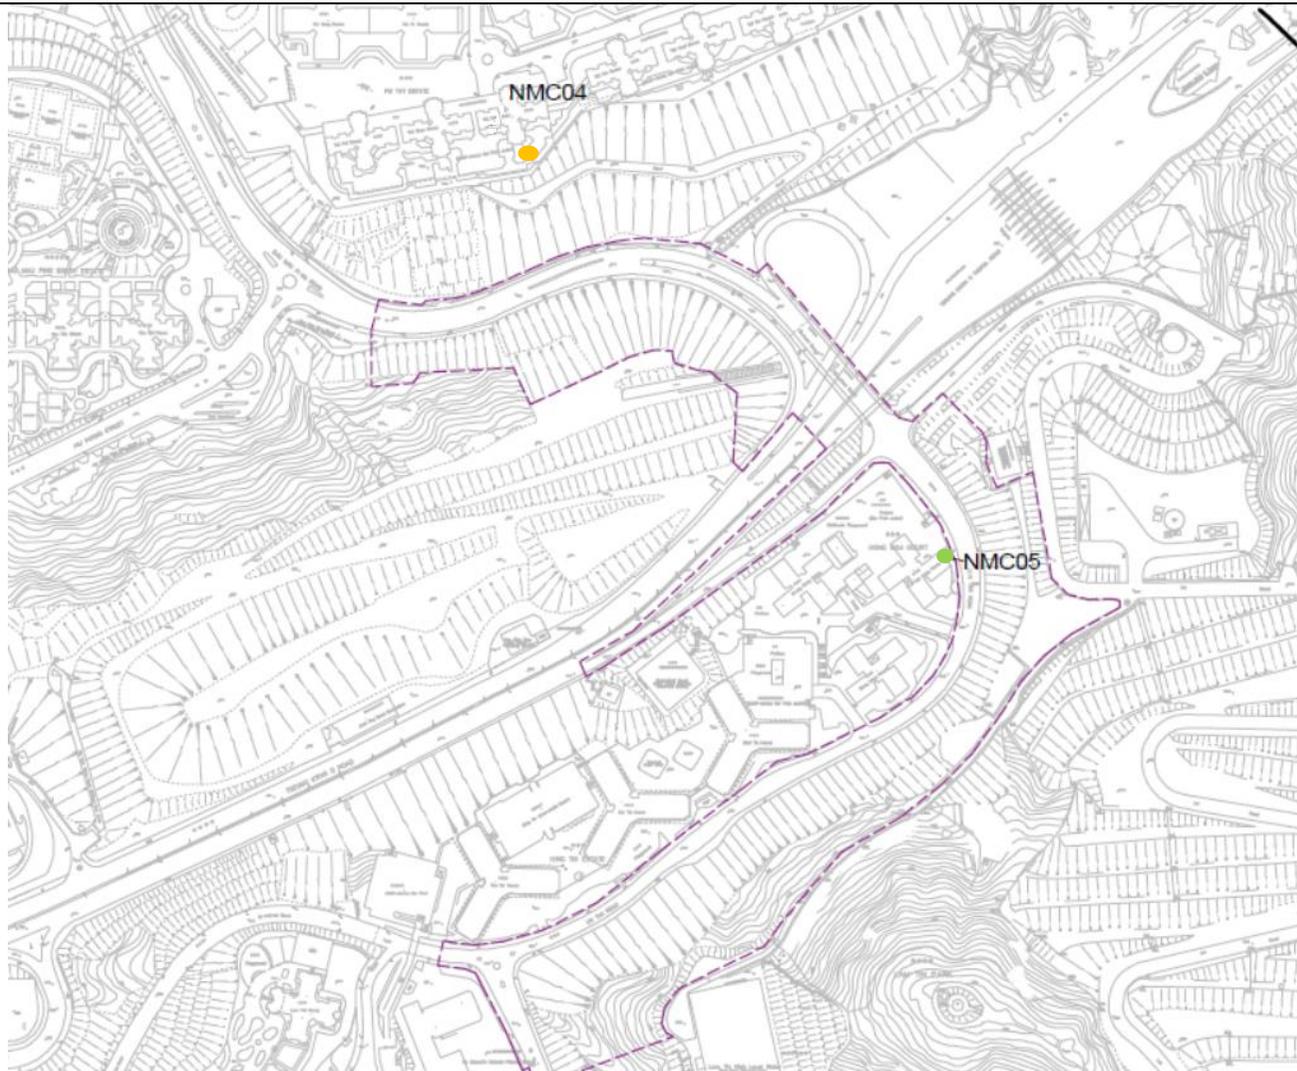
Figure 4.1
 Location of Noise Monitoring Station
 (Construction Phase)
 (for Road Improvement Work 1 & 2)

Monitoring Location ID	Description
<i>Noise Monitoring Station (Construction Phase)</i>	
NMC01	Kei Shun Special School
NMC02	Shun Lee Disciplined Services Quarters Block 6
NMC03	Sienna Garden Block 6

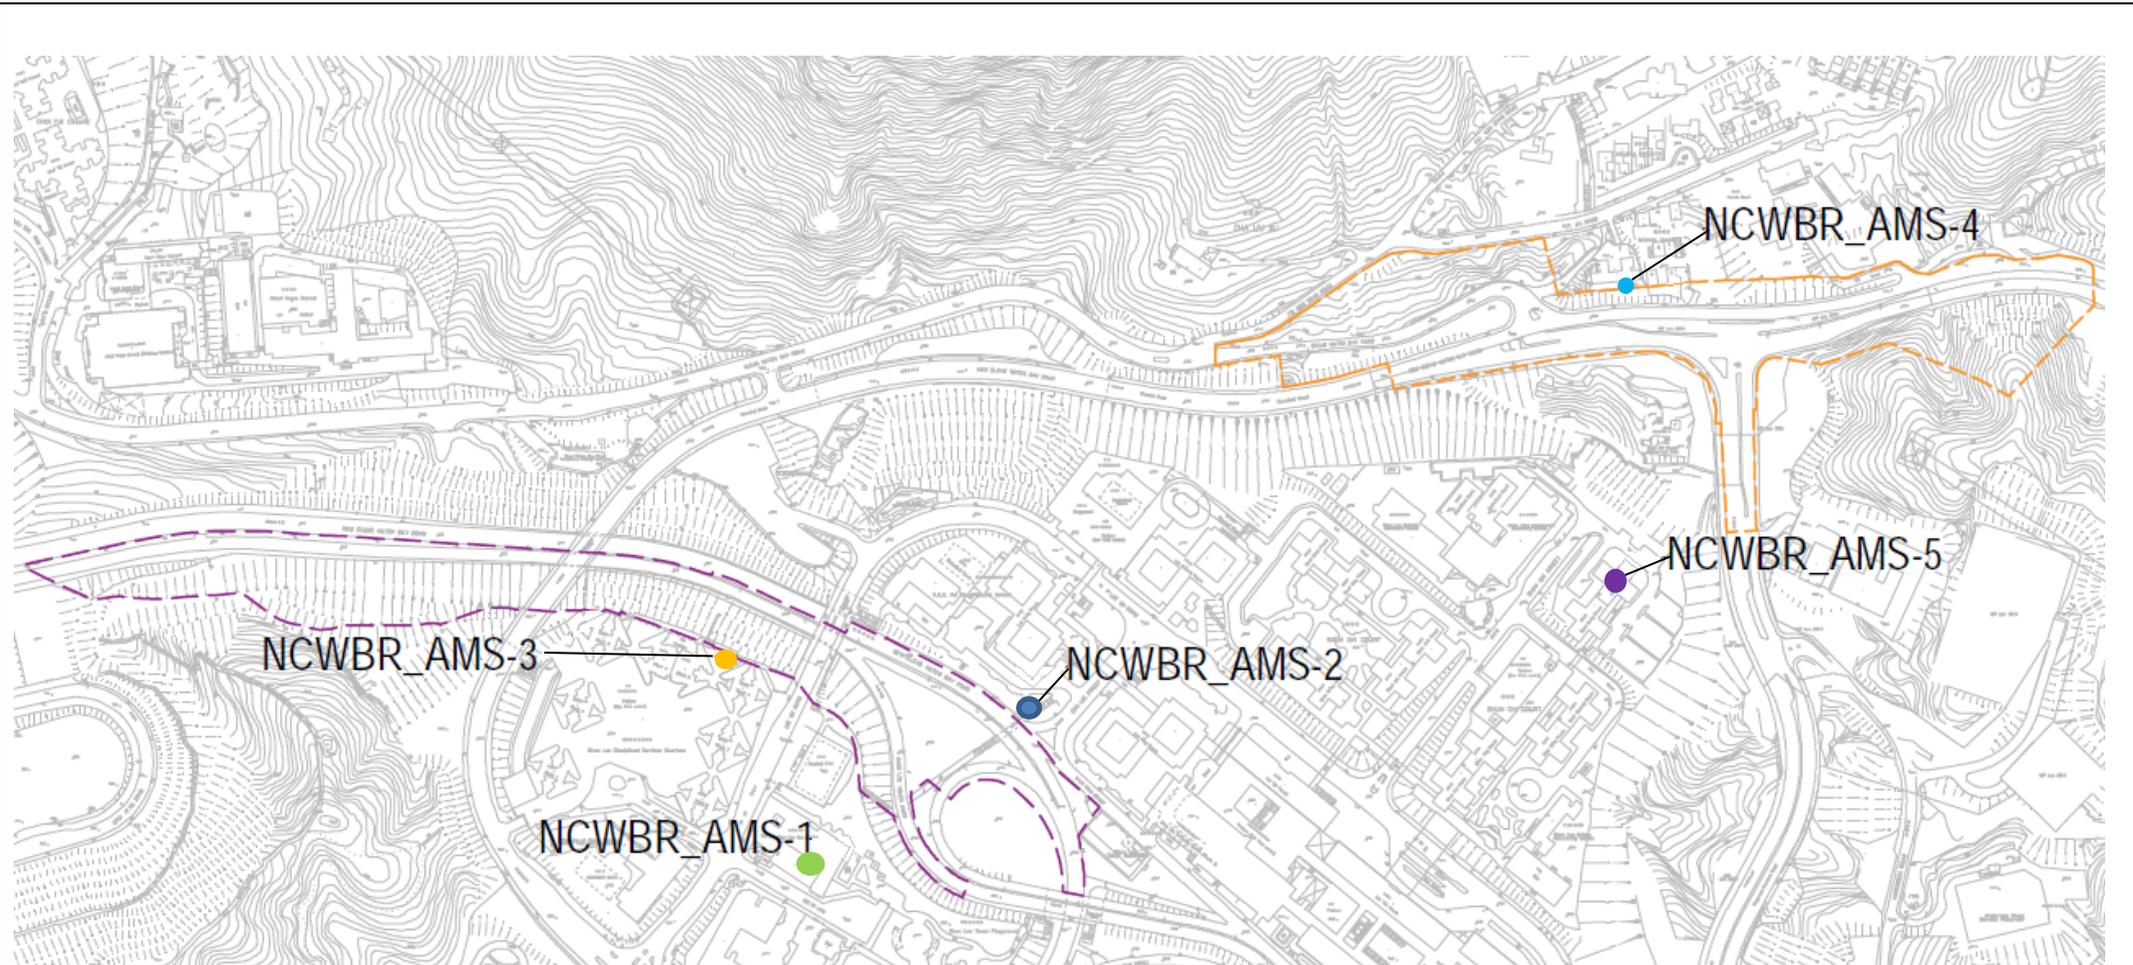
Figure 4.2
 Location of Noise Monitoring Station
 (Construction Phase)
 (for Road Improvement Work 3)

Monitoring Location ID	Description
NMC04	Po Tat Estate Tat Kai House
NMC05	Hong Wah Court Block B Yee Hong House

- vii. One limit level exceedance was recorded at NMC05 on 07 June 2021. After investigation, drilling and splitting works at RIW3 were conducted under Contract NE/2017/03 around the concerned location during the time of measurement. The drilling works at Link Tak Road was identified as the major noise source causing the exceedance by the observation during measurement on 07 June 2021. The working area of the driller was not fully covering by noise barrier or other mitigation measures for minimising the construction noise so that it was the major causes of the exceedance. As such, the exceedance was considered as project related.

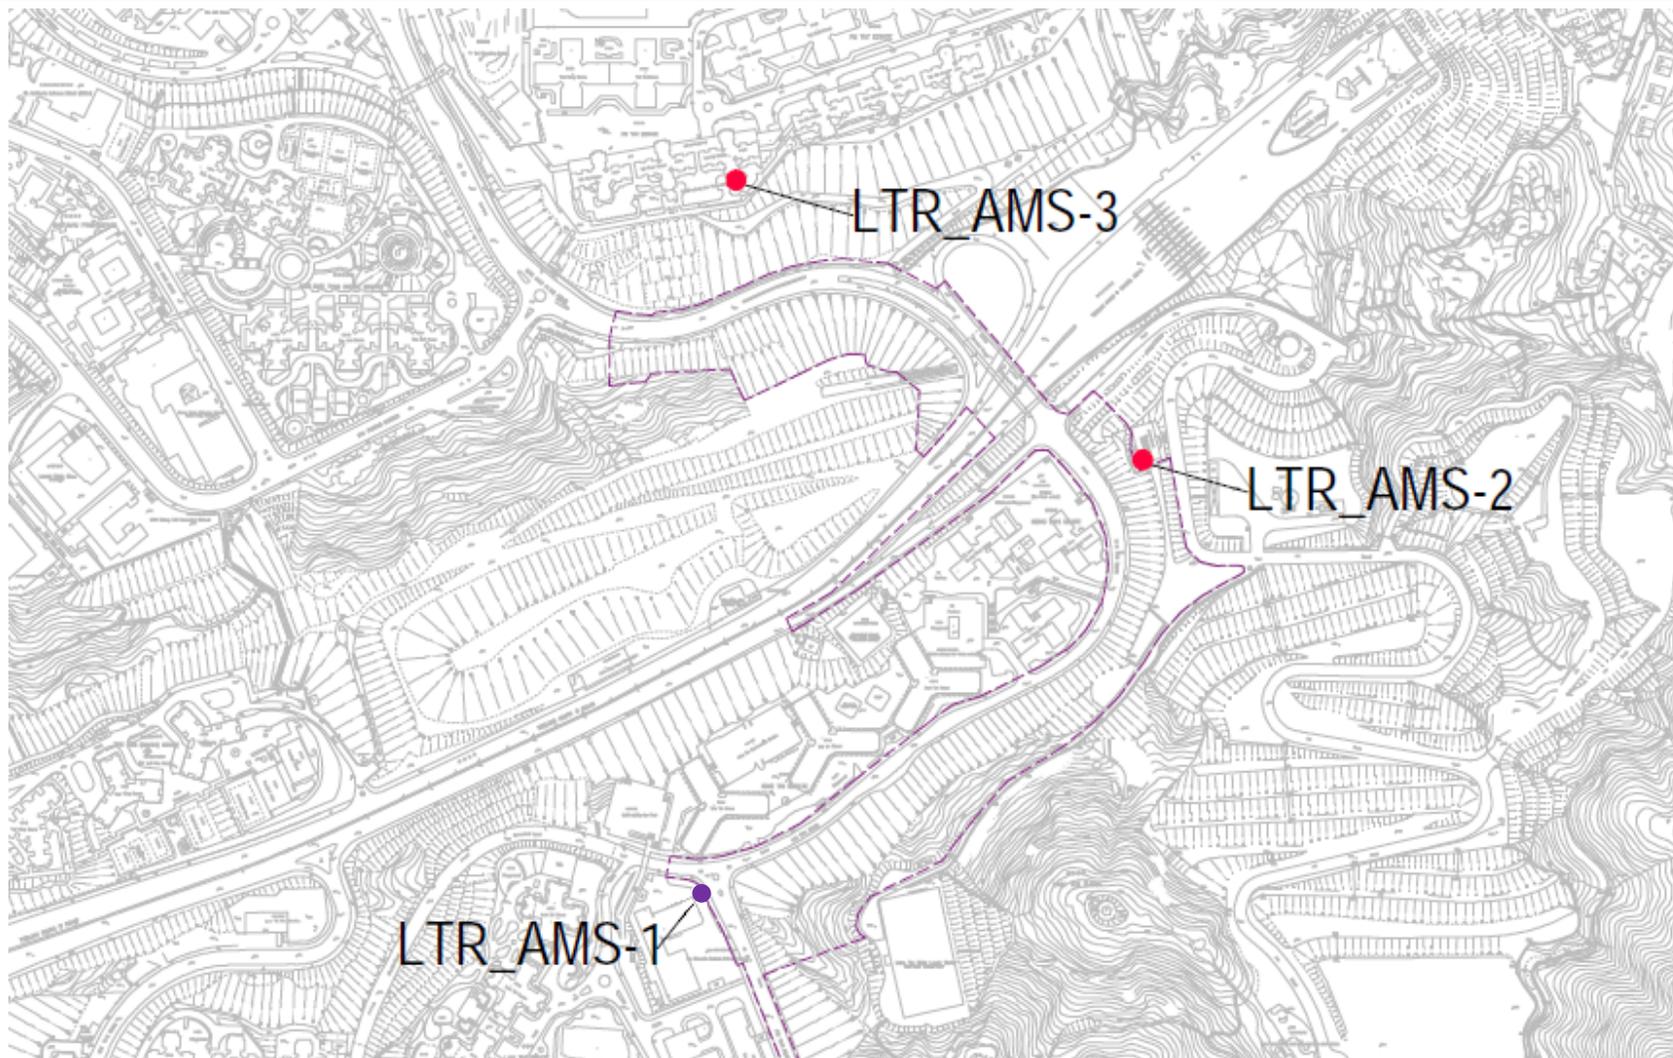
Figure 4.3
Location of Air Quality Monitoring Station
(for Road Improvement Work 1 & 2)

Monitoring Station ID	EIA ID	Location
NCWBR RIW		
NCWBR_AMS-1	ASLF-1	Shun Lee Fire Station
NCWBR_AMS-2	ASLE-21	Shun Lee Estate Lee Hang House
NCWBR_AMS-3	ASLD-10	Shun Lee Disciplined Services Quarters (Block 6)
NCWBR_AMS-4	AFNS-3	Sienna Garden
NCWBR_AMS-5	ASCC-05	Shun Chi Court Shun Fung House

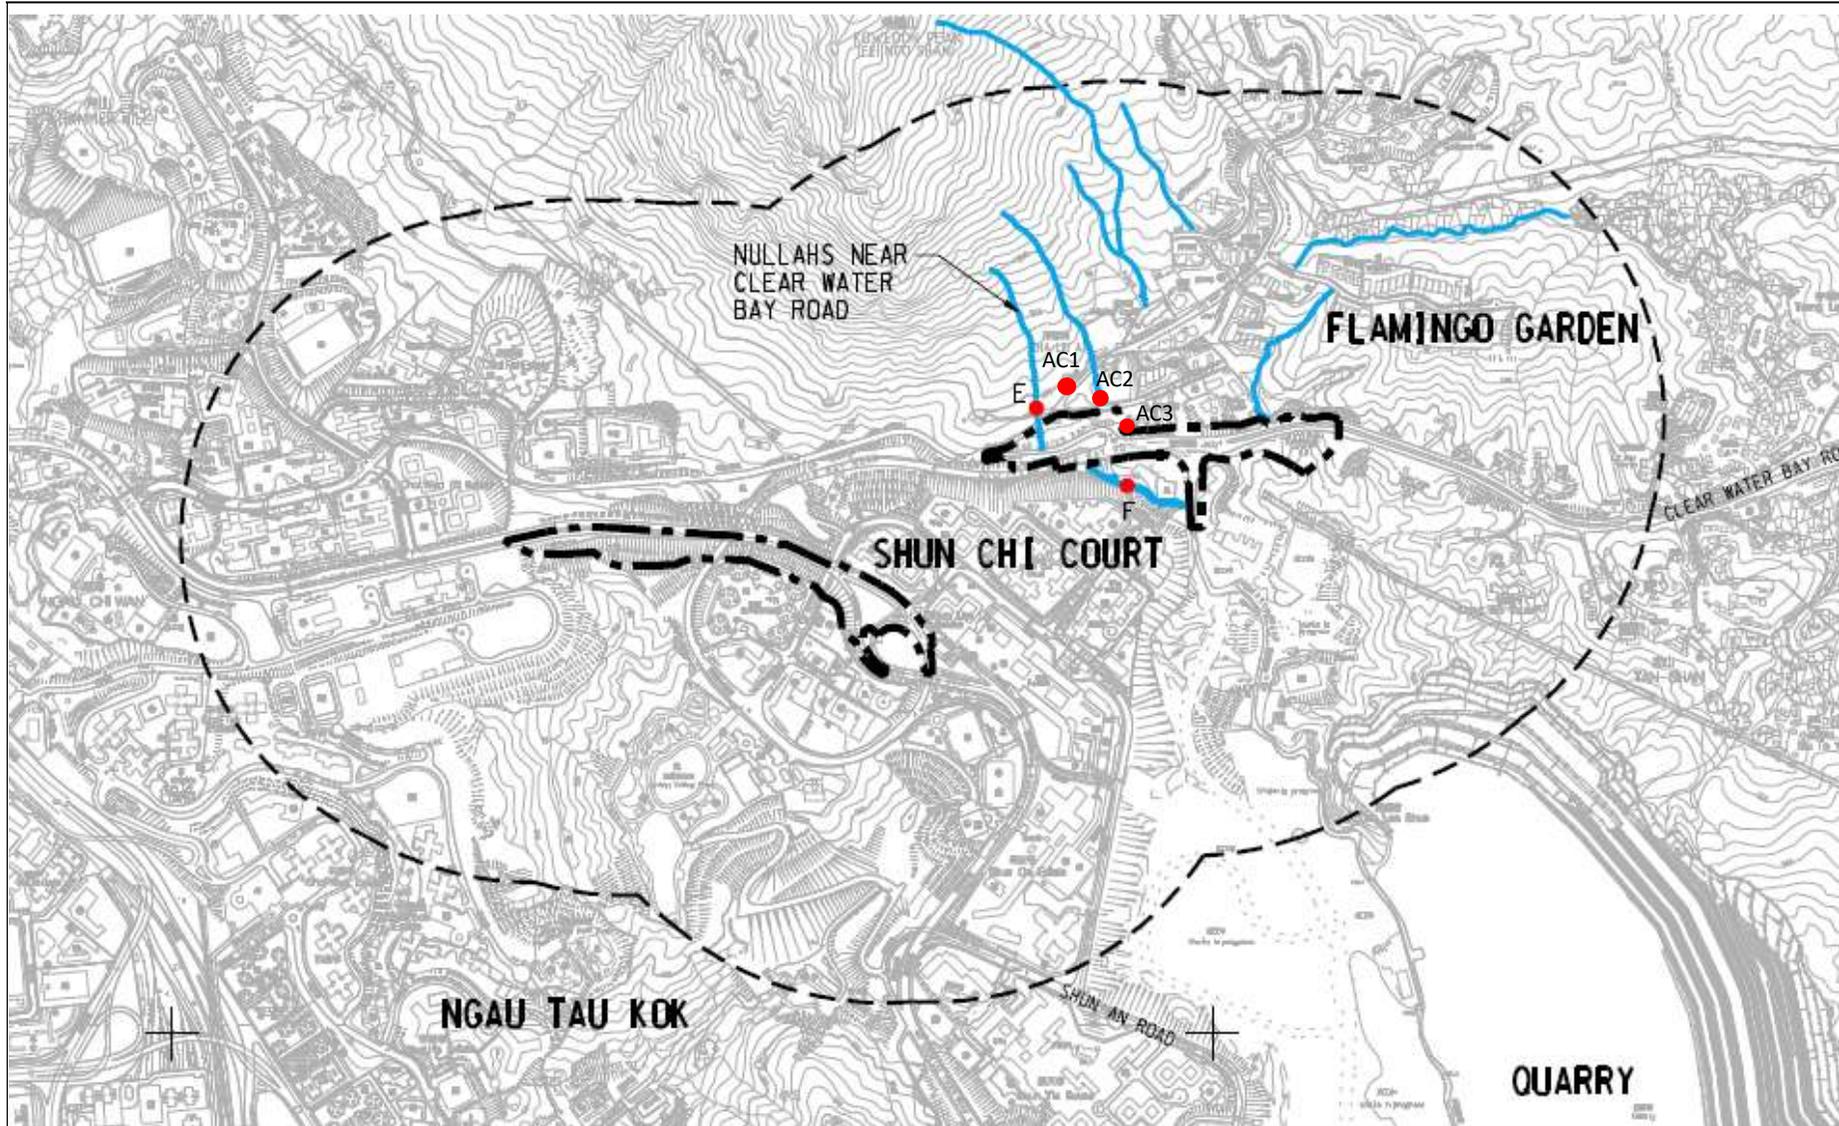
Figure 4.4
Location of Air Quality Monitoring Station
(for Road Improvement Work 3)

Monitoring Station ID	EIA ID	Location
LTR RIW		
LTR_AMS-1	ASECP-2	St Edward's Catholic Primary School
LTR_AMS-2	AEPD-01	Environmental Protection Department's Restored Landfill Site Office
LTR_AMS-3	APTE-14	Po Tat Estate Tat Kai House

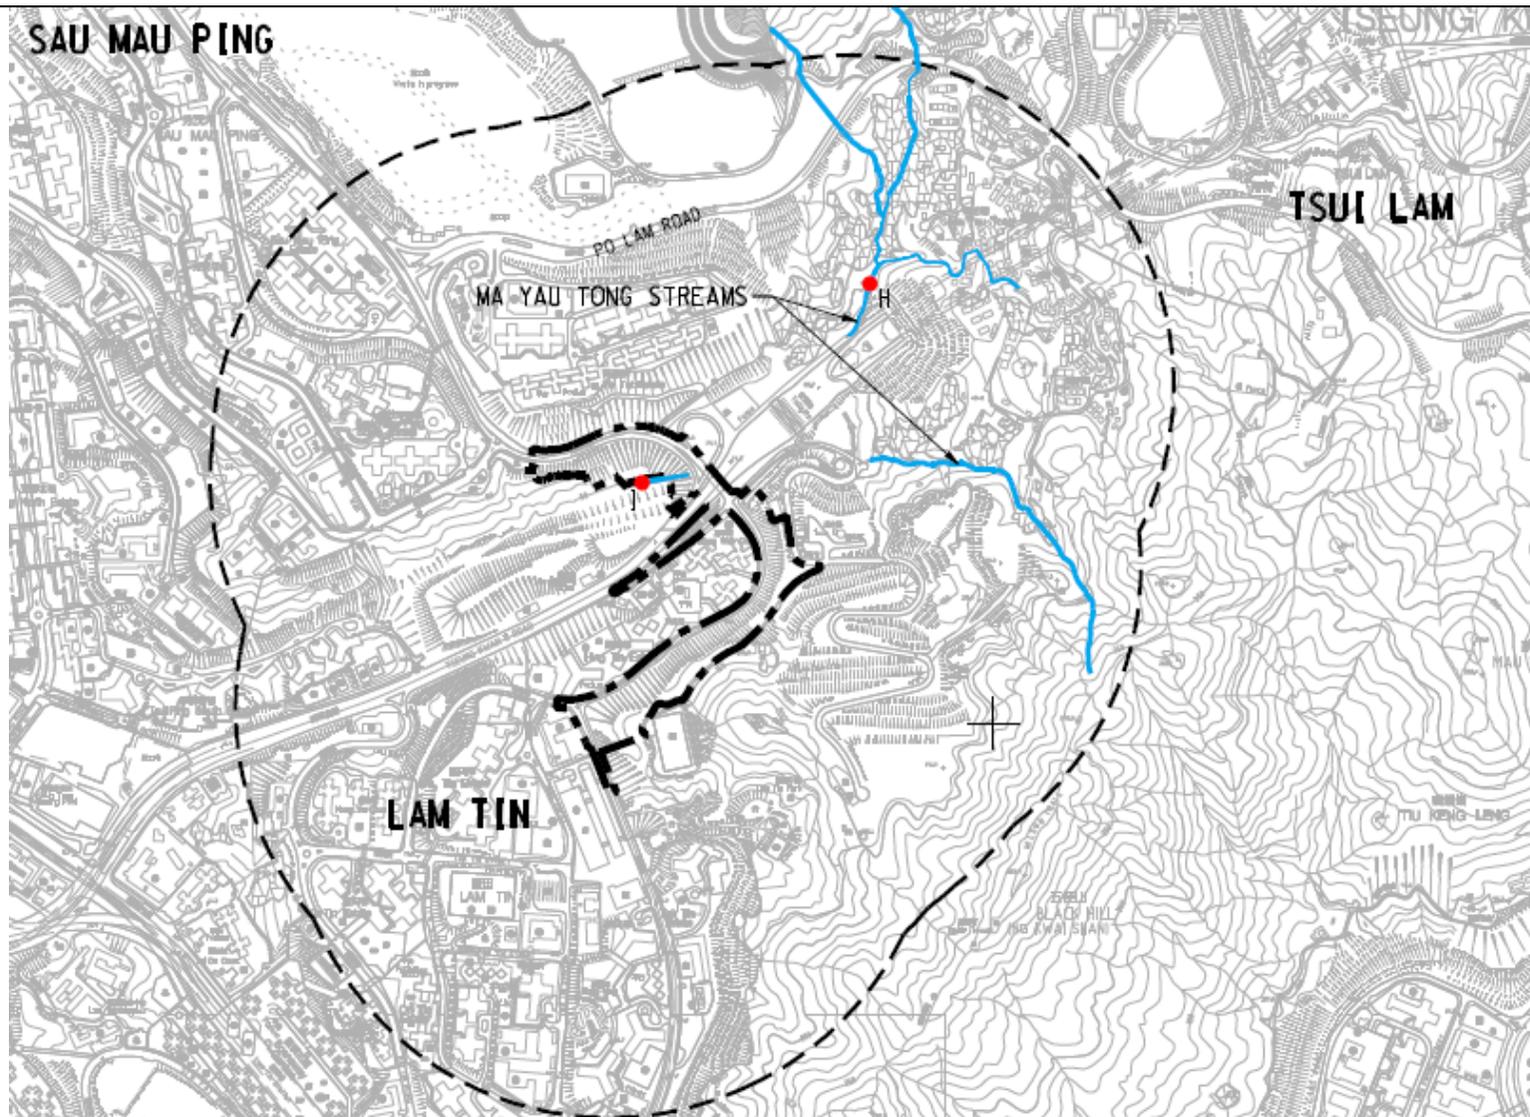
Figure 4.5
Location of Water Quality Monitoring Station
(for Road Improvement Work 1 & 2)

Inland Water	Stations	Description
Channelized nullah across the Project site	E	Upstream Control Station
	F	Downstream Impact Station
	AC1	Upstream Reference Station
	AC2	Upstream Reference Station
	AC3	Upstream Reference Station

- 5.3.3 Limit level exceedance of suspended solid and Turbidity were recorded at Station F on 02 June 2021. After investigation, silty water slightly grey in colour was observed at monitoring station F during water quality monitoring. Drilling and excavation were conducted at RIW2 construction site area under Contract No. NE/2017/03 on 02 June 2021. However, no surface runoff was observed discharging into nearby gullies during monitoring. The weather was rainy from 01 to 02 June 2021, Amber and Red Rainstorm Warning Signal came into force on 01 June 2021, runoff from unknown sources may also affect the water quality of station F. Turbidity and suspended solid results were relatively high at station AC2 (26.5 NTU and 82.8 mg/L). Thus, it is considered that the exceedances were not related to Project works at RIW2.

- 5.3.4 Limit level exceedance of suspended solid and Turbidity were recorded at Station F on 15 June 2021. After investigation, silty water slightly grey in colour was observed at monitoring station F during water quality monitoring. Drilling and welding were conducted at RIW2 construction site area under Contract No. NE/2017/03 on 15 June 2021. However, no surface runoff was observed discharging into nearby gullies during monitoring. The weather was rainy on 15 June 2021, runoff from unknown sources may also affect the water quality of station F. Turbidity and suspended solid results were relatively high at station AC2 (30.7 NTU and 65.6 mg/L). Thus, it is considered that the exceedances were not related to Project works at RIW2.

- 5.3.5 Limit level exceedance of suspended solid and Turbidity were recorded at Station F on 28 June 2021. After investigation, silty water slightly grey in colour was observed at monitoring station F during water quality monitoring. Drilling and welding were conducted at RIW2 construction site area under Contract No. NE/2017/03 on 28 June 2021. However, no surface runoff was observed discharging into nearby gullies during monitoring. The weather was rainy from 27 to 28 June 2021, Black Rainstorm Warning Signal came into force on 28 June 2021,

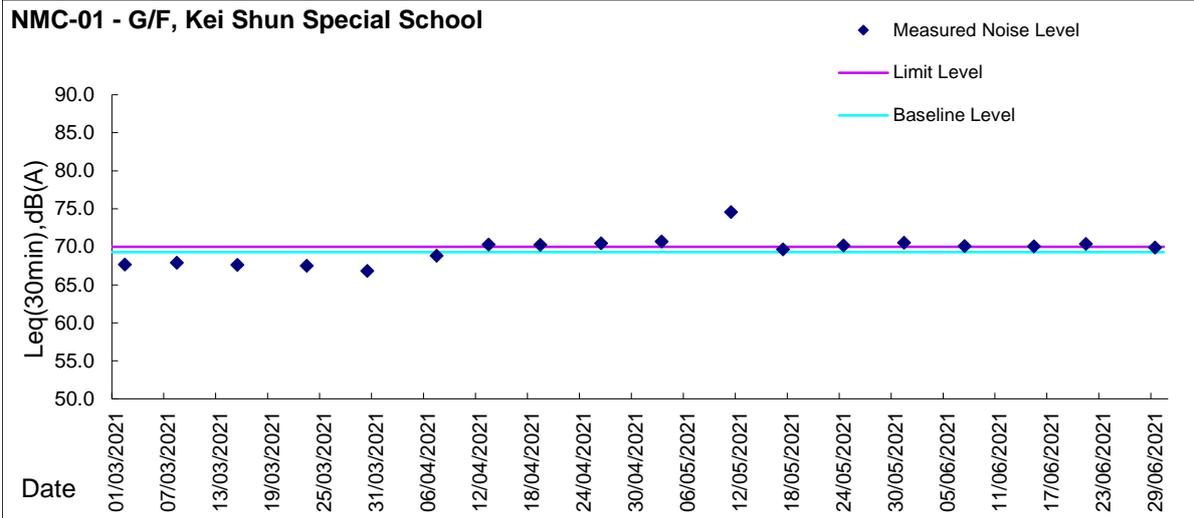
NMC-01 - G/F, Kei Shun Special School

Day Time (0700 - 1900hrs on normal weekdays)
