**ENVIRONMENTAL TEAM FOR  
DEVELOPMENT OF  
ANDERSON ROAD QUARRY SITE -  
ROAD IMPROVEMENT WORKS**

**UNDER ENVIRONMENTAL PERMIT NO. EP-513/2016**

**MONTHLY ENVIRONMENTAL MONITORING & AUDIT REPORT**

**OCTOBER 2021**

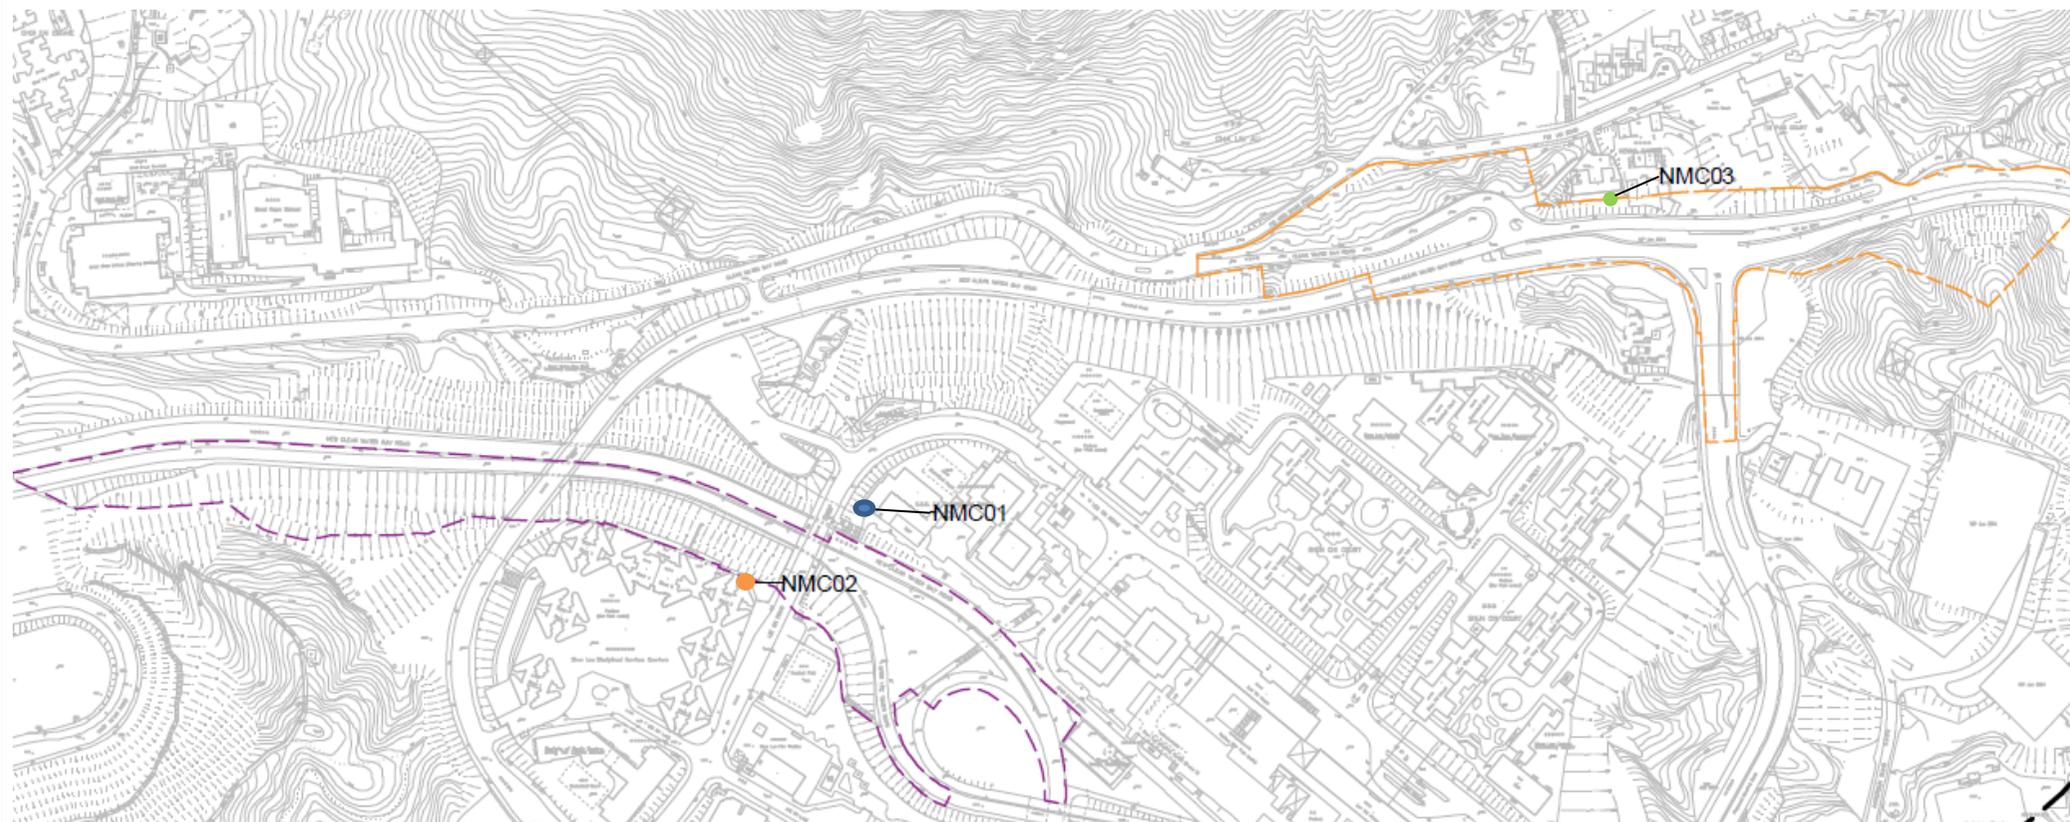
Figure 4.1  
 Location of Noise Monitoring Station  
 (Construction Phase)  
 (for Road Improvement Work 1 & 2)

Monitoring Location ID	Description
<i>Noise Monitoring Station (Construction Phase)</i>	
NMC01	Kei Shun Special School
NMC02	Shun Lee Disciplined Services Quarters Block 6
NMC03	Sienna Garden Block 6

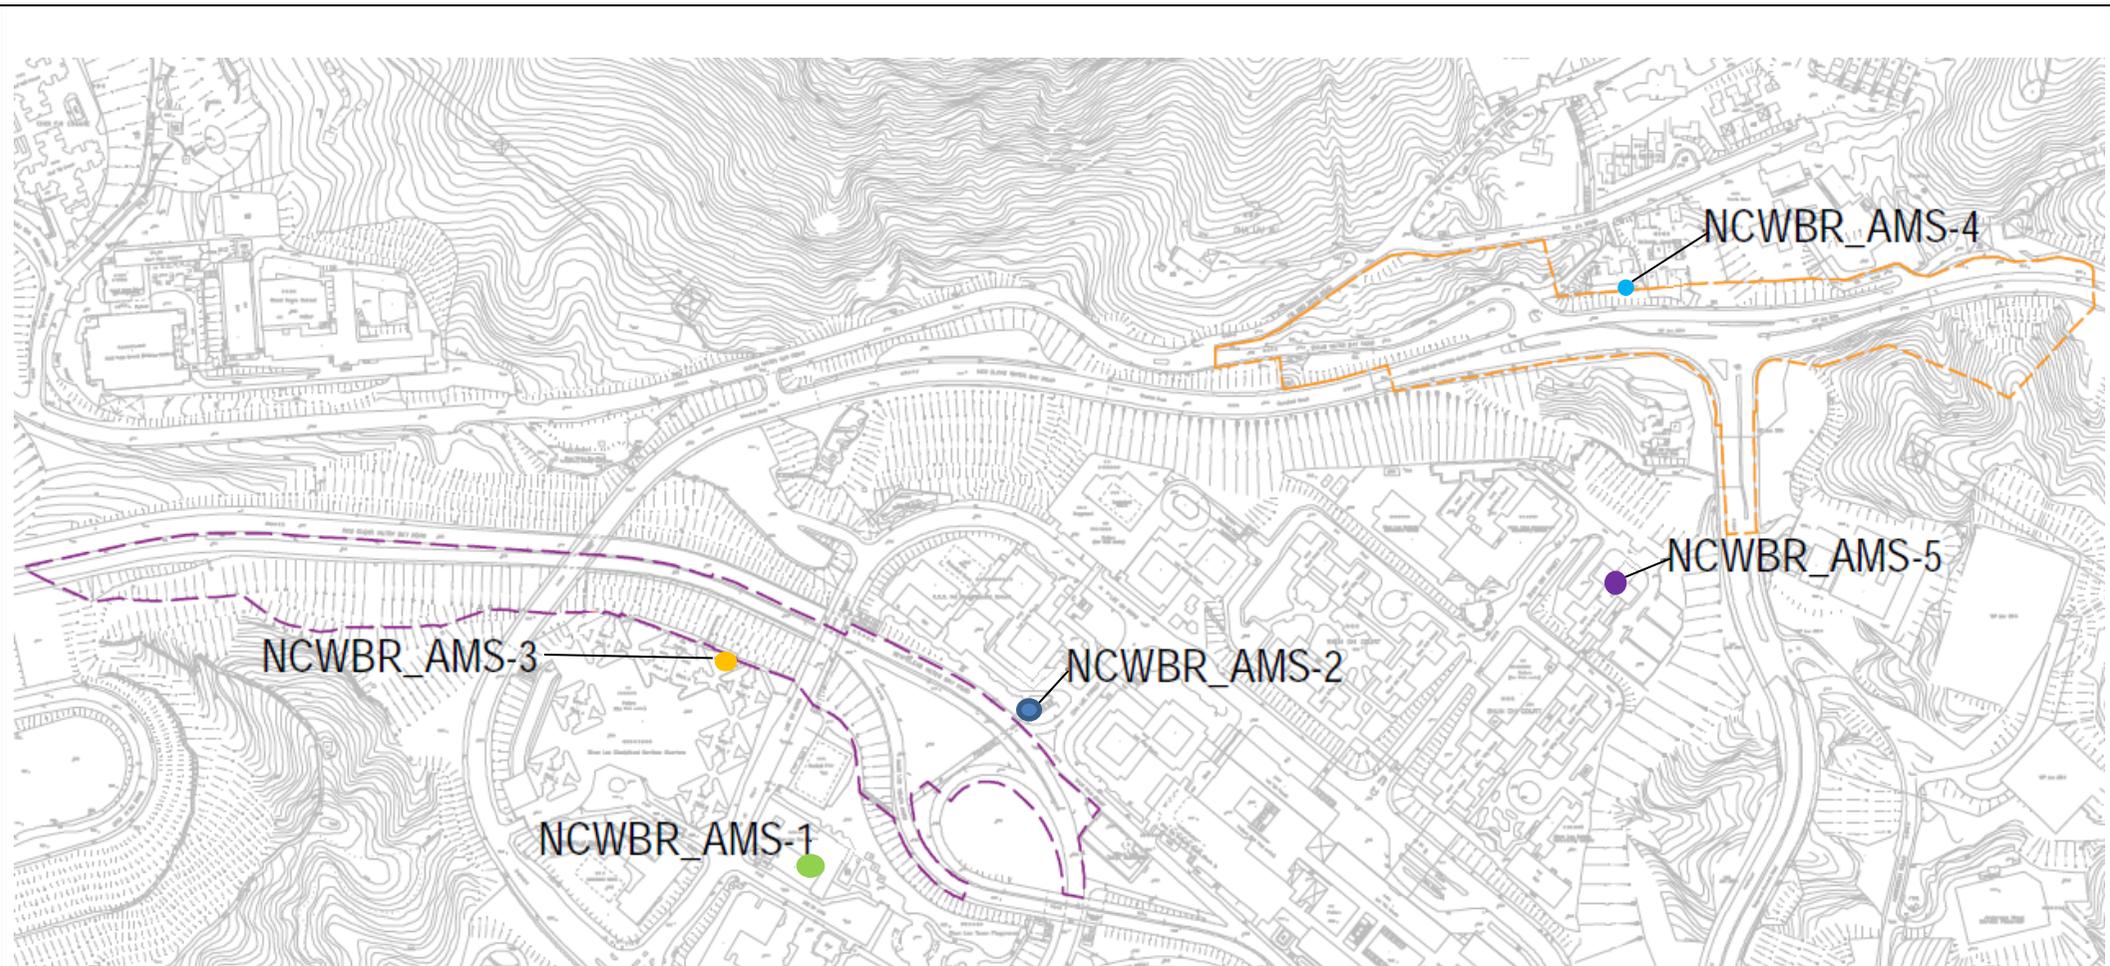
Figure 4.3  
Location of Air Quality Monitoring Station  
(for Road Improvement Work 1 & 2)

Monitoring Station ID	EIA ID	Location
<b>NCWBR RIW</b>		
NCWBR_AMS-1	ASLF-1	Shun Lee Fire Station
NCWBR_AMS-2	ASLE-21	Shun Lee Estate Lee Hang House
NCWBR_AMS-3	ASLD-10	Shun Lee Disciplined Services Quarters (Block 6)
NCWBR_AMS-4	AFNS-3	Sienna Garden
NCWBR_AMS-5	ASCC-05	Shun Chi Court Shun Fung House

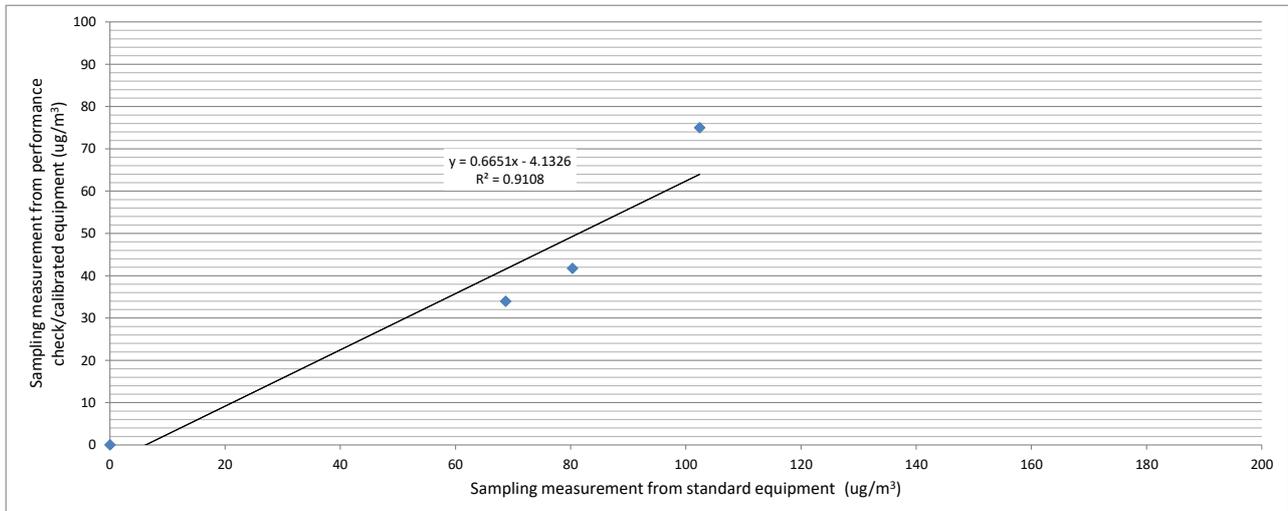
Linear Regression of Y on X

Slope (K- factor) : 1.4000
Correlation Coefficient : 0.9544
Validity of Performance Check / Calibration Record : 22/3/2022

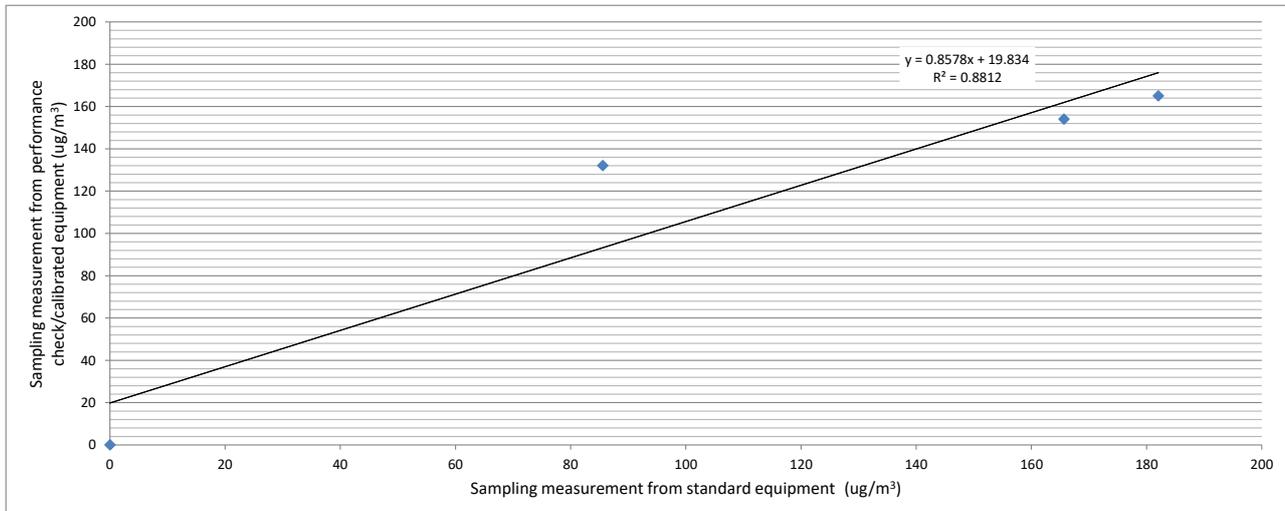
Linear Regression of Y on X

Slope (K- factor) : 1.1000
Correlation Coefficient : 0.9387
Validity of Performance Check / Calibration Record : 29/12/2021

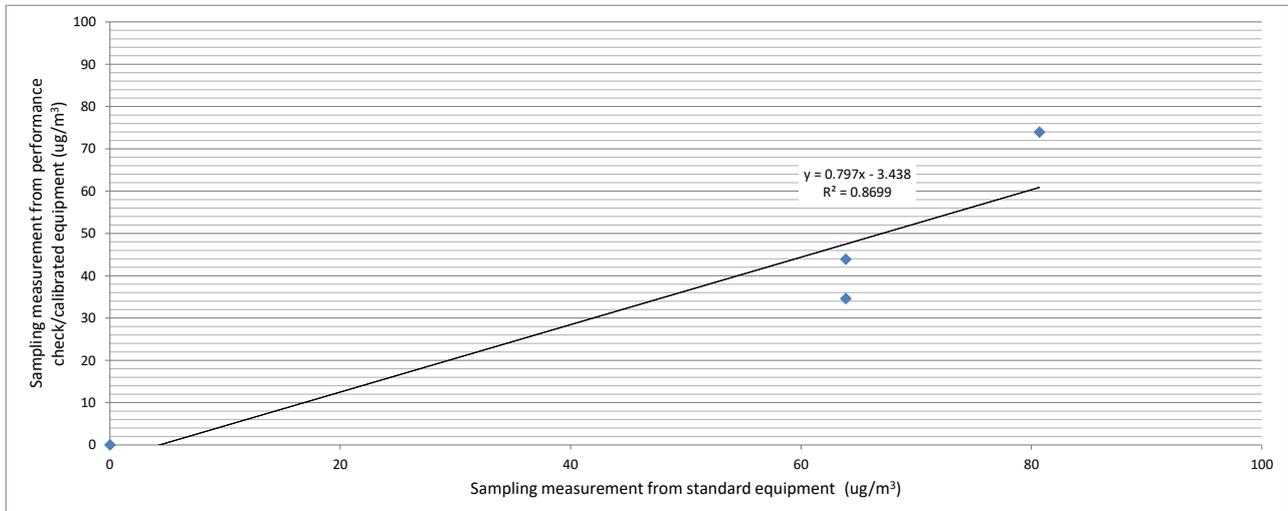
Linear Regression of Y on X

Slope (K- factor) : 1.1000
Correlation Coefficient : 0.9327
Validity of Performance Check / Calibration Record : 18/6/2022

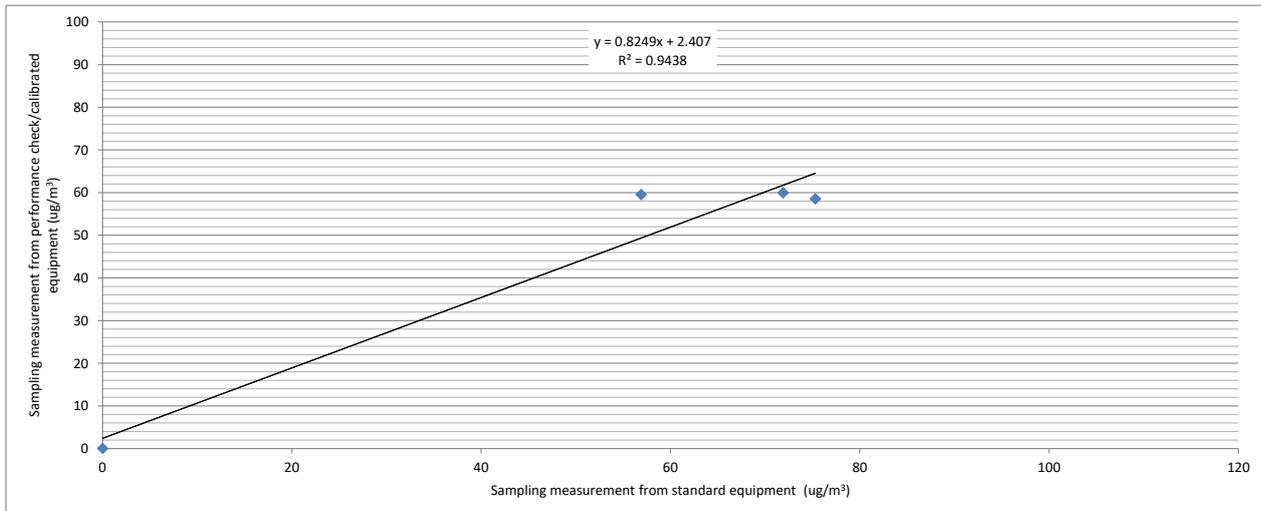
Linear Regression of Y on X

Slope (K- factor) : 1.2000
Correlation Coefficient : 0.9715
Validity of Performance Check / Calibration Record : 10/5/2022

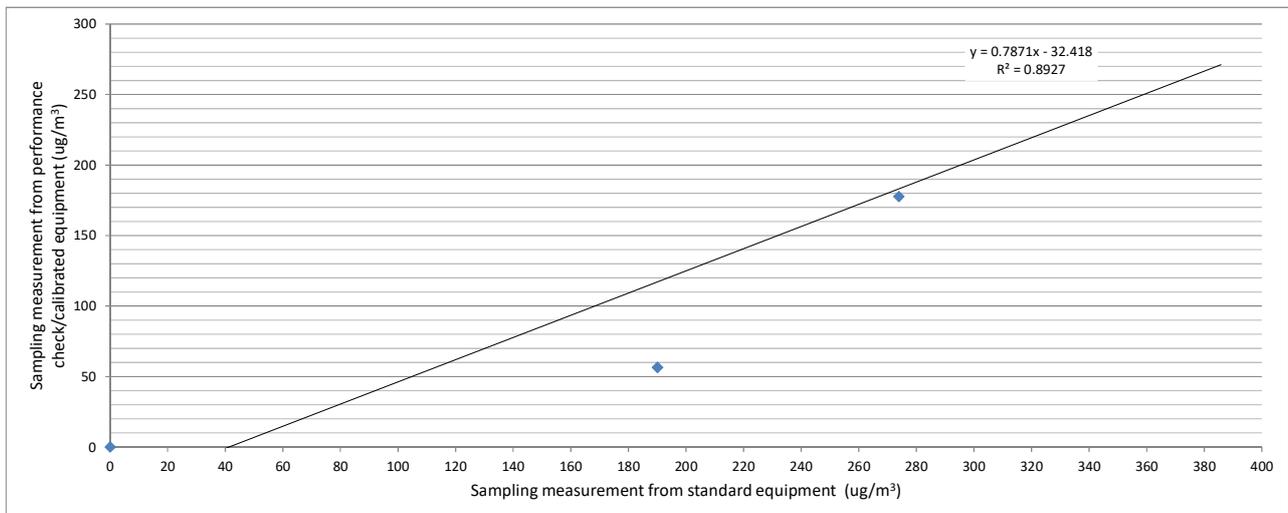
Linear Regression of Y on X

Slope (K- factor) : 1.2000
Correlation Coefficient : 0.9448
Validity of Performance Check / Calibration Record : 20/4/2022

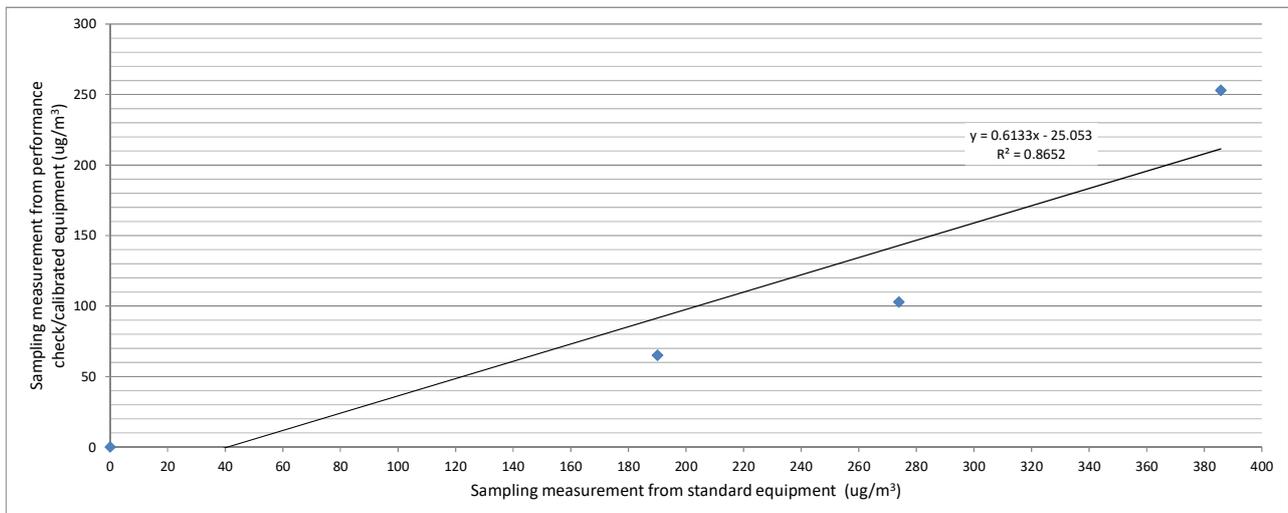
Linear Regression of Y on X

Slope (K- factor) : 1.5000
Correlation Coefficient : 0.9302
Validity of Performance Check / Calibration Record : 20/4/2022

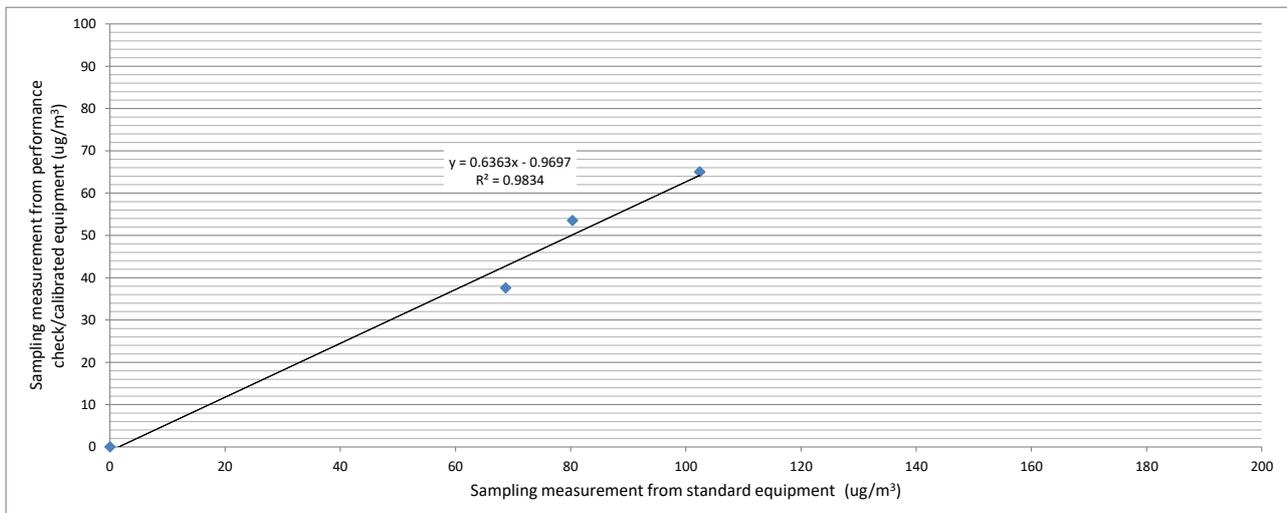
**Linear Regression of Y on X**

Slope (K- factor) : 1.6000  
 Correlation Coefficient : 0.9917  
 Validity of Performance Check / Calibration Record : 22/3/2022

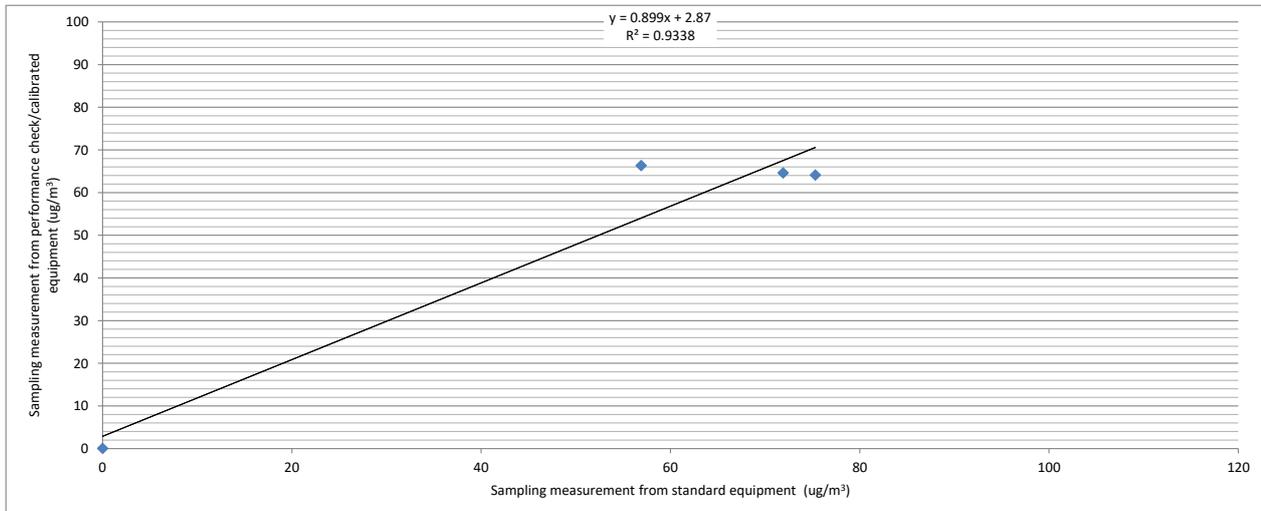
Linear Regression of Y on X

Slope (K- factor) : 1.1000
Correlation Coefficient : 0.9663
Validity of Performance Check / Calibration Record : 10/5/2022

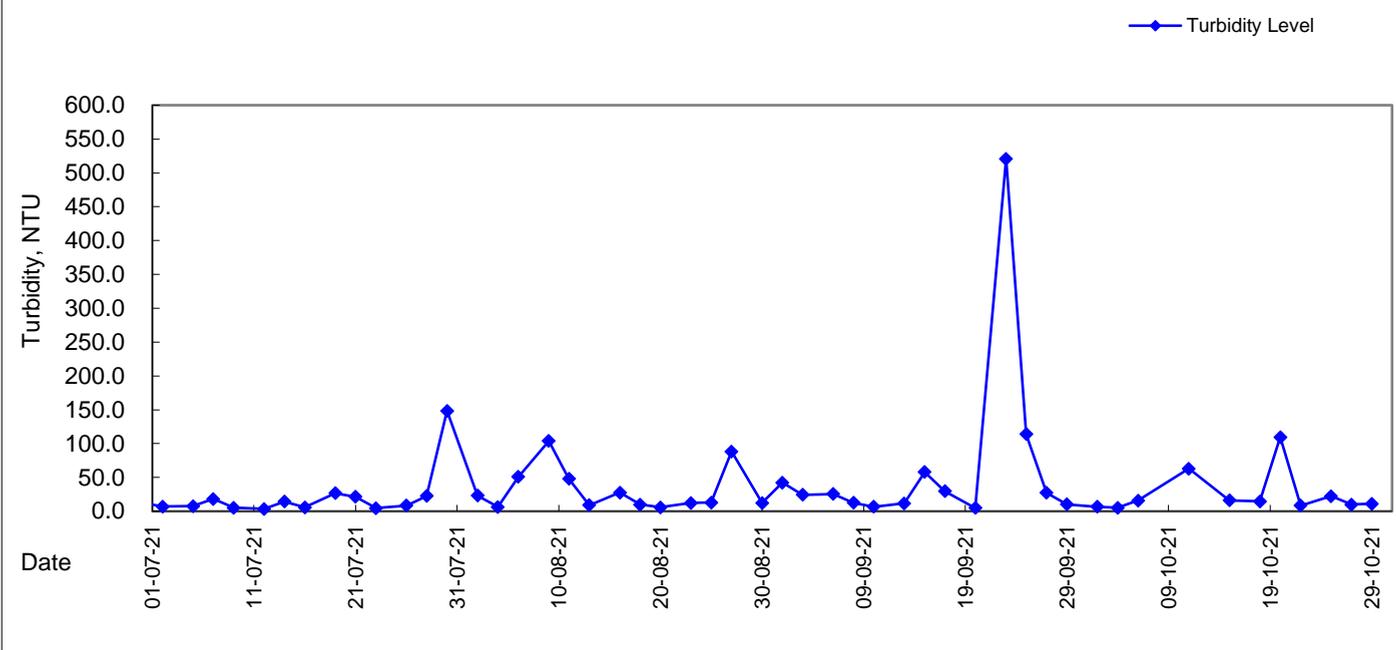
Station H - Ma Yau Tong Stream (Upstream Control Station) - Turbidity

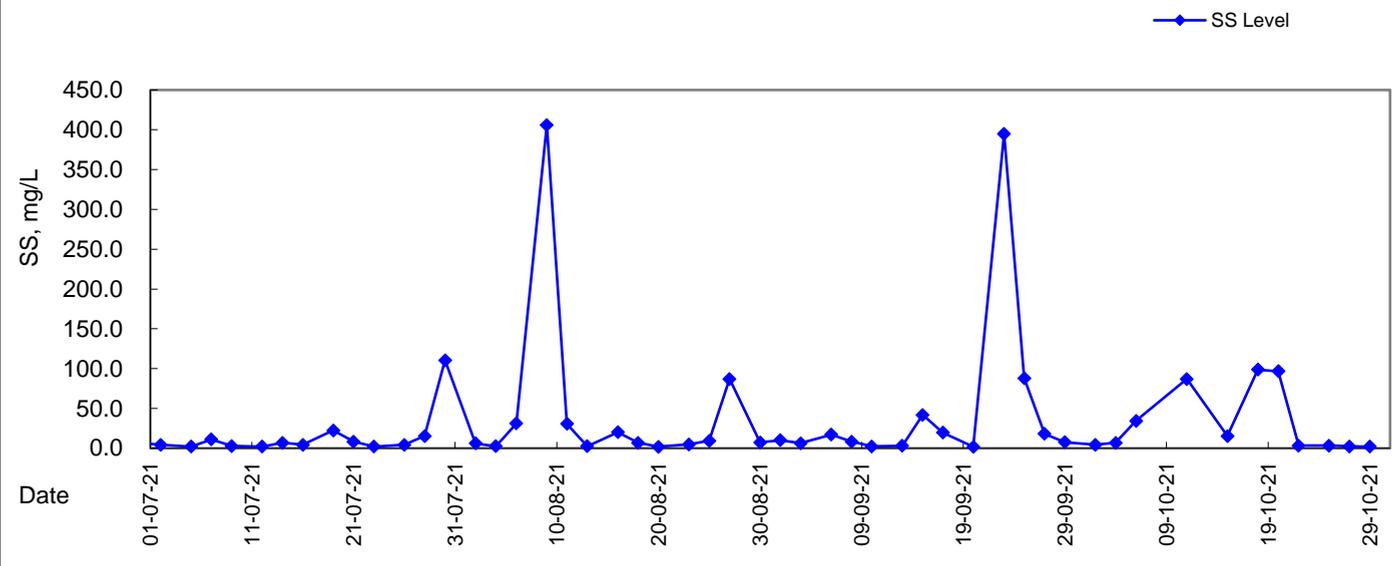
Station H - Ma Yau Tong Stream (Upstream Control Station) - Suspended Solid
