**ENVIRONMENTAL TEAM FOR
DEVELOPMENT OF
ANDERSON ROAD QUARRY SITE -
ROAD IMPROVEMENT WORKS**

UNDER ENVIRONMENTAL PERMIT NO. EP-513/2016

MONTHLY ENVIRONMENTAL MONITORING & AUDIT REPORT

JANUARY 2022

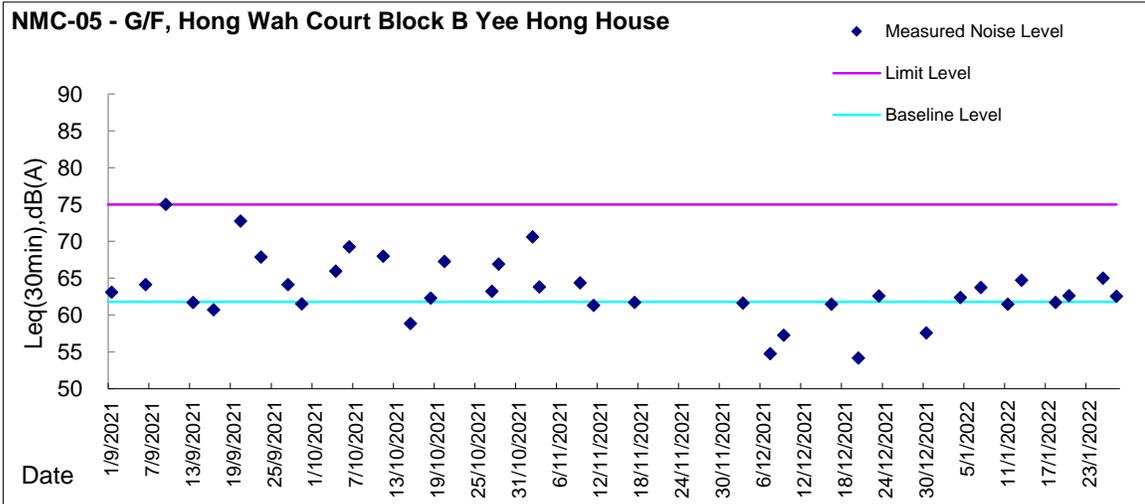
Graphic Presentation of Noise Monitoring Result

NMC-05 - G/F, Hong Wah Court Block B Yee Hong House

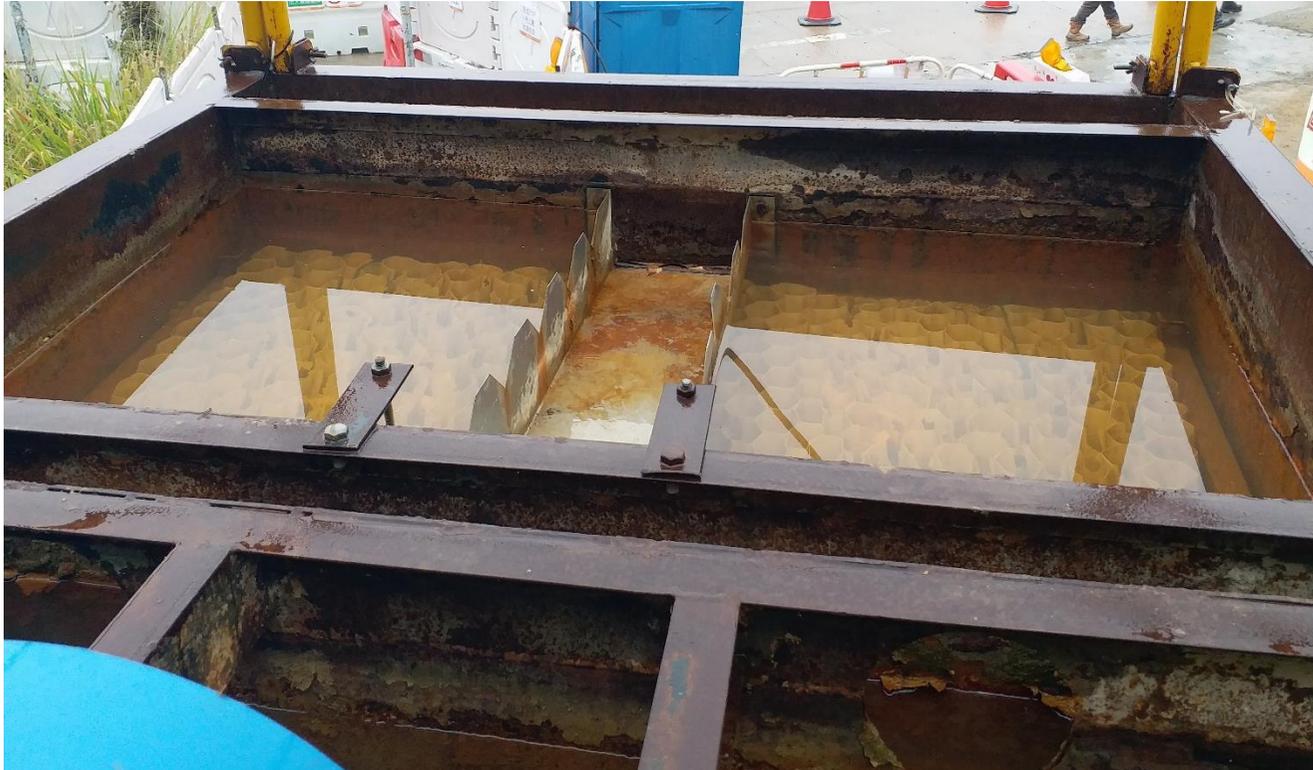
The Condition of the Wastewater treatment facility near Monitoring Station F on 28 January 2022
