Service Contract No: EDO/01/2017
Environmental Team for
Development of Anderson Road Quarry Site
Road Improvement Works
Monthly EM&A Report (July 2021)

**ENVIRONMENTAL TEAM FOR
DEVELOPMENT OF
ANDERSON ROAD QUARRY SITE -
ROAD IMPROVEMENT WORKS**

MONTHLY ENVIRONMENTAL MONITORING & AUDIT REPORT

JULY 2021

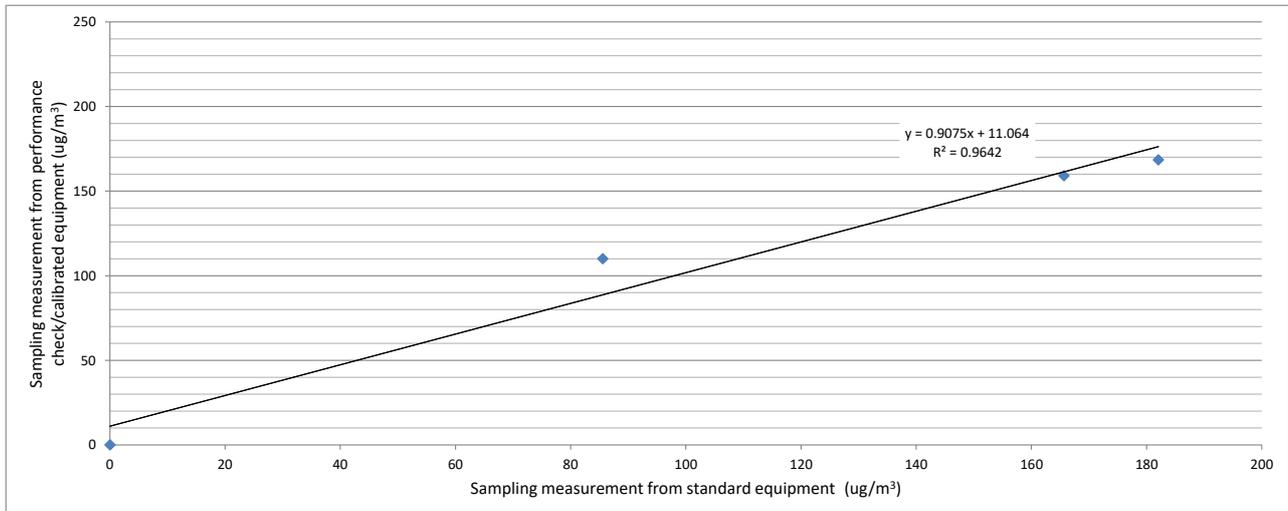
Linear Regression of Y on X

Slope (K- factor) : 1.1000
Correlation Coefficient : 0.9819
Validity of Performance Check / Calibration Record : 29/12/2021

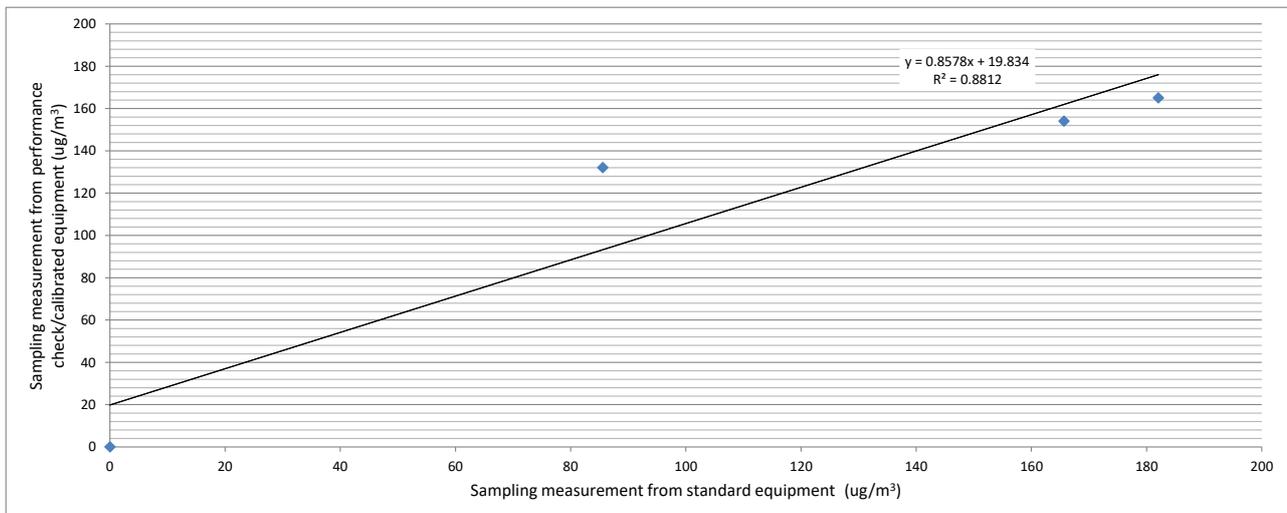
Linear Regression of Y on X

Slope (K- factor) : 1.1000
 Correlation Coefficient : 0.9387
 Validity of Performance Check / Calibration Record : 29/12/2021

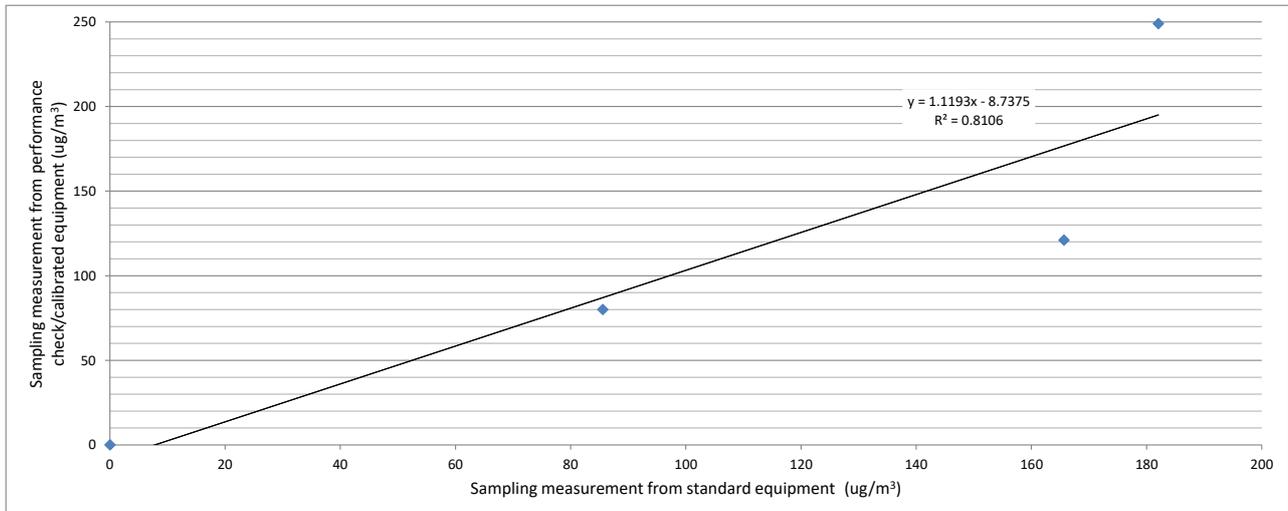
Linear Regression of Y on X

Slope (K- factor) : 0.8000
 Correlation Coefficient : 0.9003
 Validity of Performance Check / Calibration Record : 29/12/2021

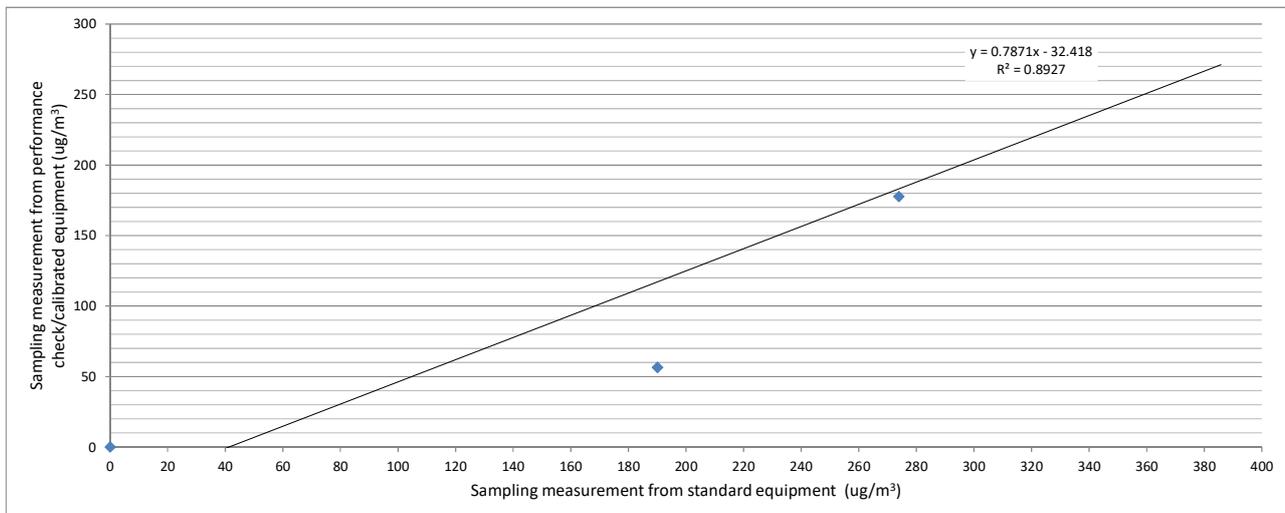
Linear Regression of Y on X

Slope (K- factor) : 1.2000
Correlation Coefficient : 0.9448
Validity of Performance Check / Calibration Record : 20/4/2022

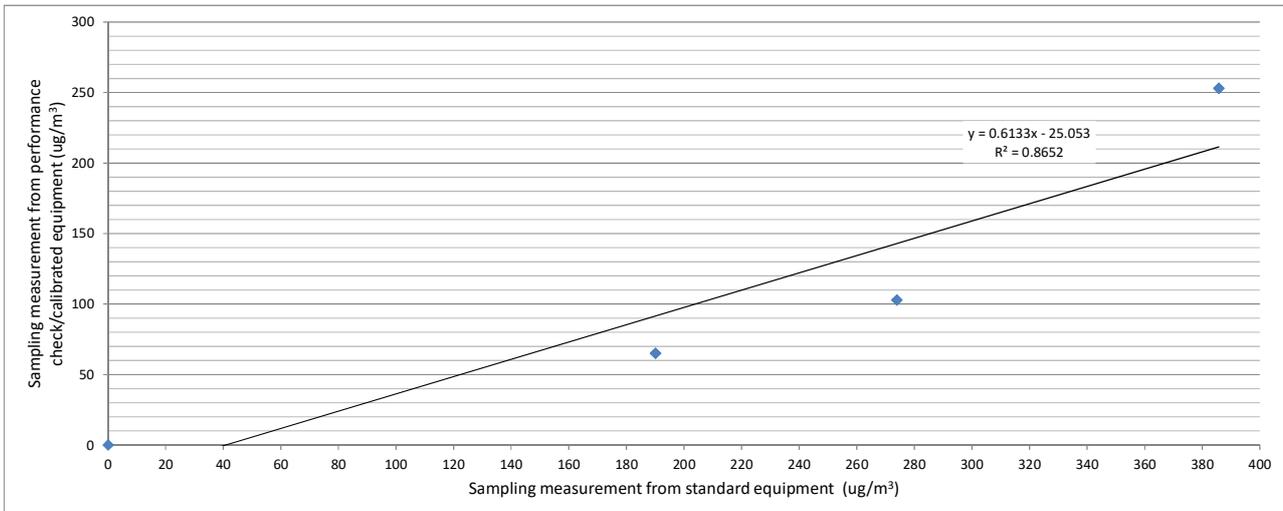
Linear Regression of Y on X

Slope (K- factor) : 1.5000
Correlation Coefficient : 0.9302
Validity of Performance Check / Calibration Record : 20/4/2022

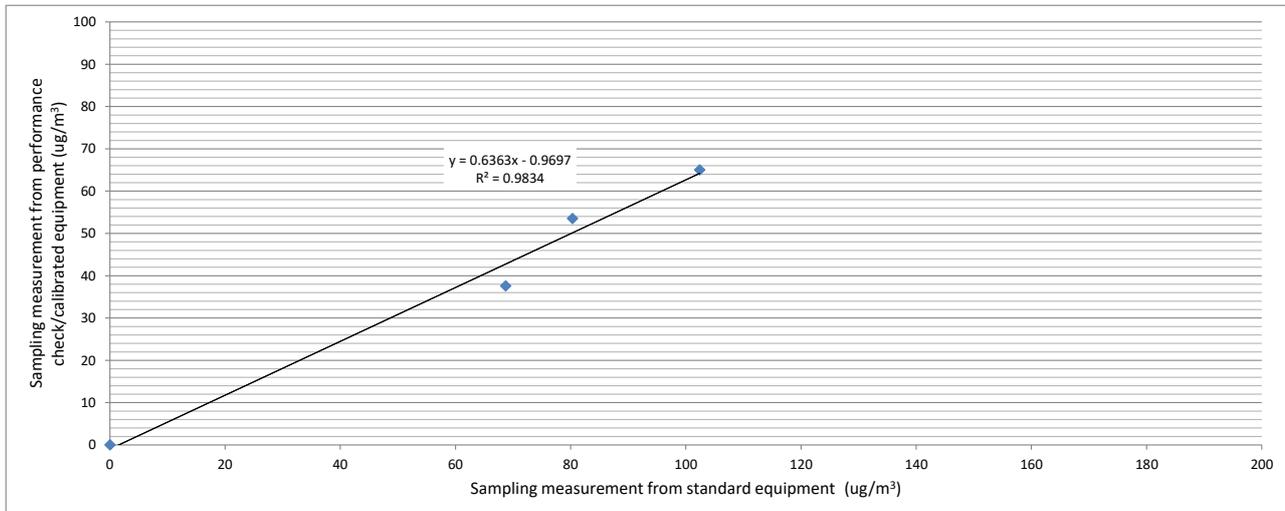
Linear Regression of Y on X

Slope (K- factor) : 1.6000
 Correlation Coefficient : 0.9917
 Validity of Performance Check / Calibration Record : 22/3/2022

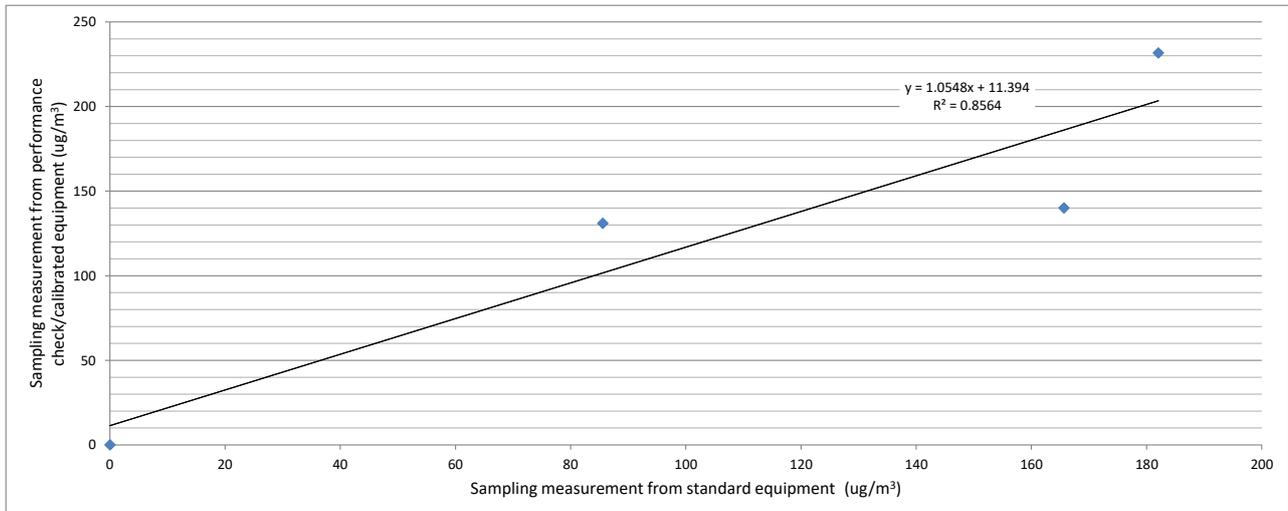
Linear Regression of Y on X

Slope (K- factor) : 0.9000
Correlation Coefficient : 0.9254
Validity of Performance Check / Calibration Record : 29/12/2021
