**ENVIRONMENTAL TEAM FOR
DEVELOPMENT OF
ANDERSON ROAD QUARRY SITE -
ROAD IMPROVEMENT WORKS**

UNDER ENVIRONMENTAL PERMIT NO. EP-513/2016

MONTHLY ENVIRONMENTAL MONITORING & AUDIT REPORT

DECEMBER 2021

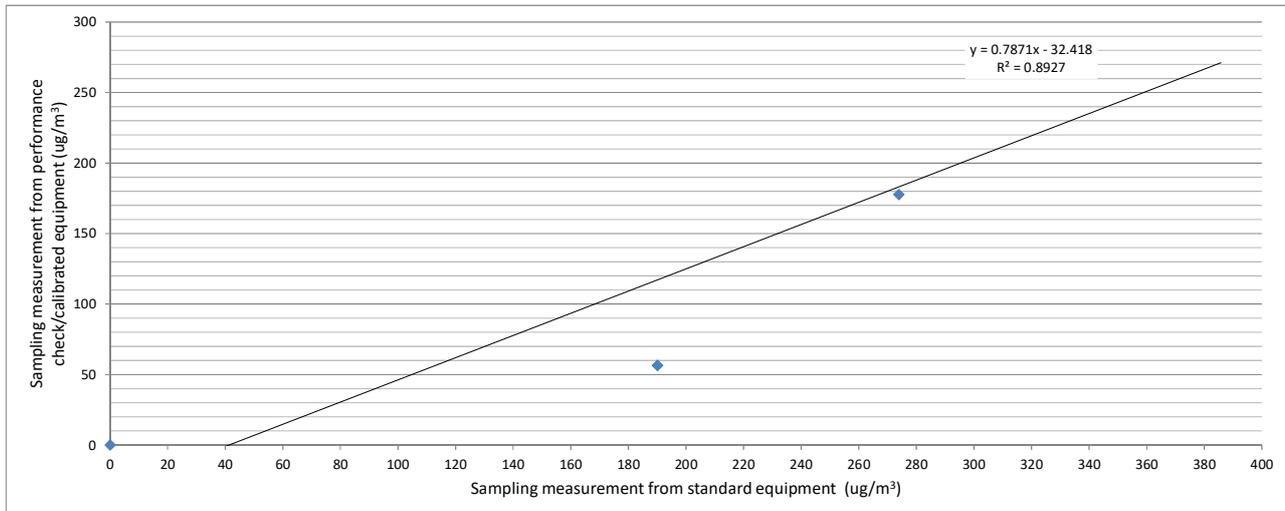
Linear Regression of Y on X

Slope (K- factor) : 1.2000
Correlation Coefficient : 0.9448
Validity of Performance Check / Calibration Record : 20/4/2022

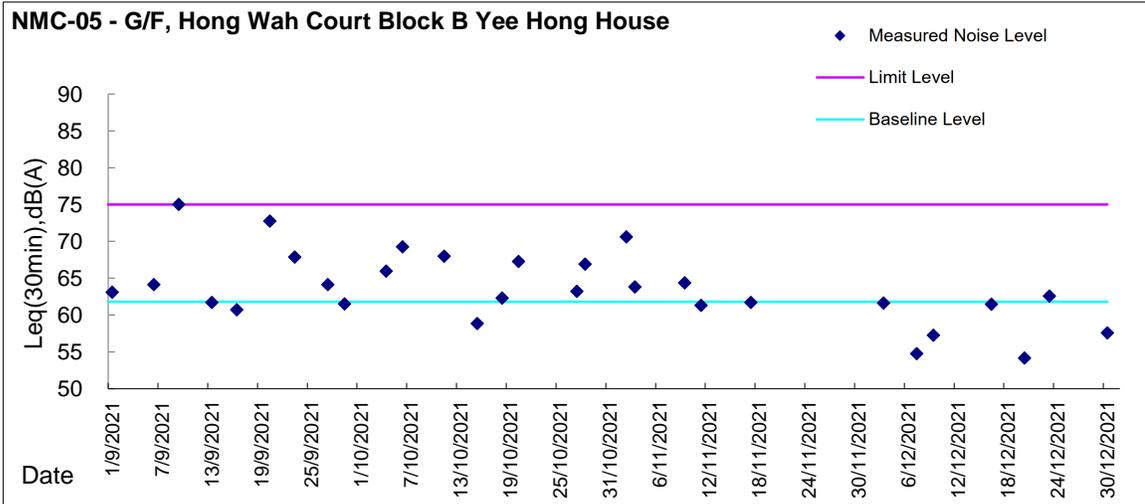
Graphic Presentation of Noise Monitoring Result

Day Time (0700 - 1900hrs on normal weekdays)

NMC-05 - G/F, Hong Wah Court Block B Yee Hong House
