**ENVIRONMENTAL TEAM FOR  
DEVELOPMENT OF  
ANDERSON ROAD QUARRY SITE -  
ROAD IMPROVEMENT WORKS**

**MONTHLY ENVIRONMENTAL MONITORING & AUDIT REPORT**

**MARCH 2026**

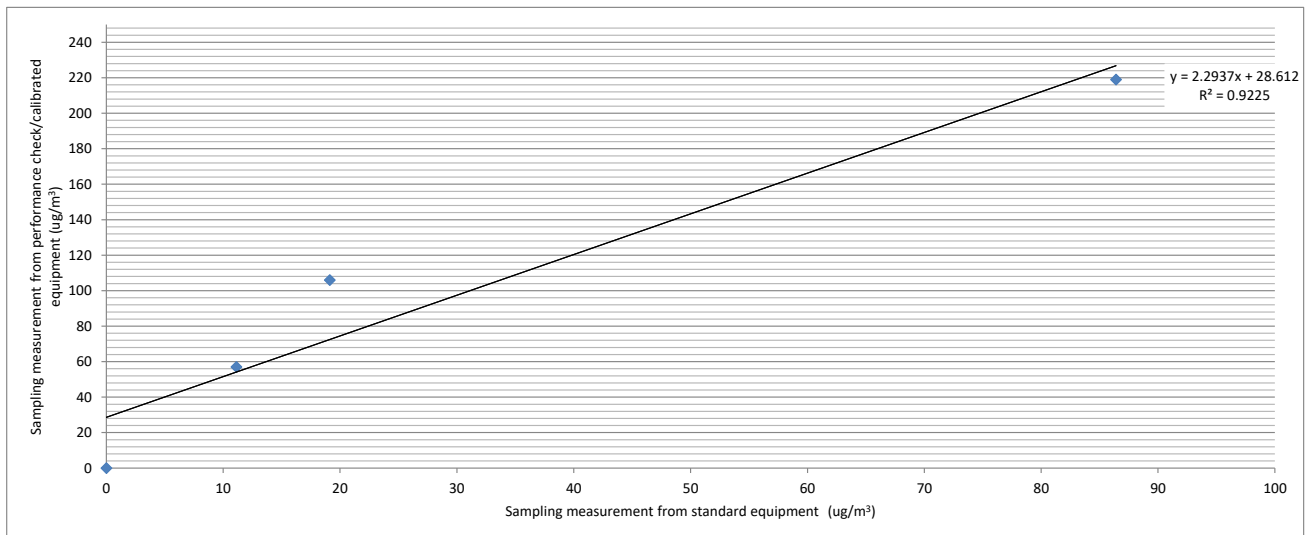
Linear Regression of Y on X

Slope (K- factor) : 2.3000
Correlation Coefficient : 0.9605
Validity of Performance Check / Calibration Record : 25/3/2026

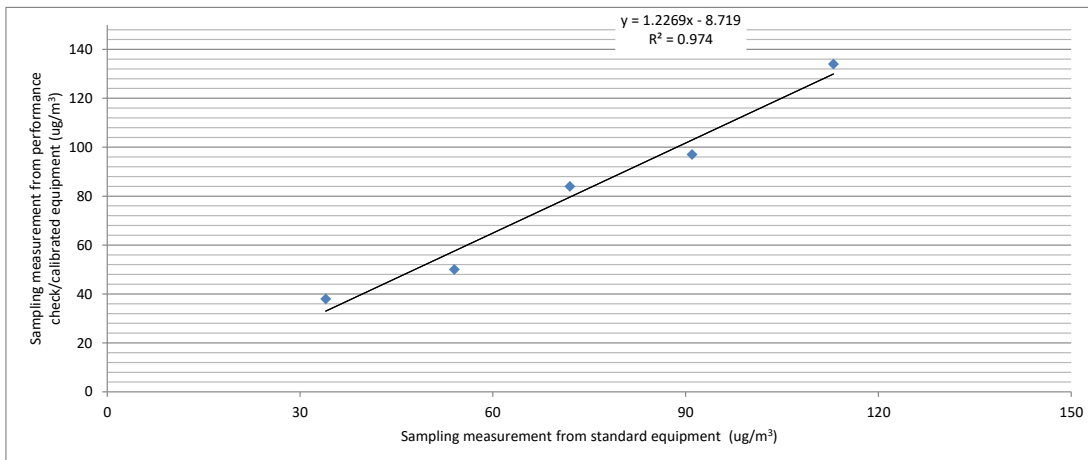
### Linear Regression of Y on X

Slope (K- factor) : 0.8000  
 Correlation Coefficient : 0.9869  
 Validity of Performance Check / Calibration Record : 9/3/2027

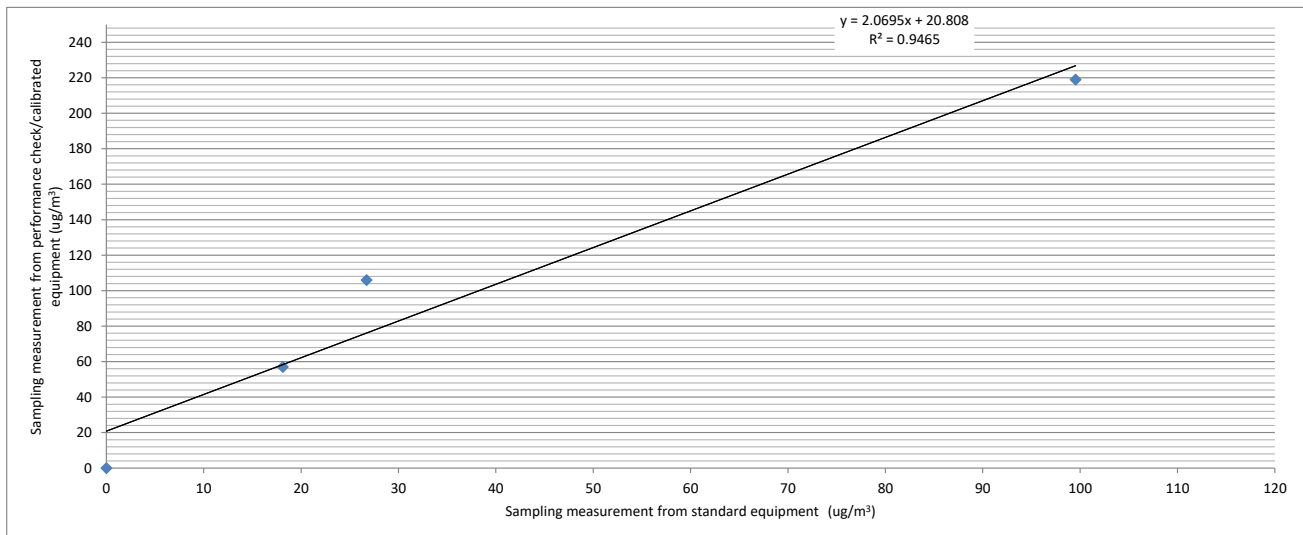
Linear Regression of Y on X

Slope (K- factor) : 2.1000
Correlation Coefficient : 0.9729
Validity of Performance Check / Calibration Record : 25/3/2026

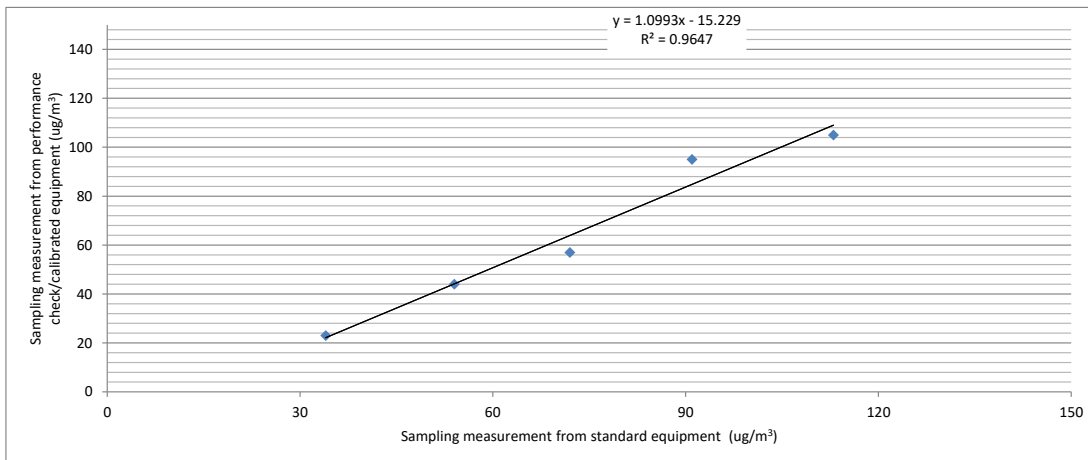
### Linear Regression of Y on X

Slope (K- factor) : 0.9000  
 Correlation Coefficient : 0.9822  
 Validity of Performance Check / Calibration Record : 9/3/2027

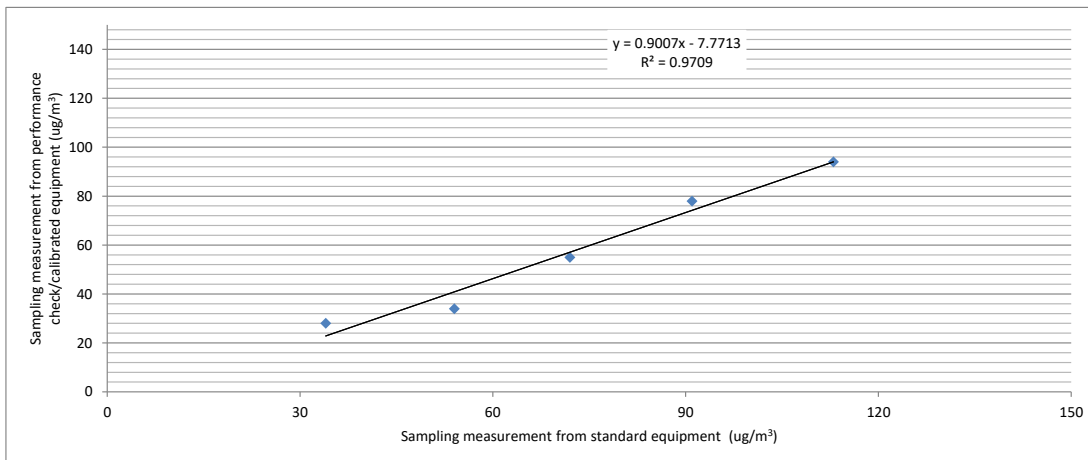
### Linear Regression of Y on X

Slope (K- factor) : 1.1000  
 Correlation Coefficient : 0.9854  
 Validity of Performance Check / Calibration Record : 9/3/2027

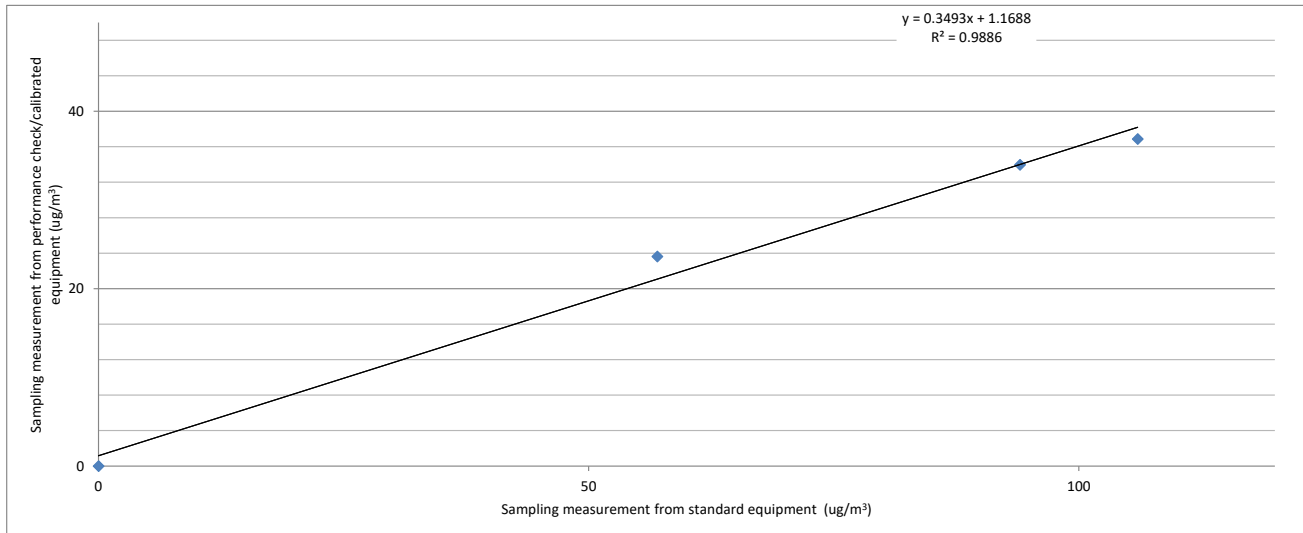
Linear Regression of Y on X

Slope (K- factor) : 3.7000
Correlation Coefficient : 0.9997
Validity of Performance Check / Calibration Record : 25/3/2026

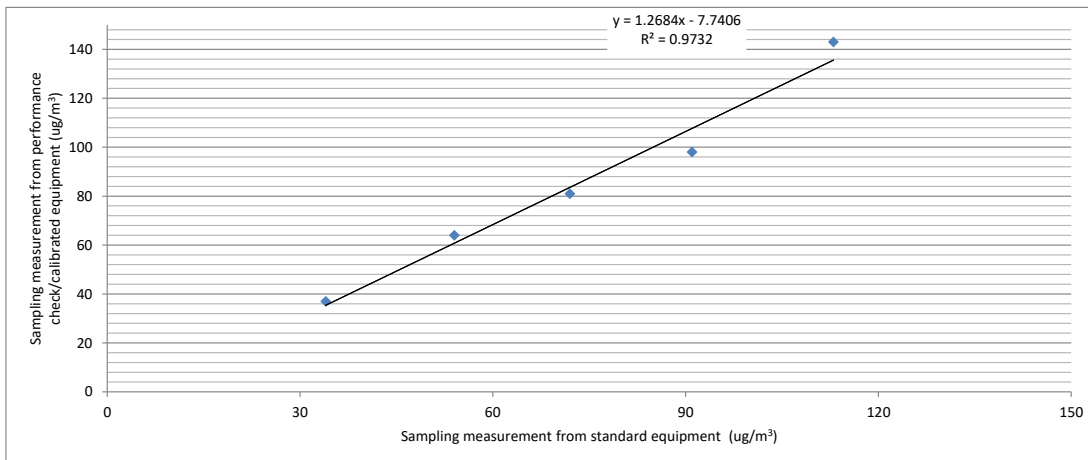
### Linear Regression of Y on X

Slope (K- factor) : 0.8000  
 Correlation Coefficient : 0.9865  
 Validity of Performance Check / Calibration Record : 9/3/2027

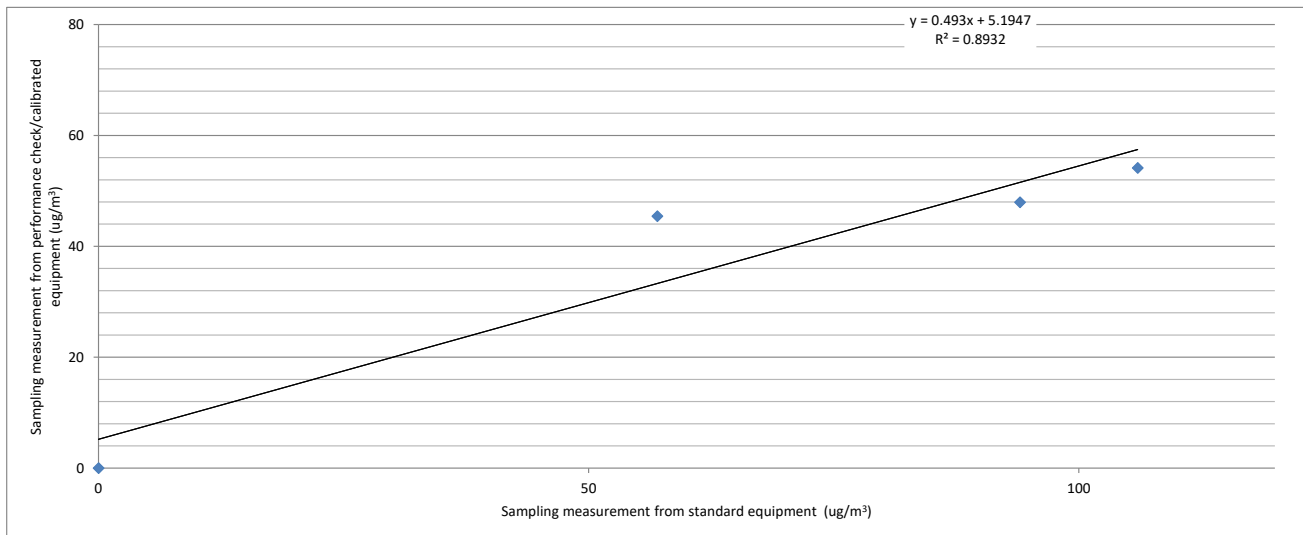
Linear Regression of Y on X

Slope (K- factor) : 1.9000
Correlation Coefficient : 0.9451
Validity of Performance Check / Calibration Record : 25/3/2026

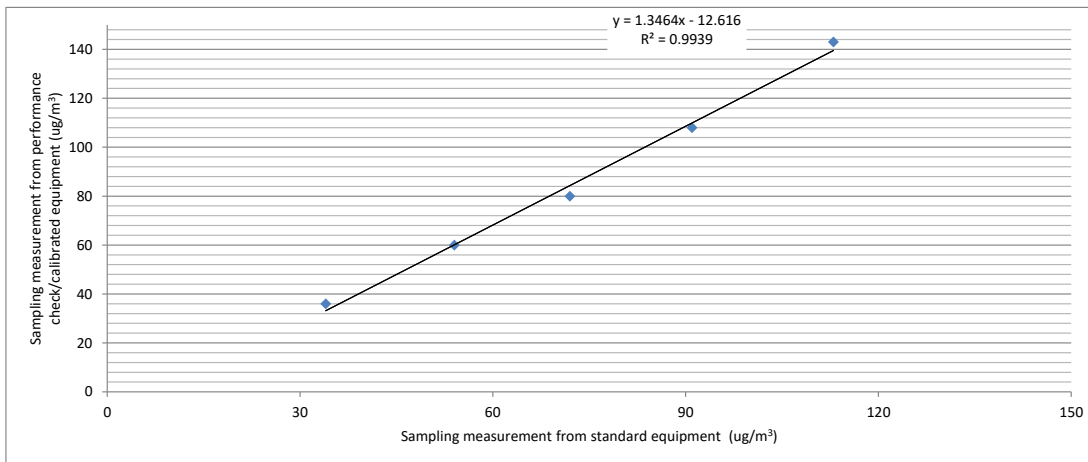
### Linear Regression of Y on X

Slope (K- factor) : 0.8000  
 Correlation Coefficient : 0.9969  
 Validity of Performance Check / Calibration Record : 9/3/2027

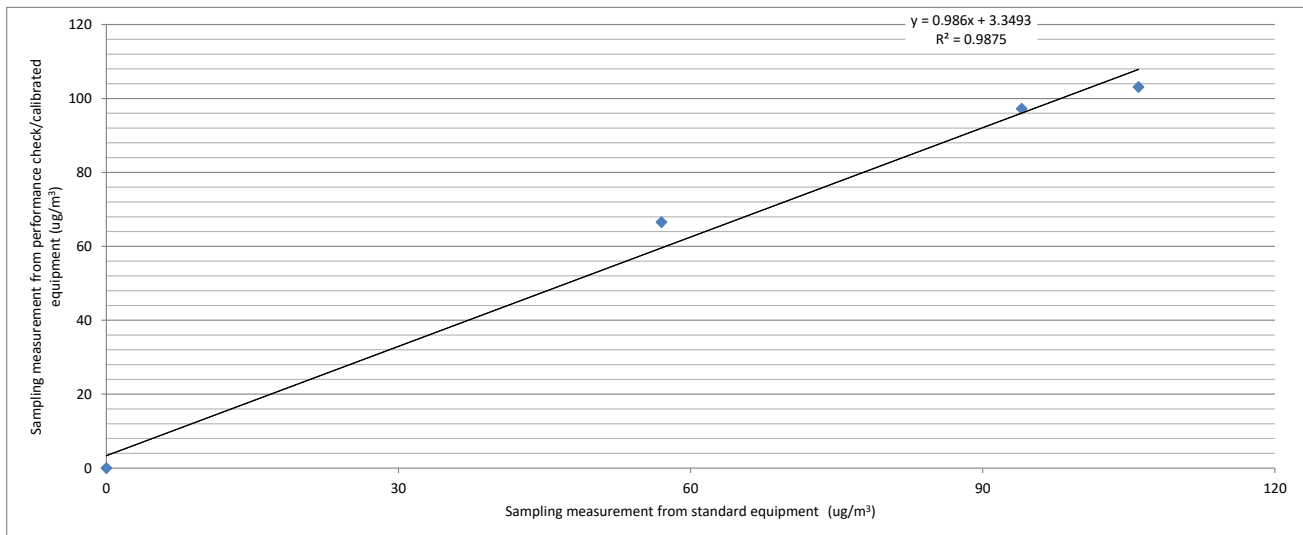
Linear Regression of Y on X

Slope (K- factor) : 1.1000
Correlation Coefficient : 0.9937
Validity of Performance Check / Calibration Record : 25/3/2026

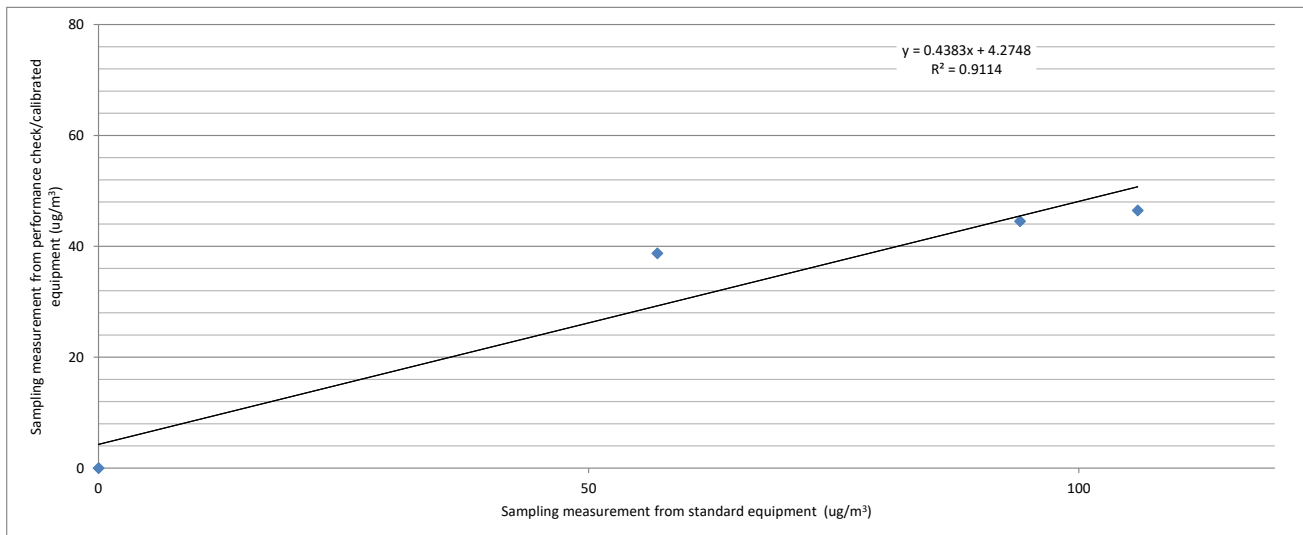
Linear Regression of Y on X

Slope (K- factor) : 2.1000
Correlation Coefficient : 0.9547
Validity of Performance Check / Calibration Record : 25/3/2026

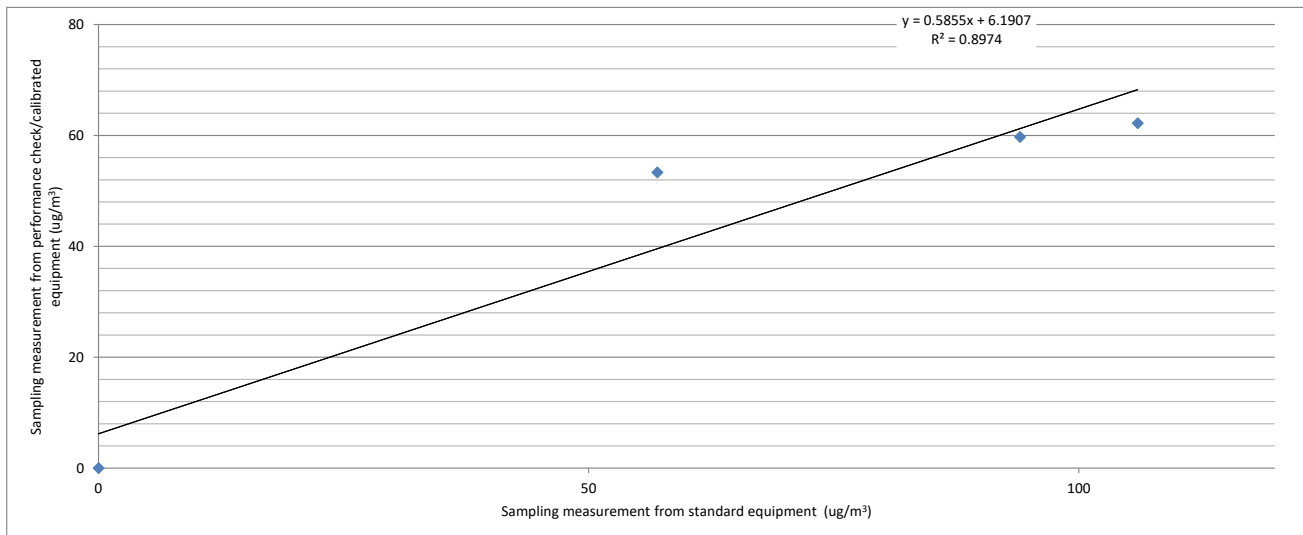
Linear Regression of Y on X

Slope (K- factor) : 1.6000
Correlation Coefficient : 0.9473
Validity of Performance Check / Calibration Record : 25/3/2026

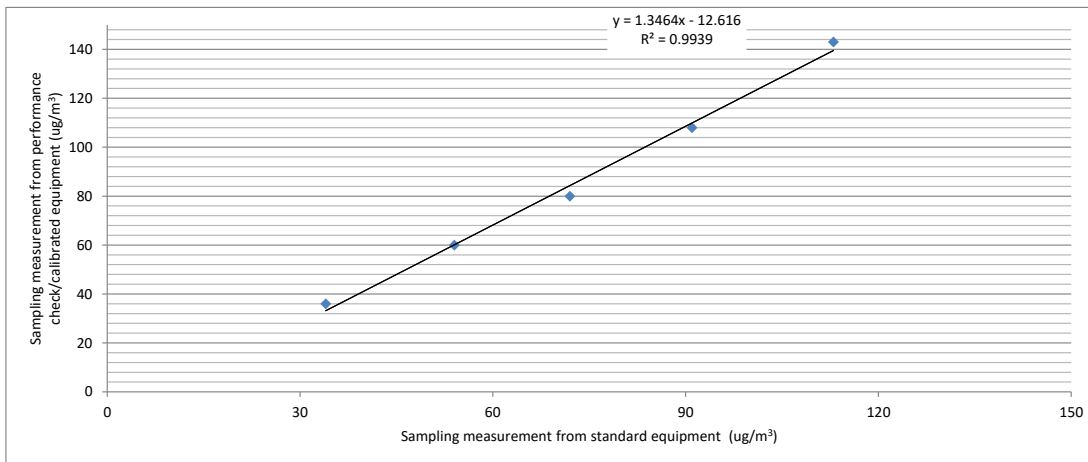
### Linear Regression of Y on X

Slope (K- factor) : 0.8000  
 Correlation Coefficient : 0.9969  
 Validity of Performance Check / Calibration Record : 9/3/2027

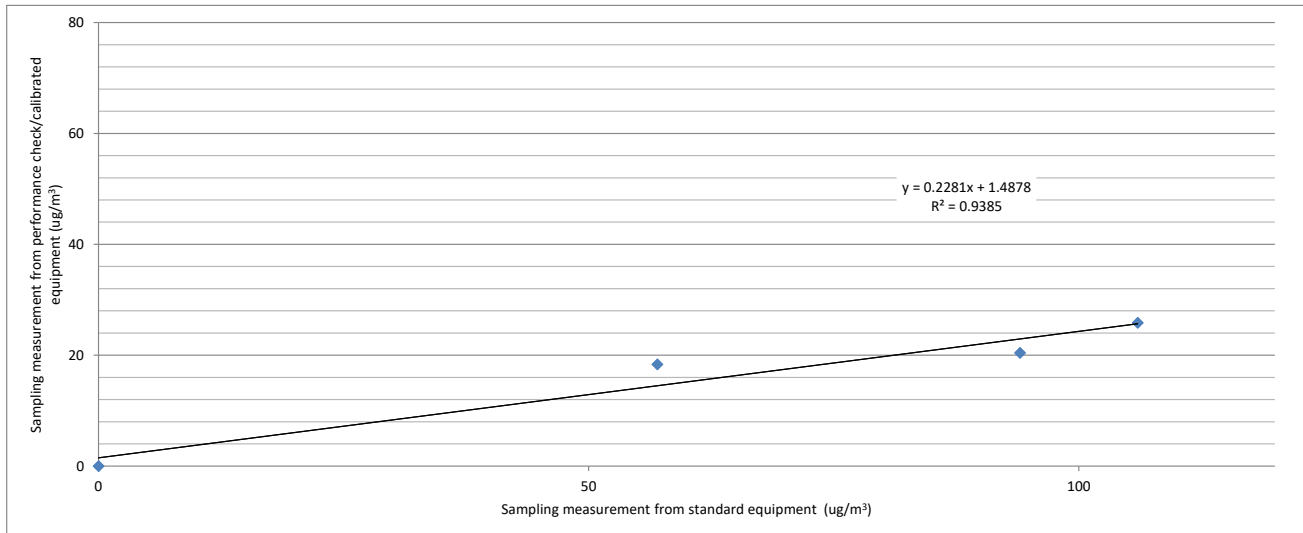
Linear Regression of Y on X

Slope (K- factor) : 4.2000
Correlation Coefficient : 0.9688
Validity of Performance Check / Calibration Record : 25/3/2026

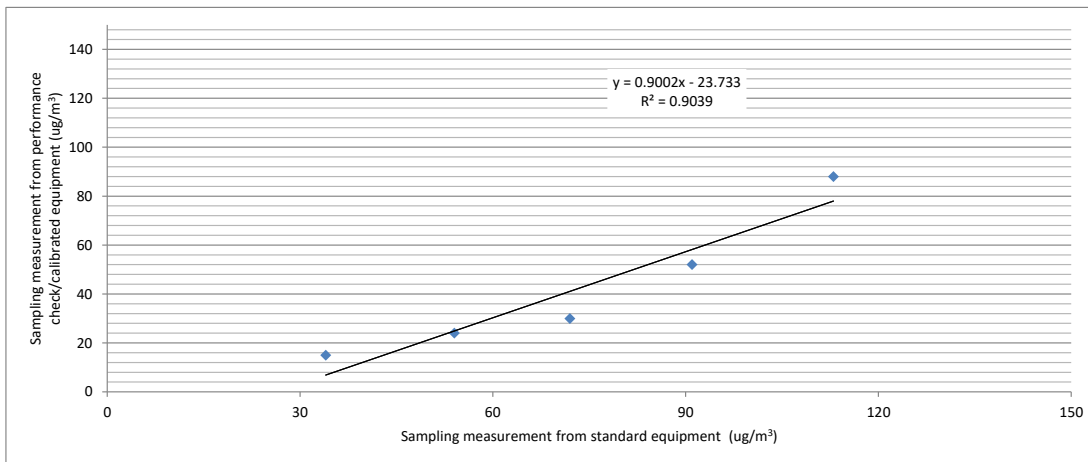
### Linear Regression of Y on X

Slope (K- factor) : 1.1000  
 Correlation Coefficient : 0.9507  
 Validity of Performance Check / Calibration Record : 9/3/2027

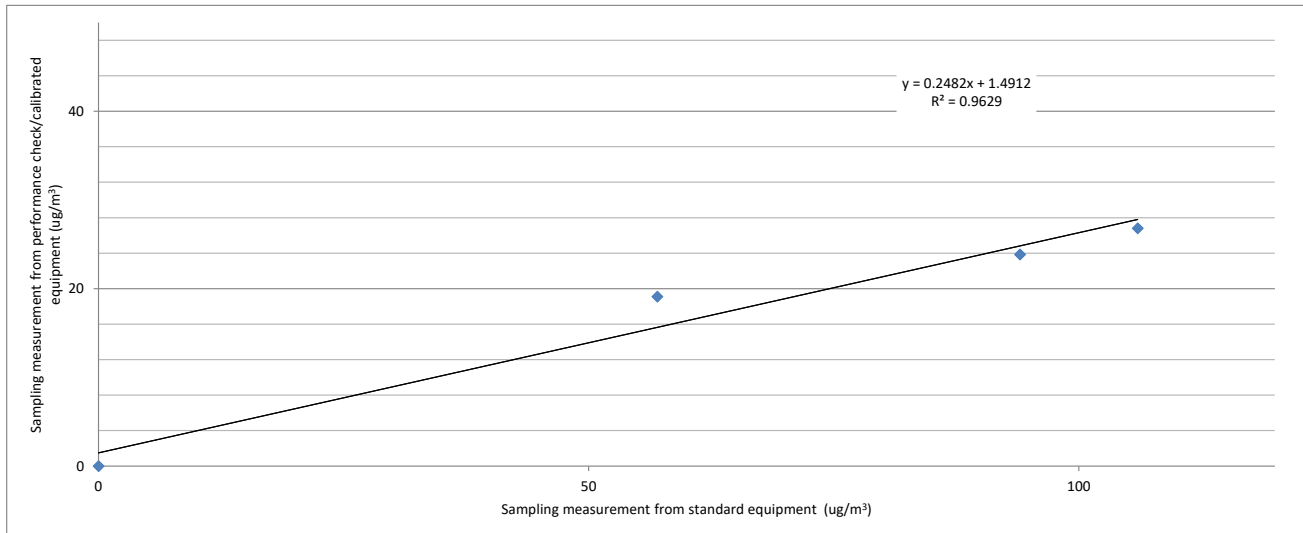
Linear Regression of Y on X

Slope (K- factor) : 3.9000
Correlation Coefficient : 0.9813
Validity of Performance Check / Calibration Record : 25/3/2026

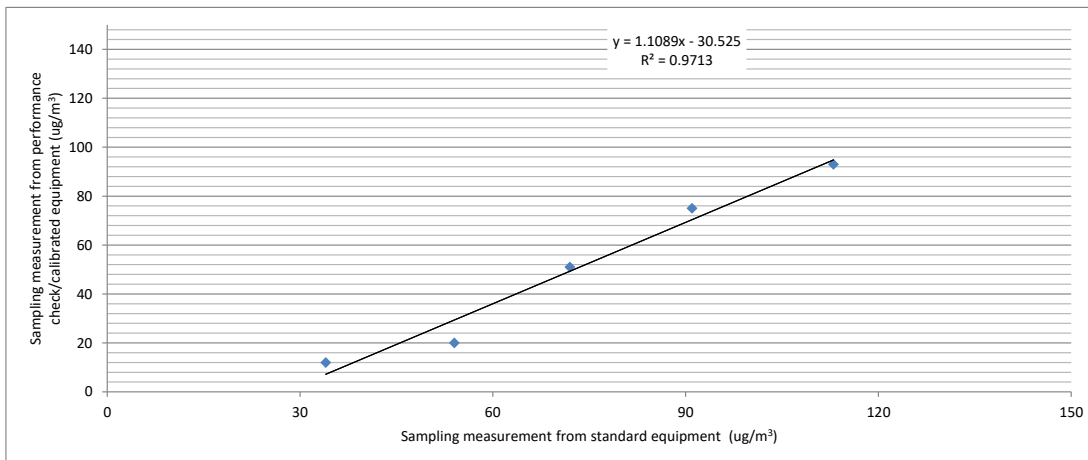
### Linear Regression of Y on X

Slope (K- factor) : 0.9000  
 Correlation Coefficient : 0.9856  
 Validity of Performance Check / Calibration Record : 9/3/2027

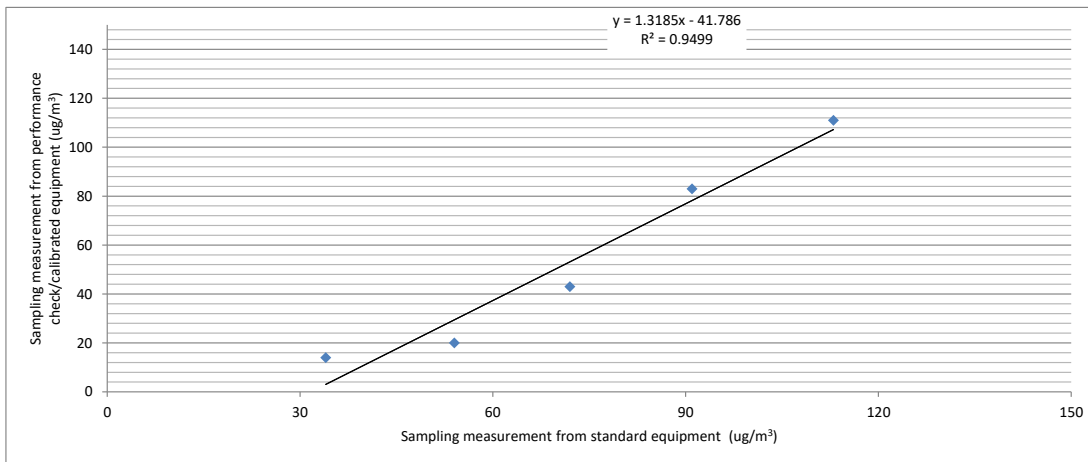
### Linear Regression of Y on X

Slope (K- factor) : 0.8000  
 Correlation Coefficient : 0.9746  
 Validity of Performance Check / Calibration Record : 9/3/2027

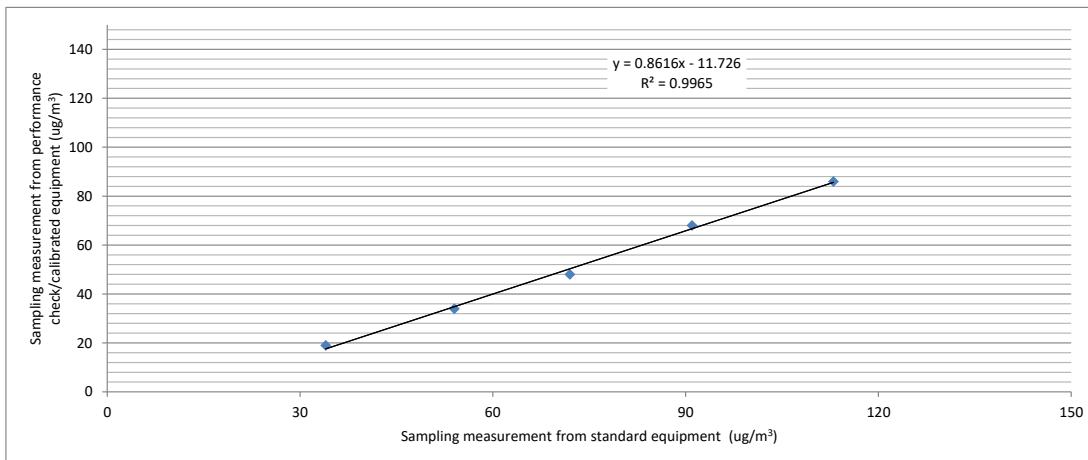
### Linear Regression of Y on X

Slope (K- factor) : 1.2000  
 Correlation Coefficient : 0.9983  
 Validity of Performance Check / Calibration Record : 9/3/2027

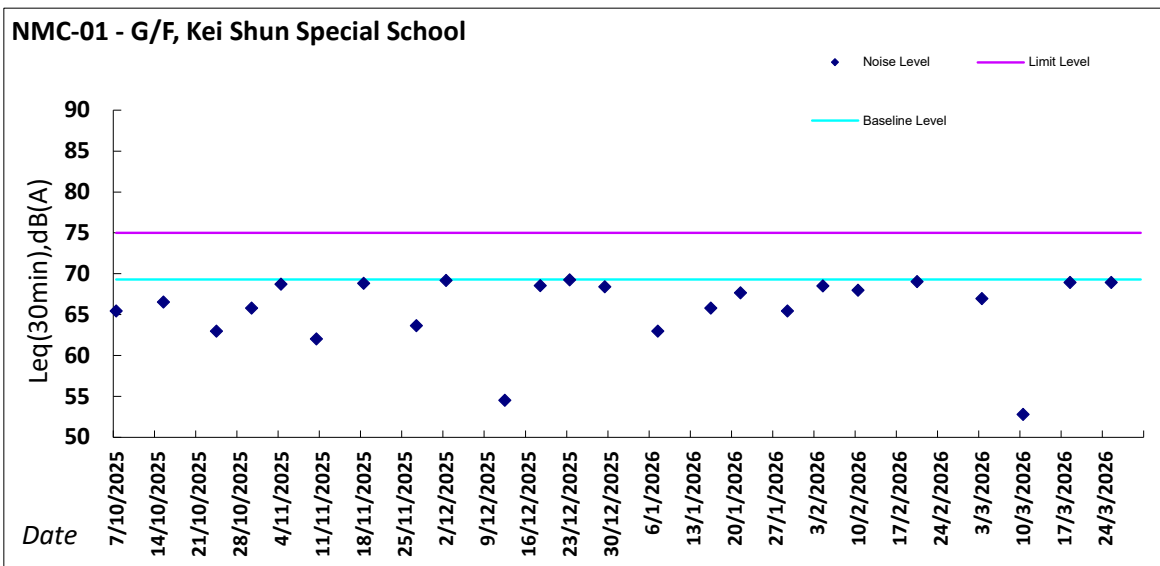
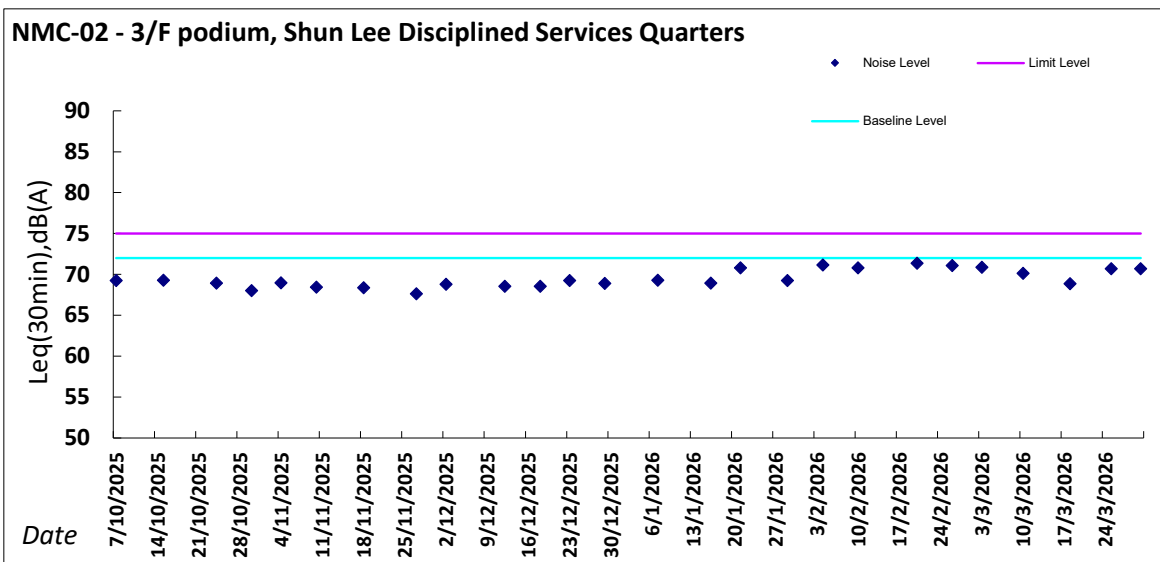
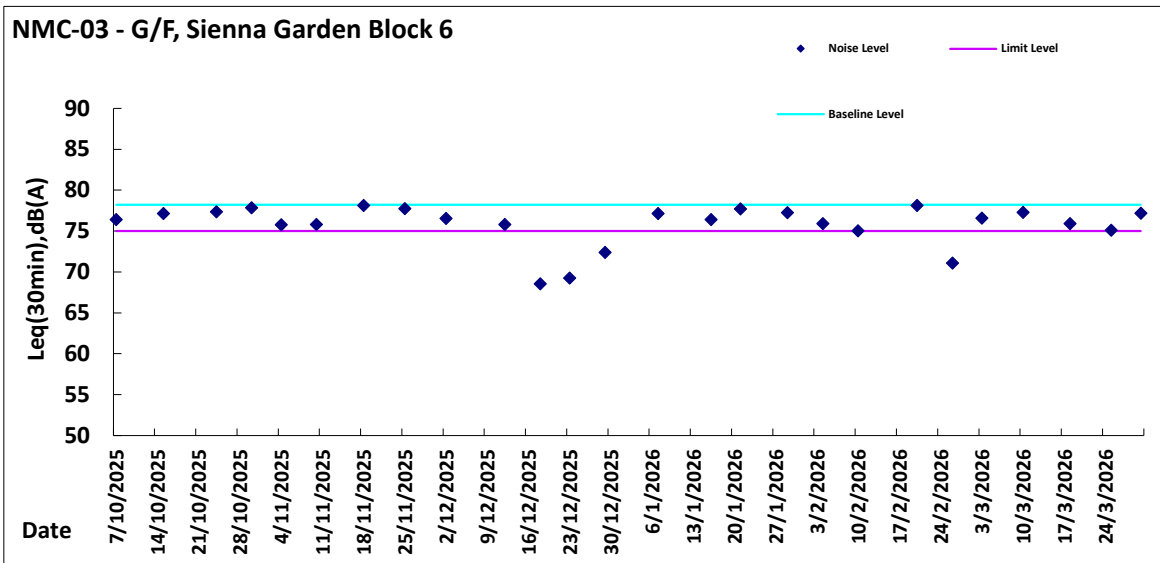
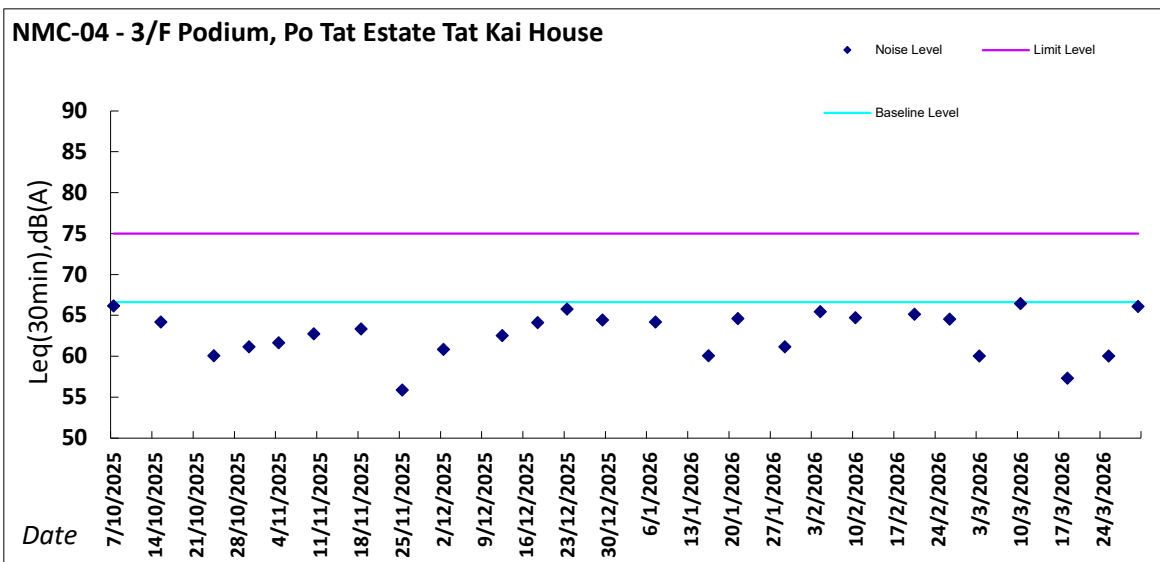
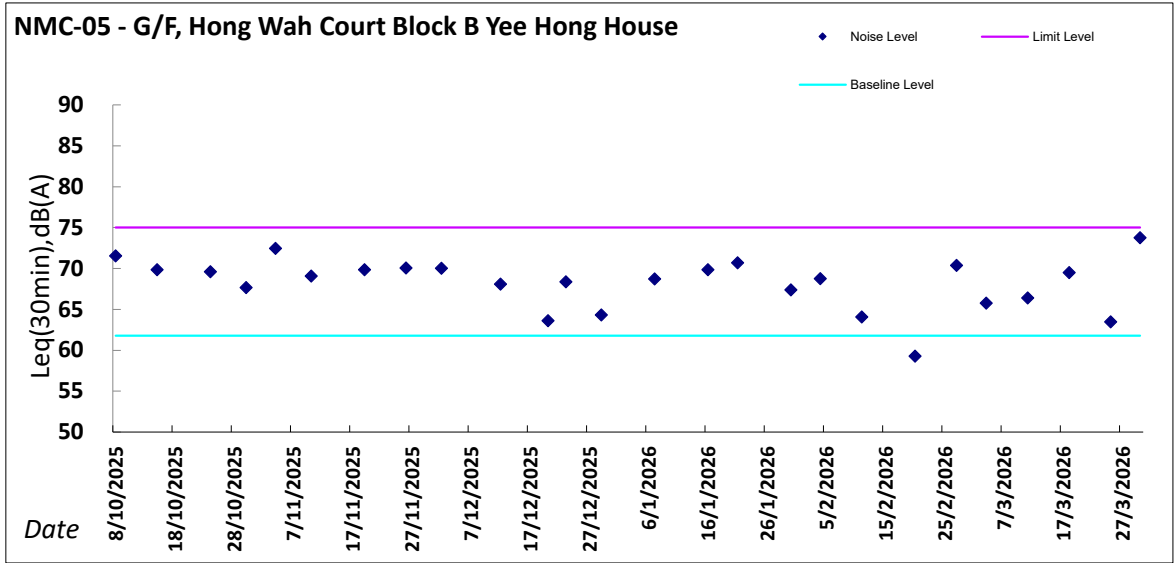
**Graphic Presentation of Noise Monitoring Result**

Day Time (0700 - 1900hrs on normal weekdays)

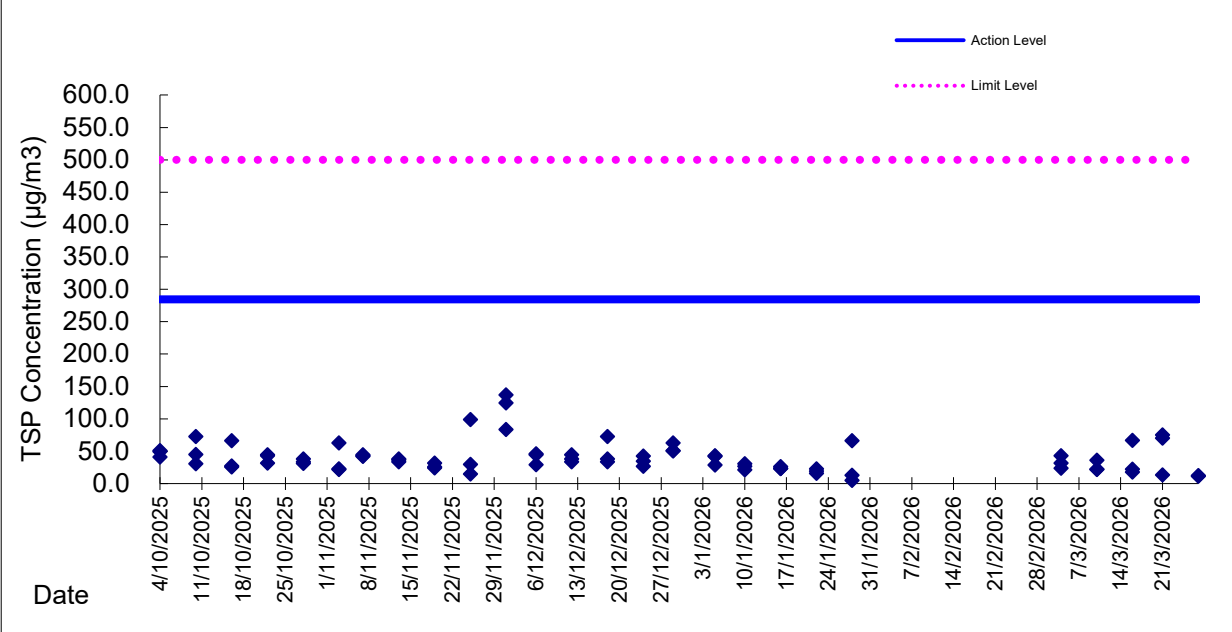
Graphic Presentation of TSP Result

NCWBR\_AMS-1 - Shun Lee Fire Station

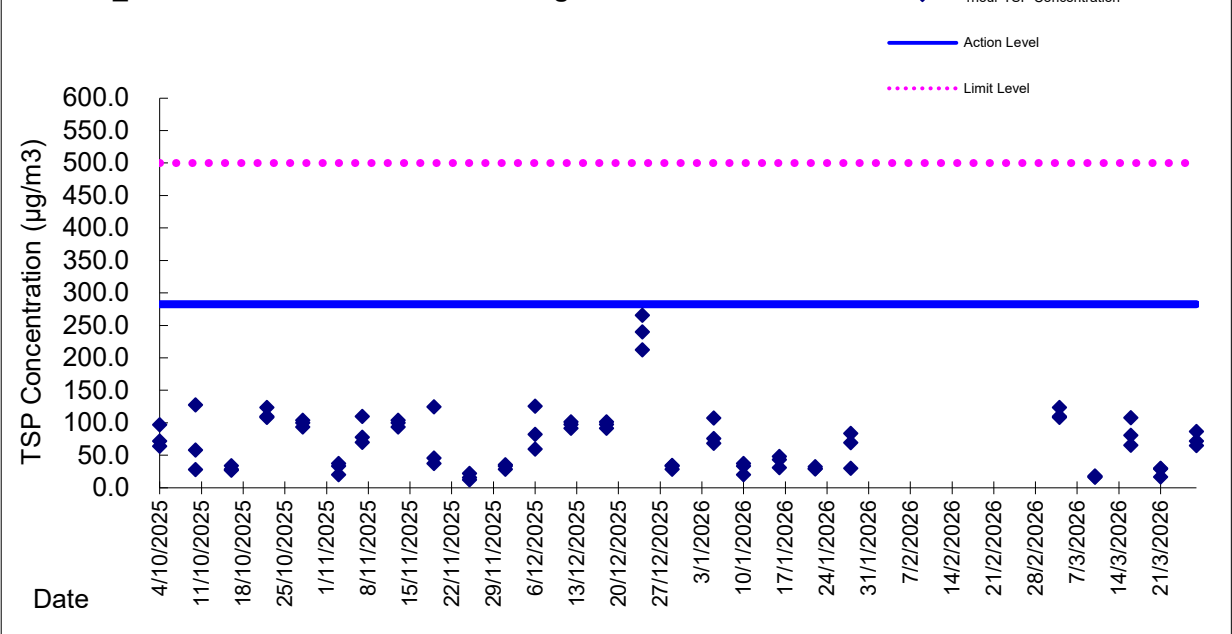
NCWBR\_AMS-2 - Shun Lee Estate Lee Hang House

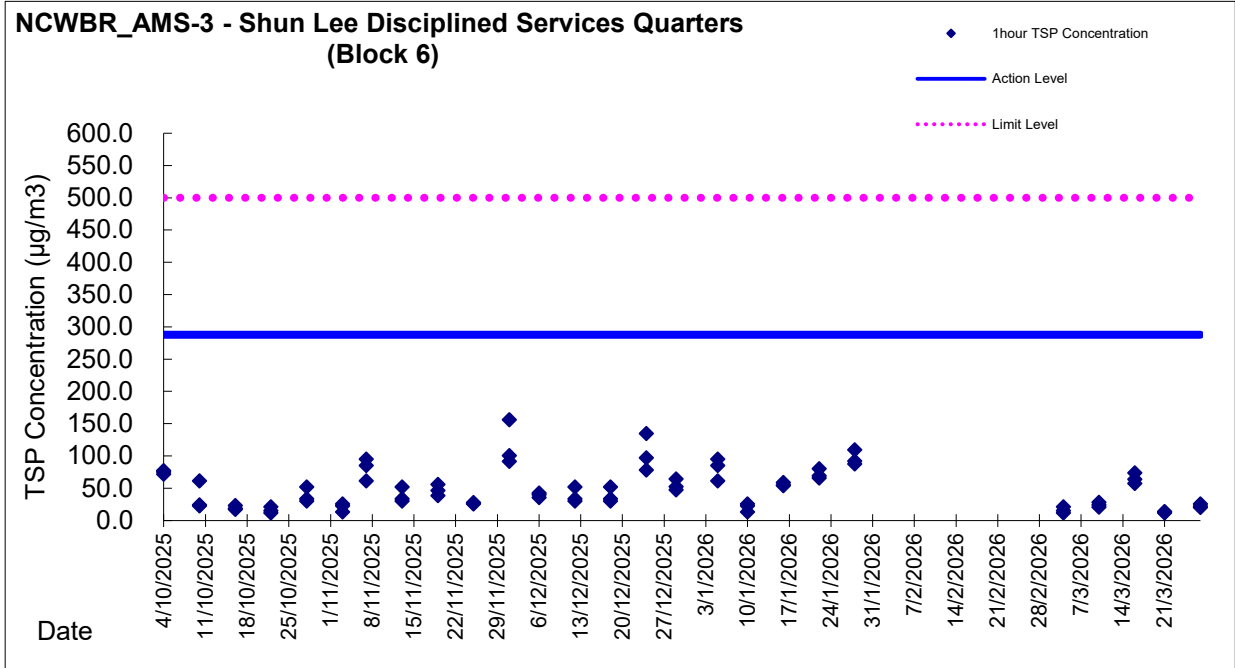
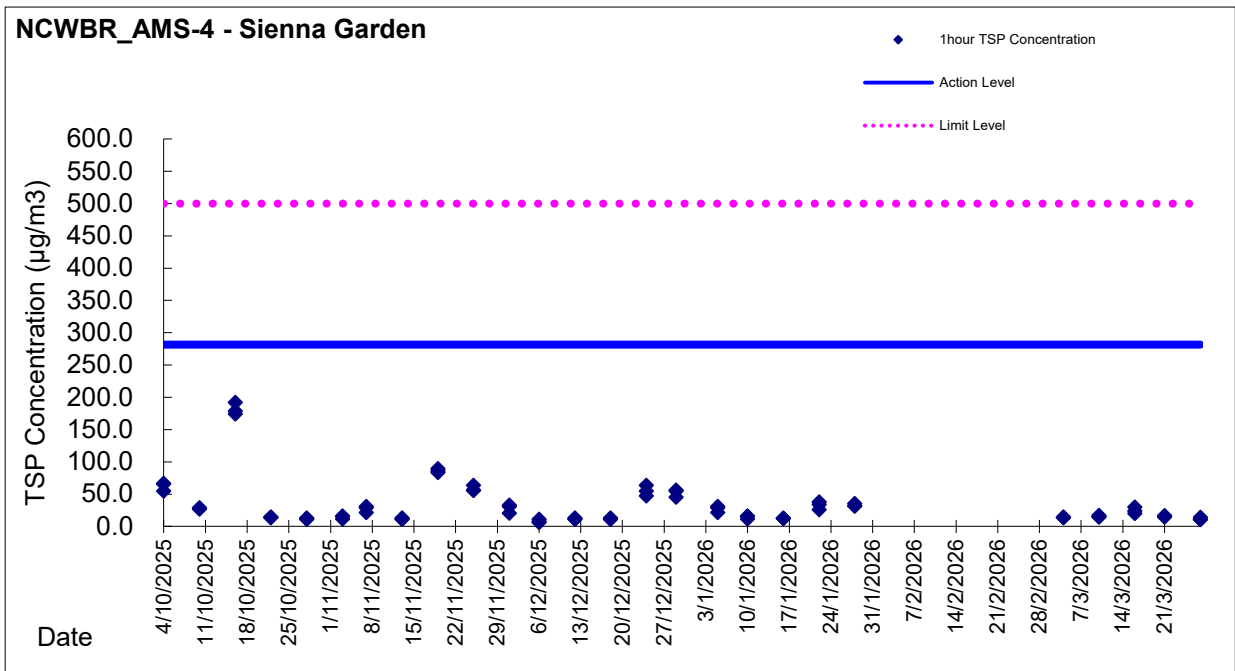
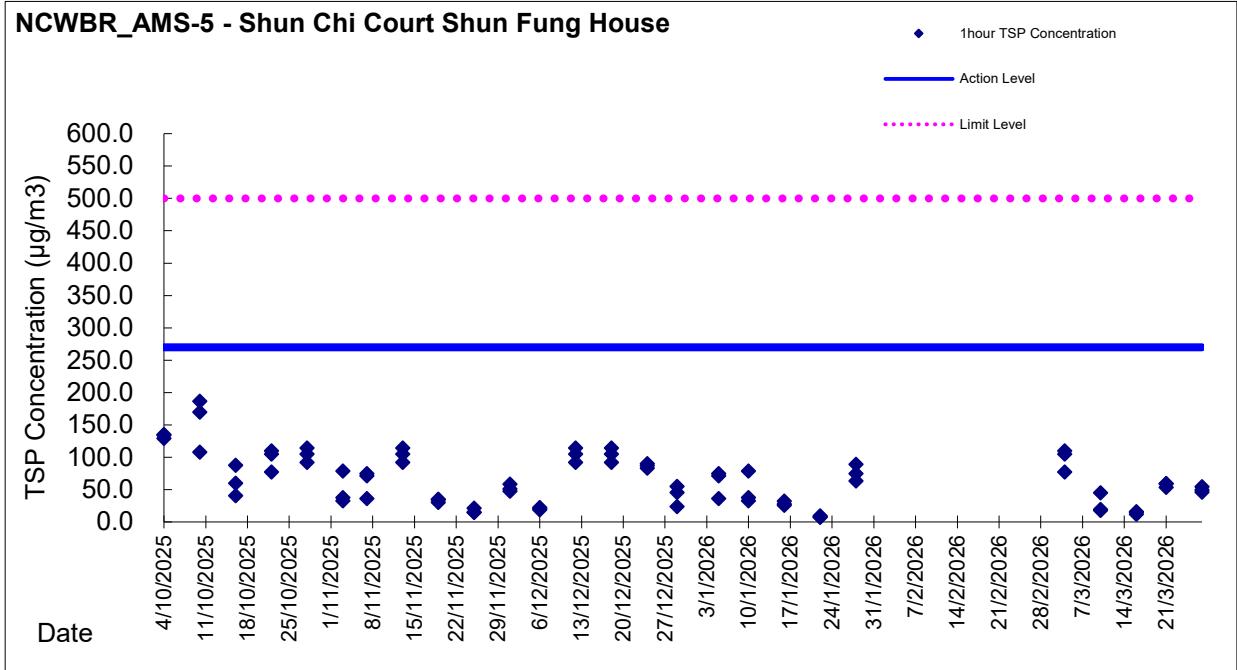
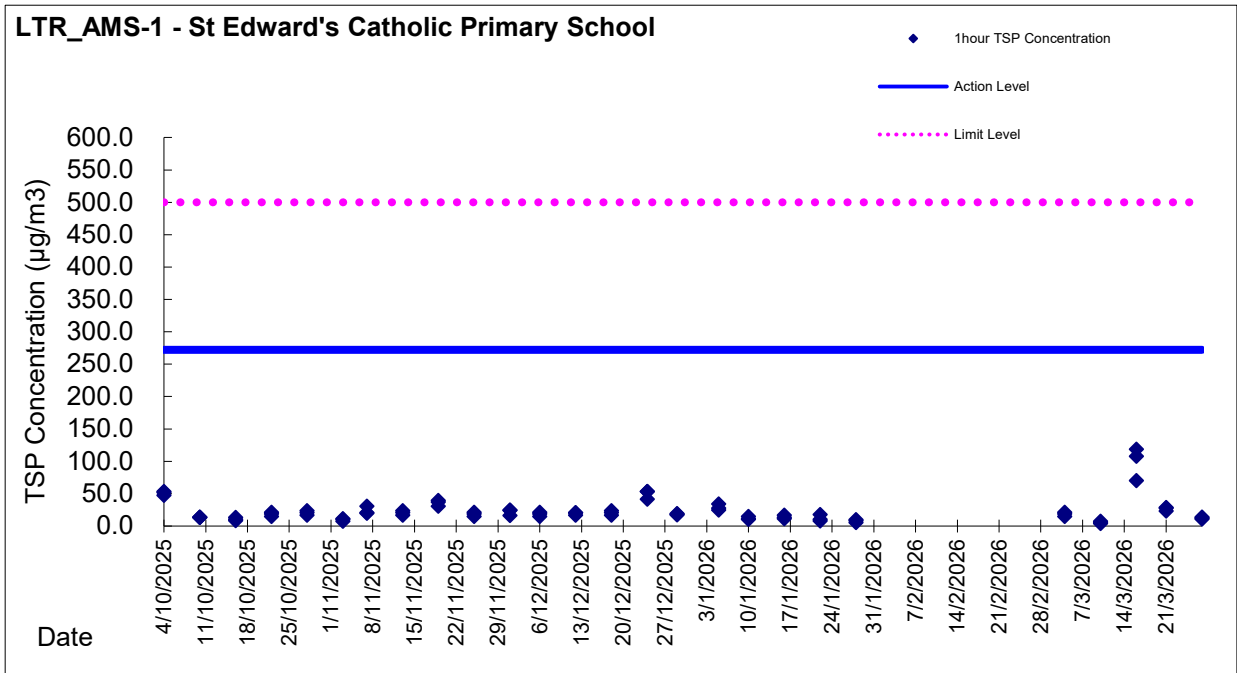
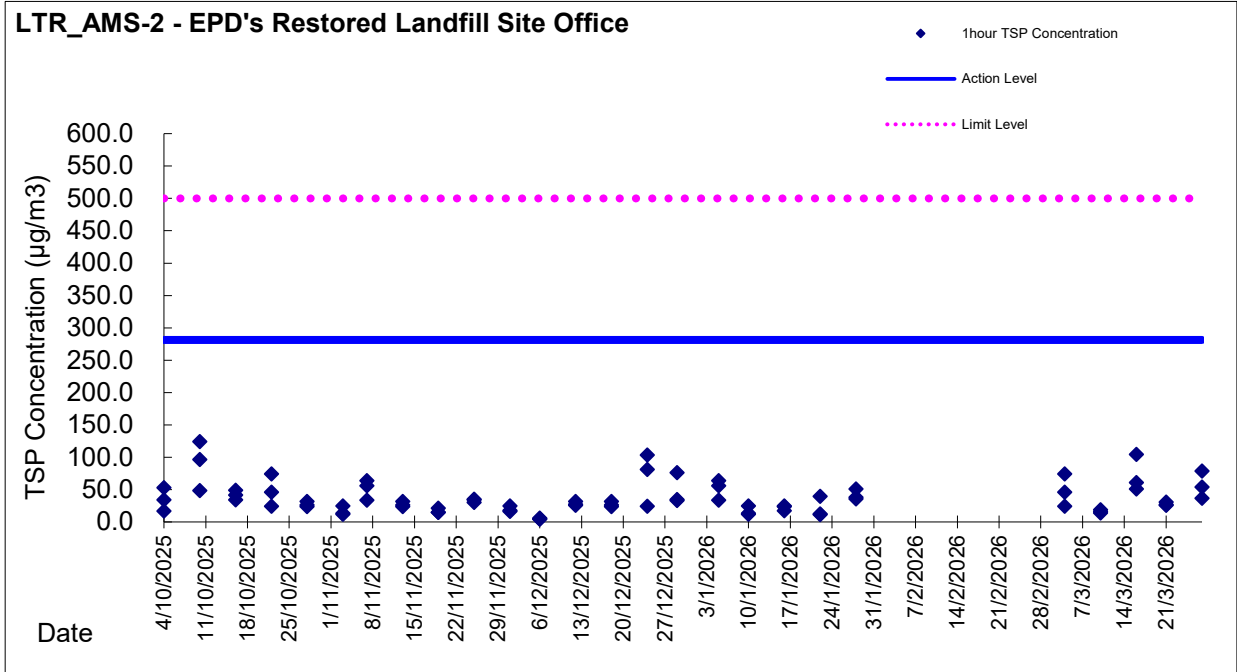
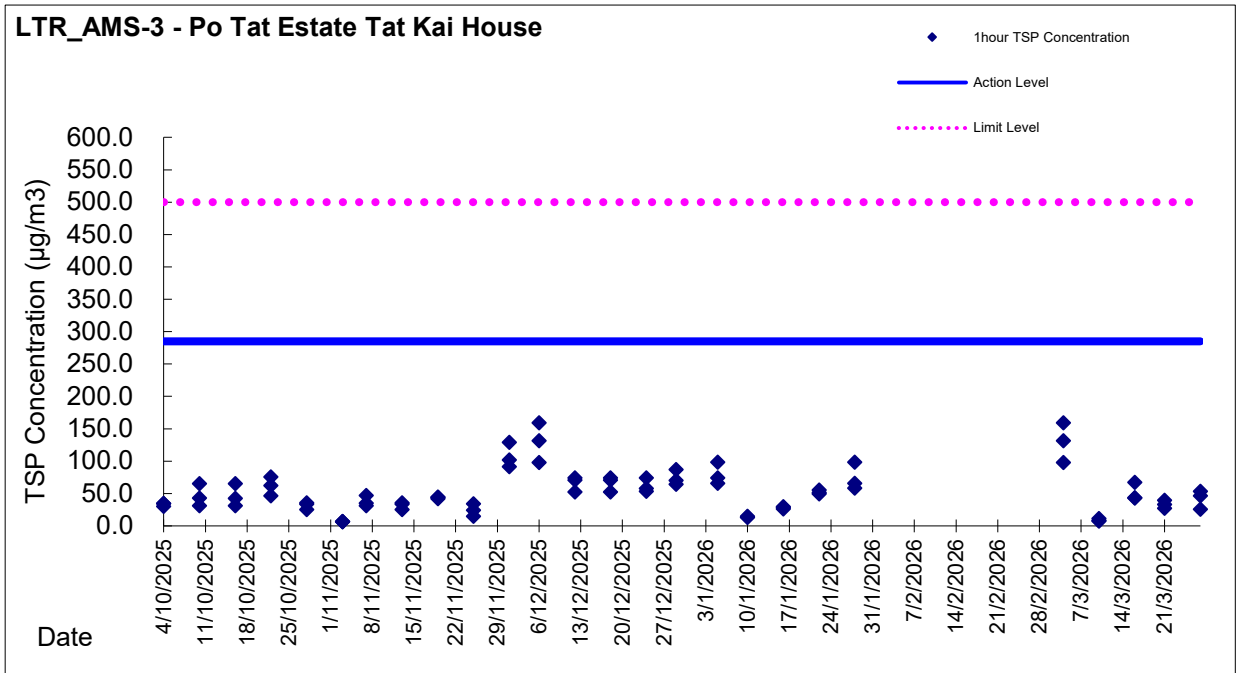
Graphic Presentation of TSP Result
