**ENVIRONMENTAL TEAM FOR  
DEVELOPMENT OF  
ANDERSON ROAD QUARRY SITE -  
ROAD IMPROVEMENT WORKS**

**MONTHLY ENVIRONMENTAL MONITORING & AUDIT REPORT**

**MARCH 2026**

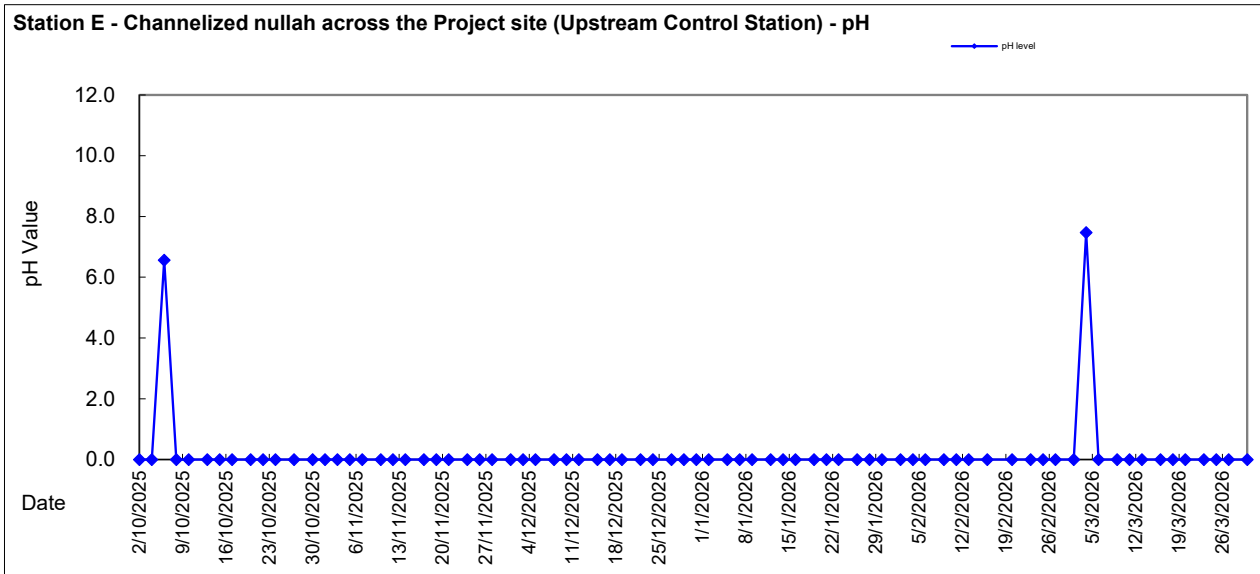
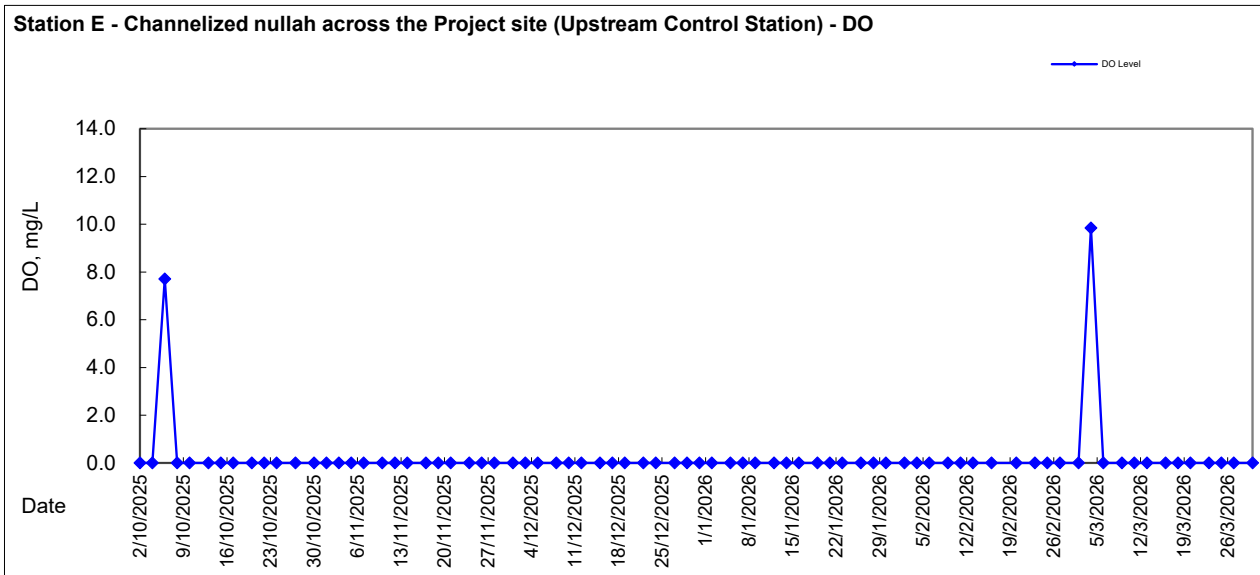
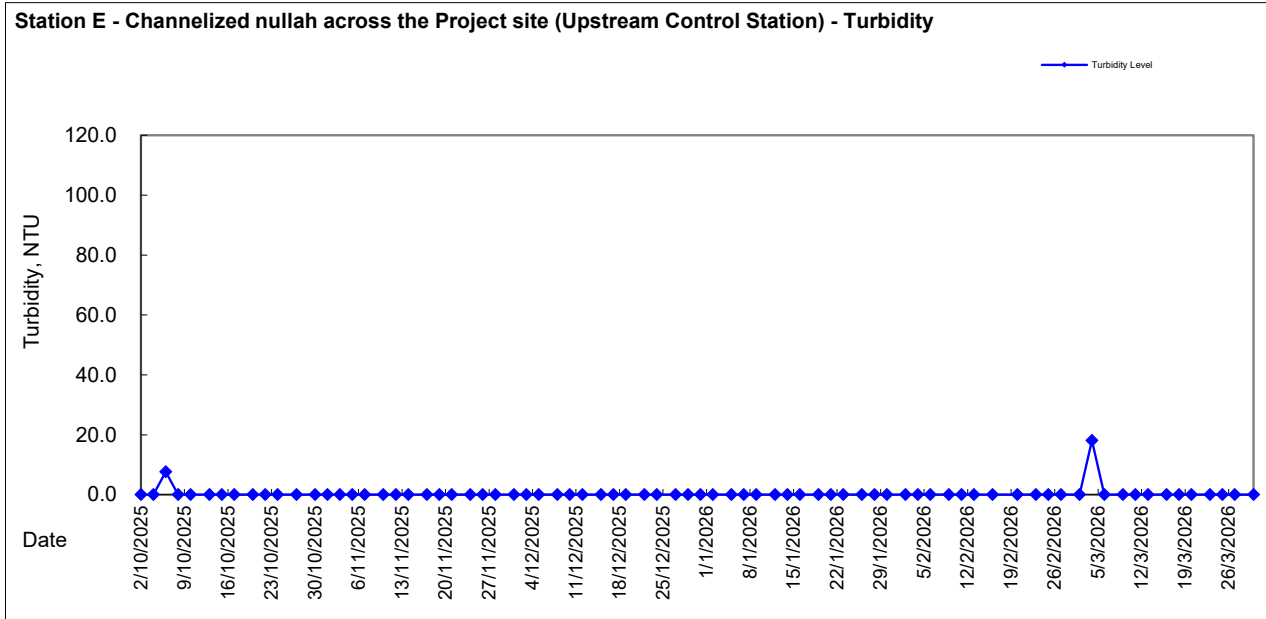
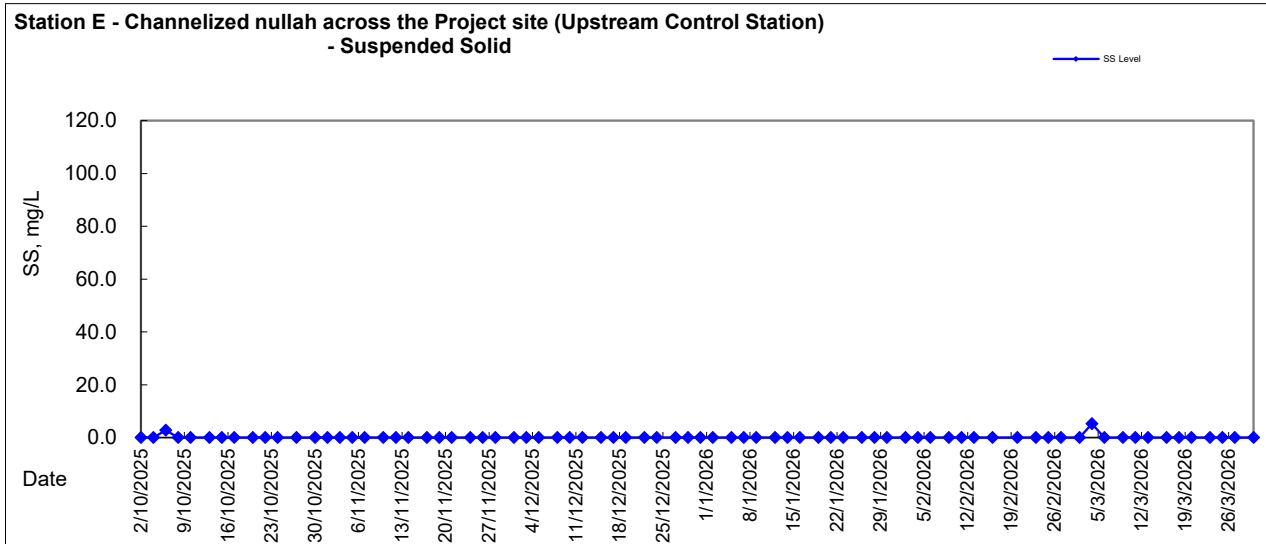
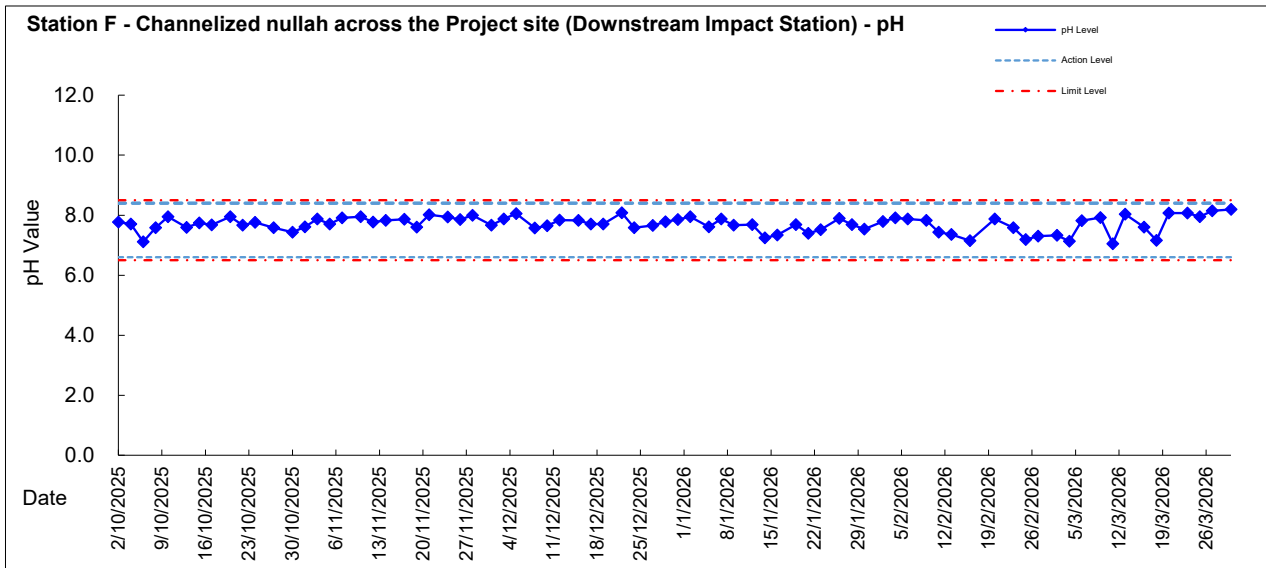
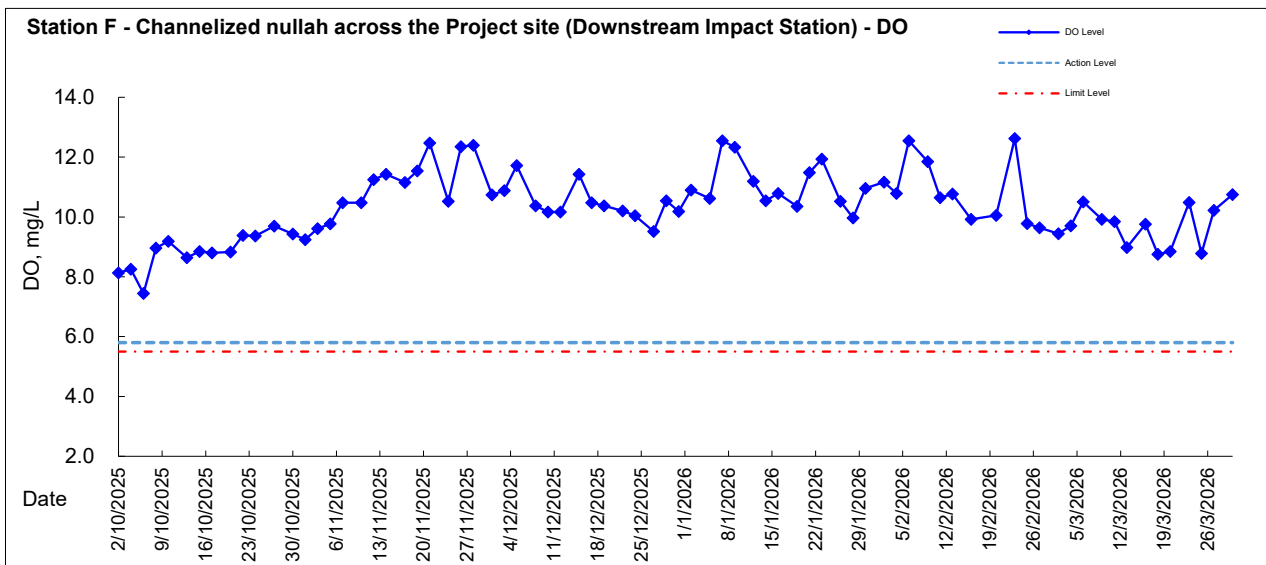
Graphic Presentation of WQM Result

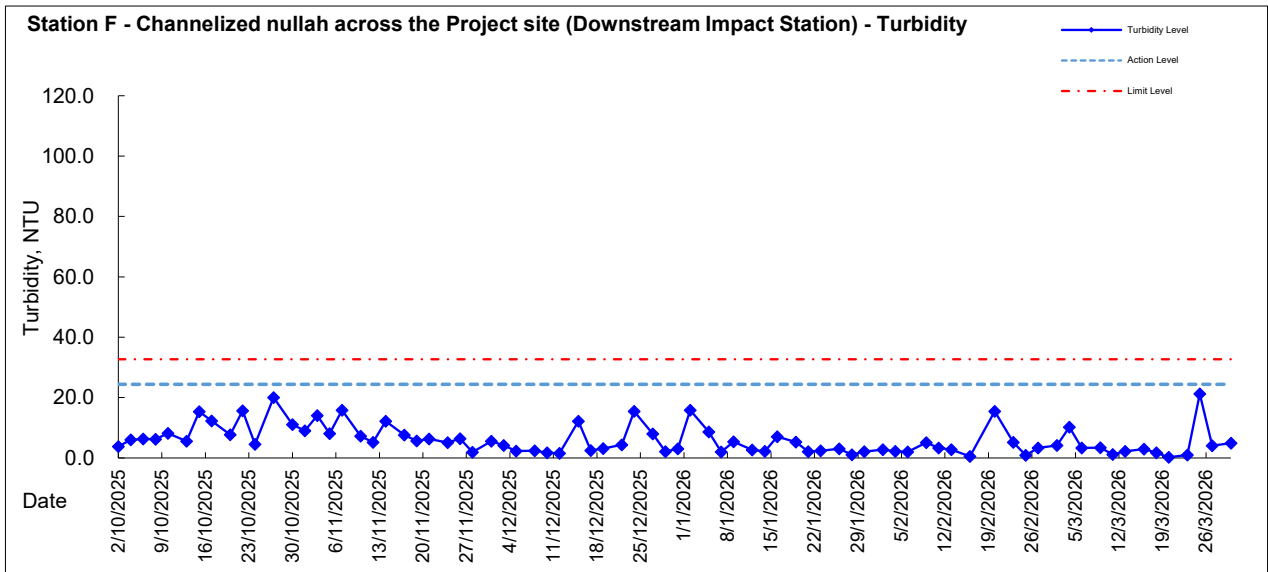
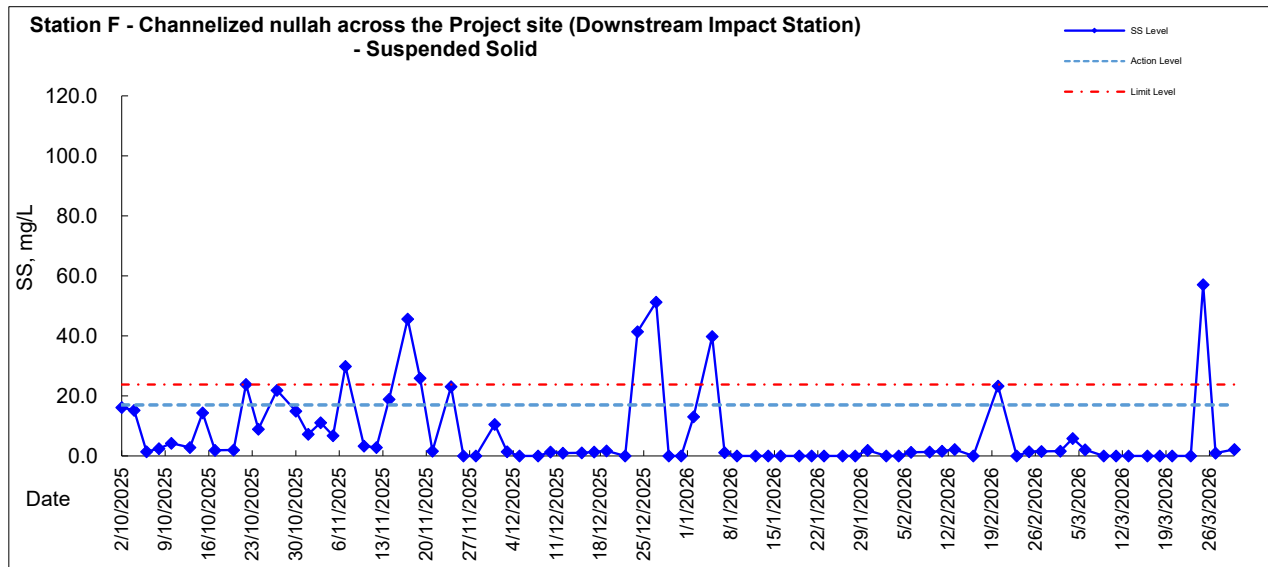
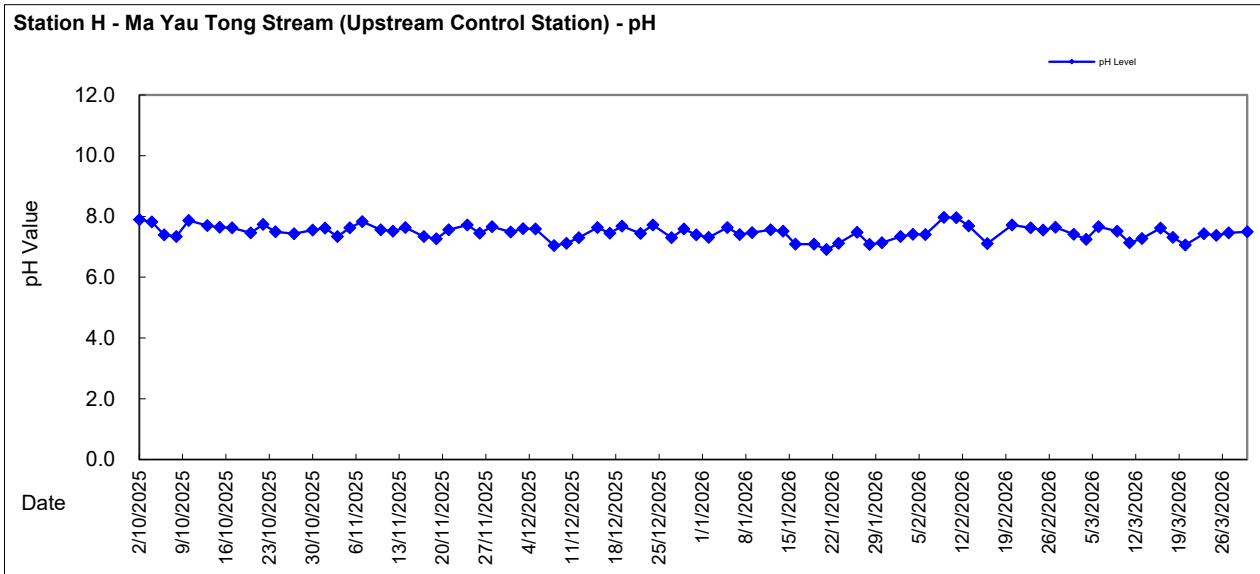
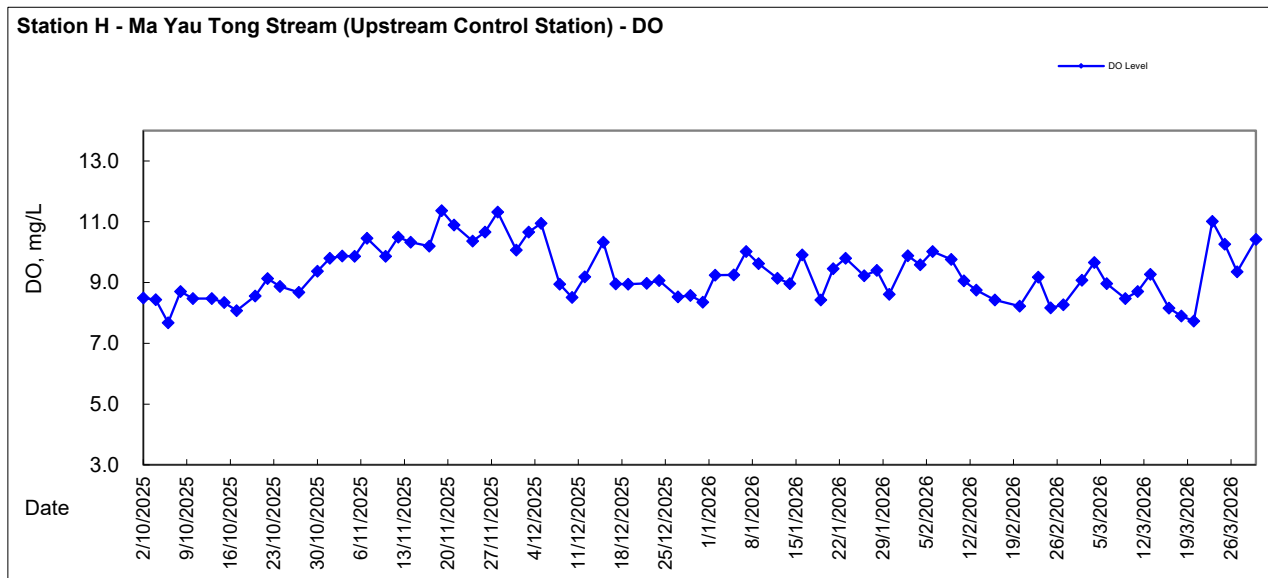
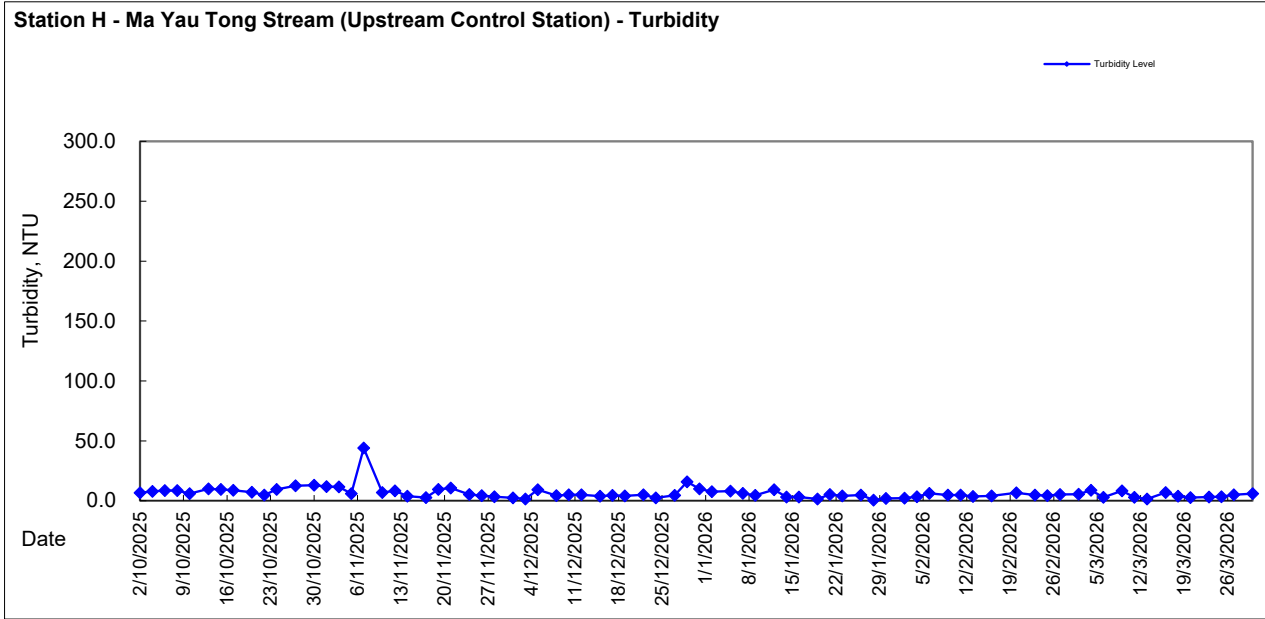
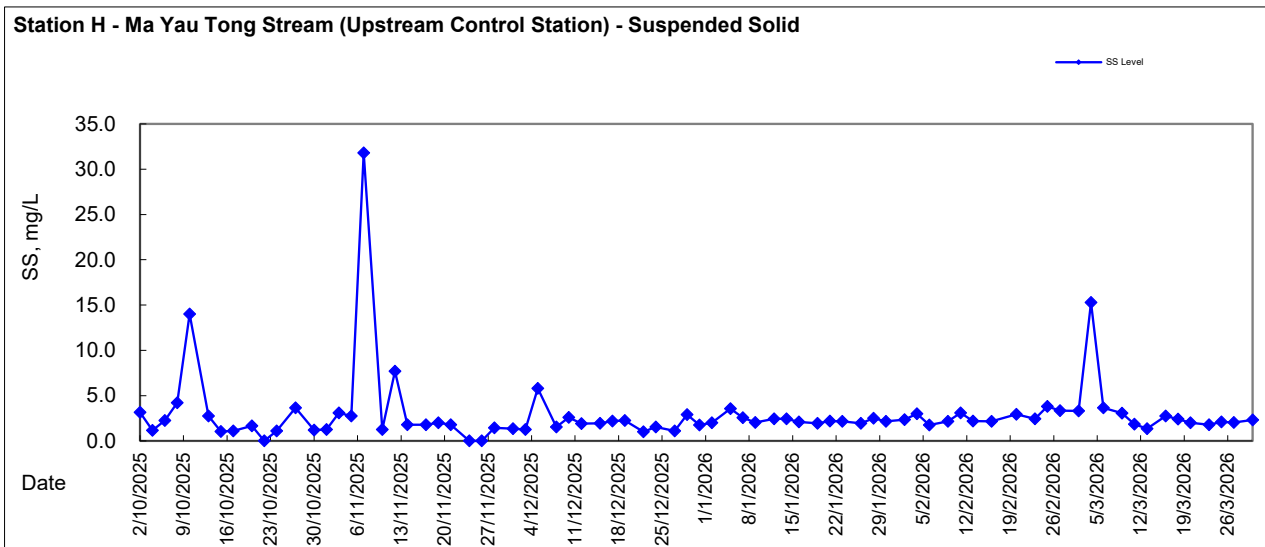
Graphic Presentation of WQM Result

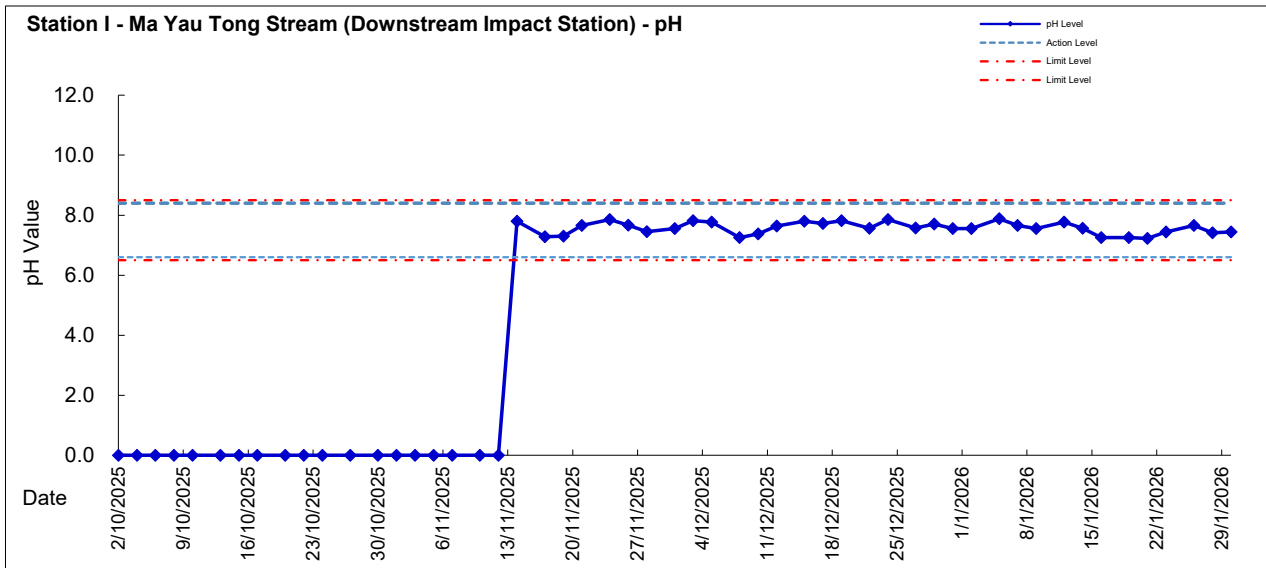
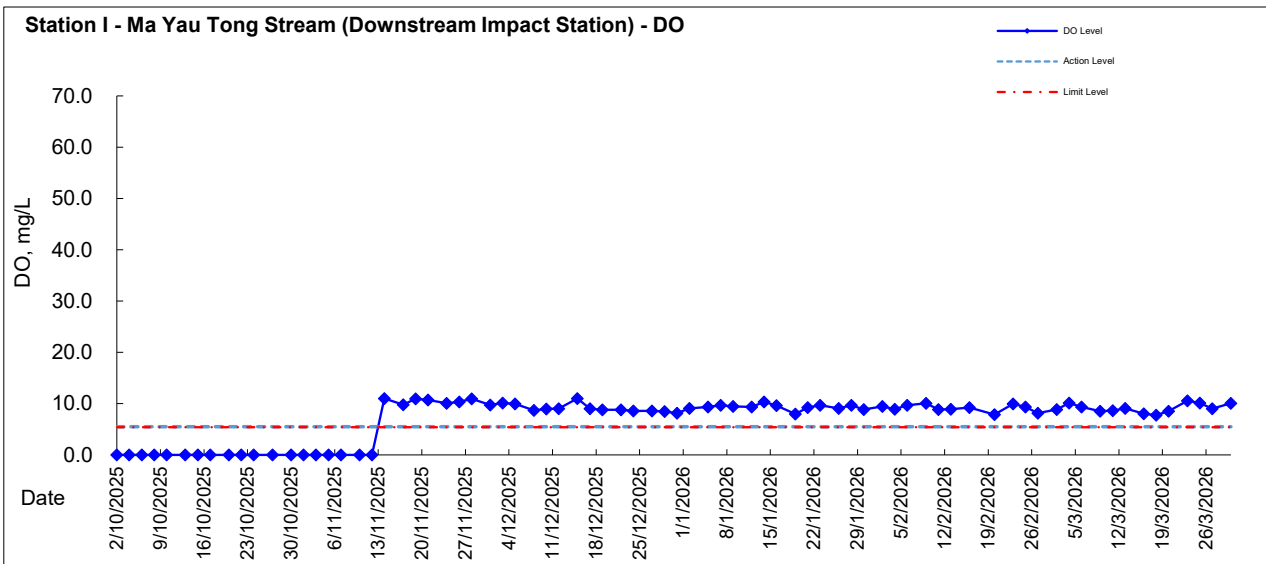
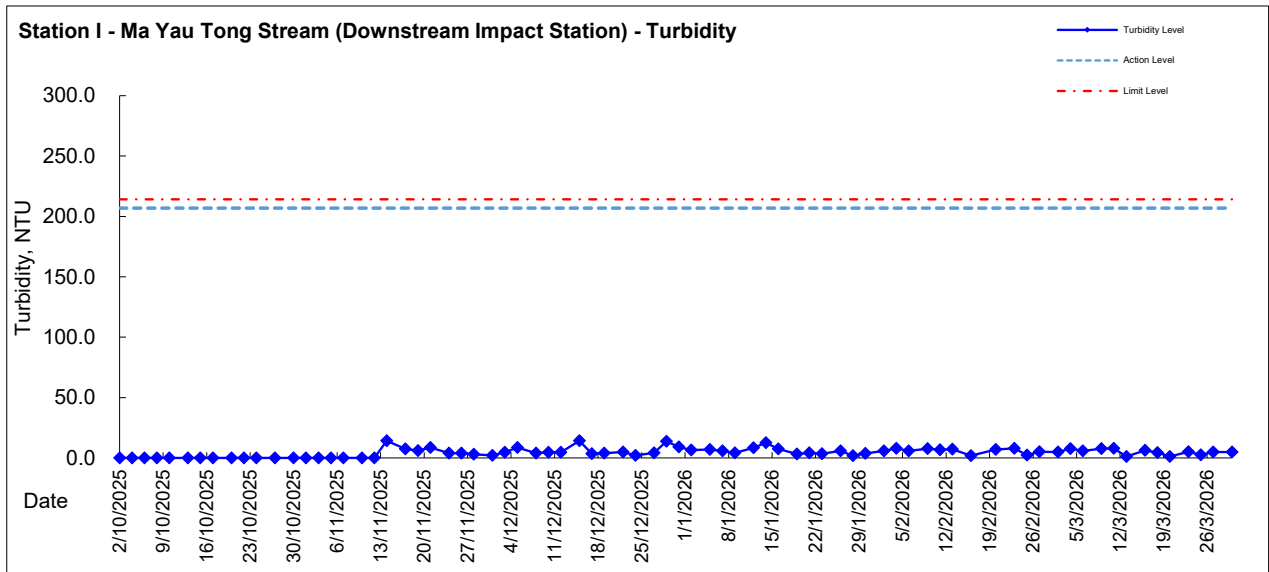
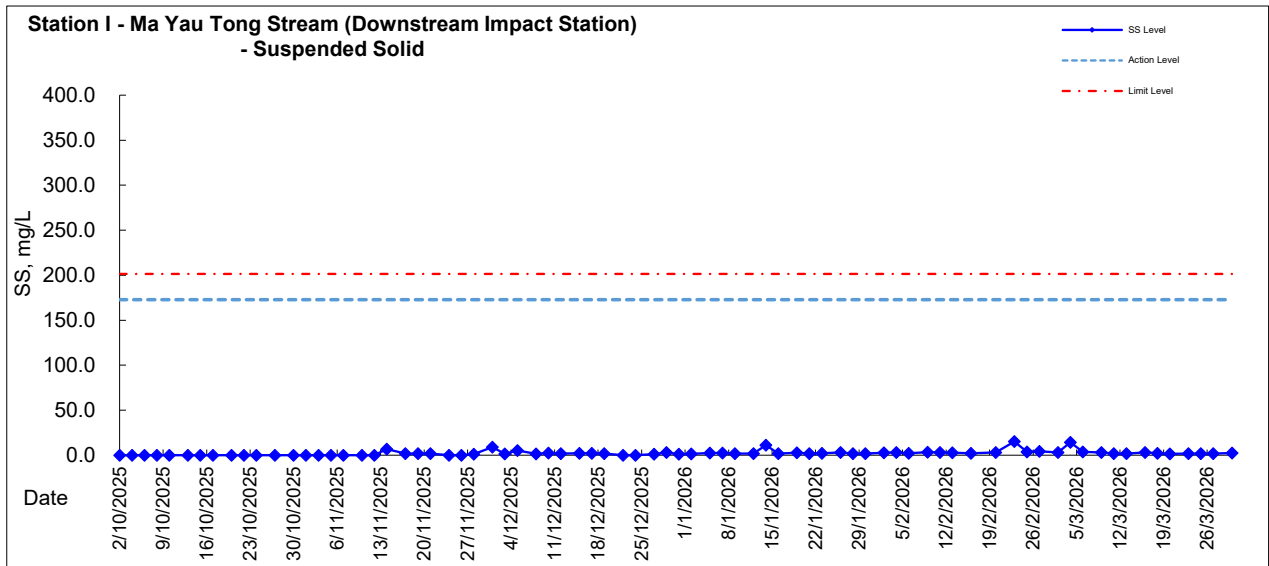
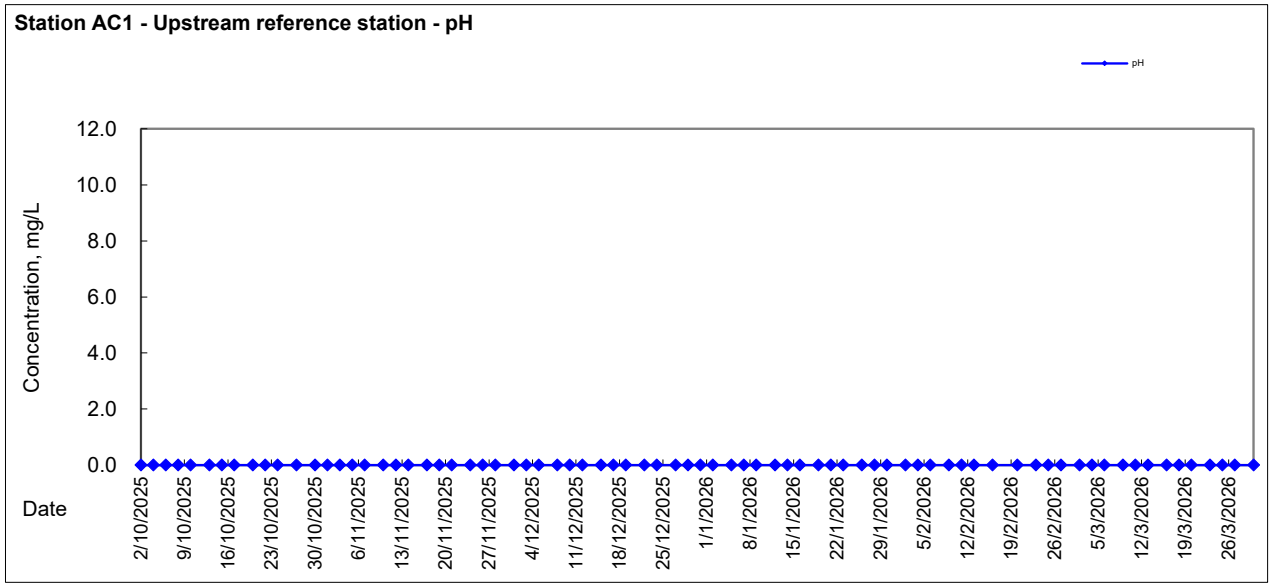
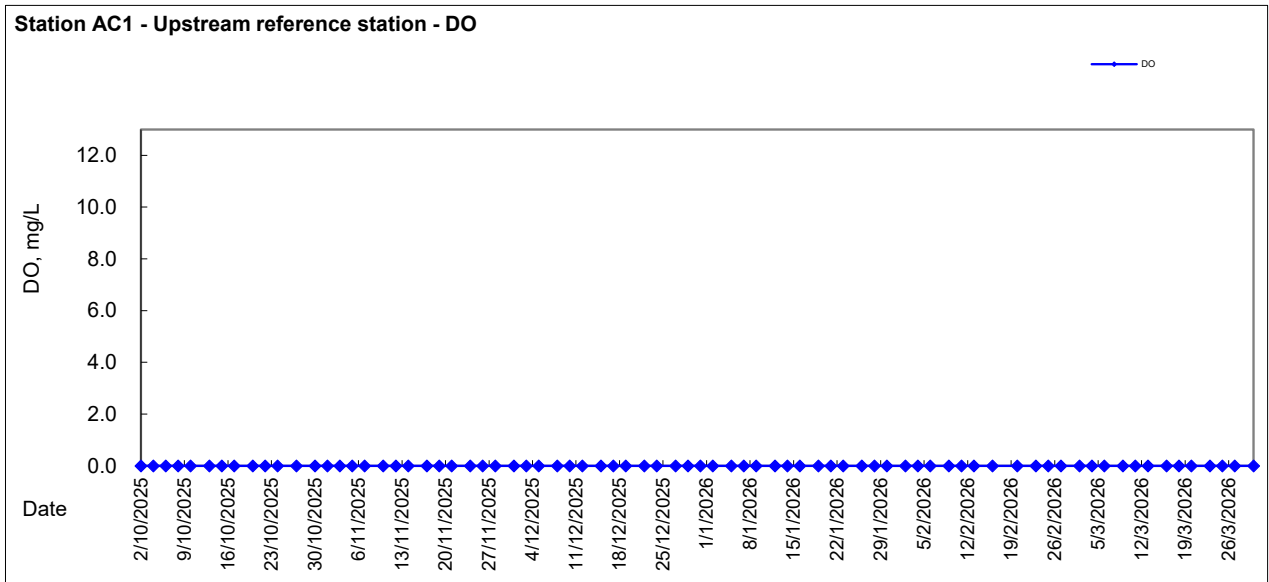
Graphic Presentation of WQM Result

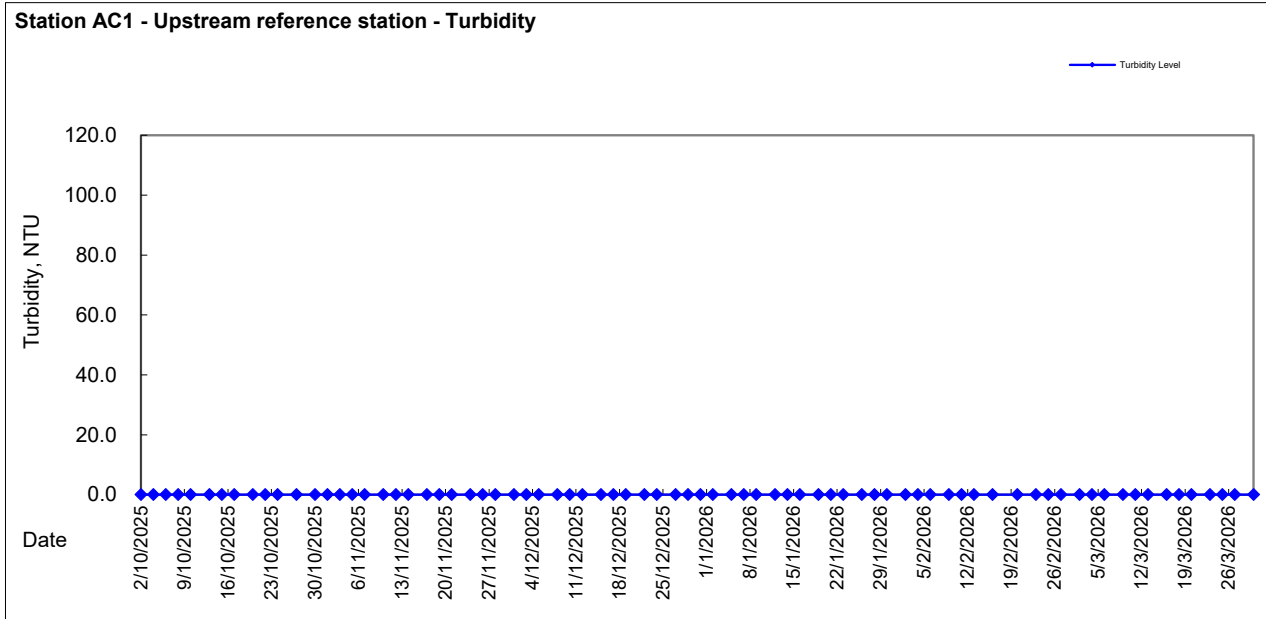
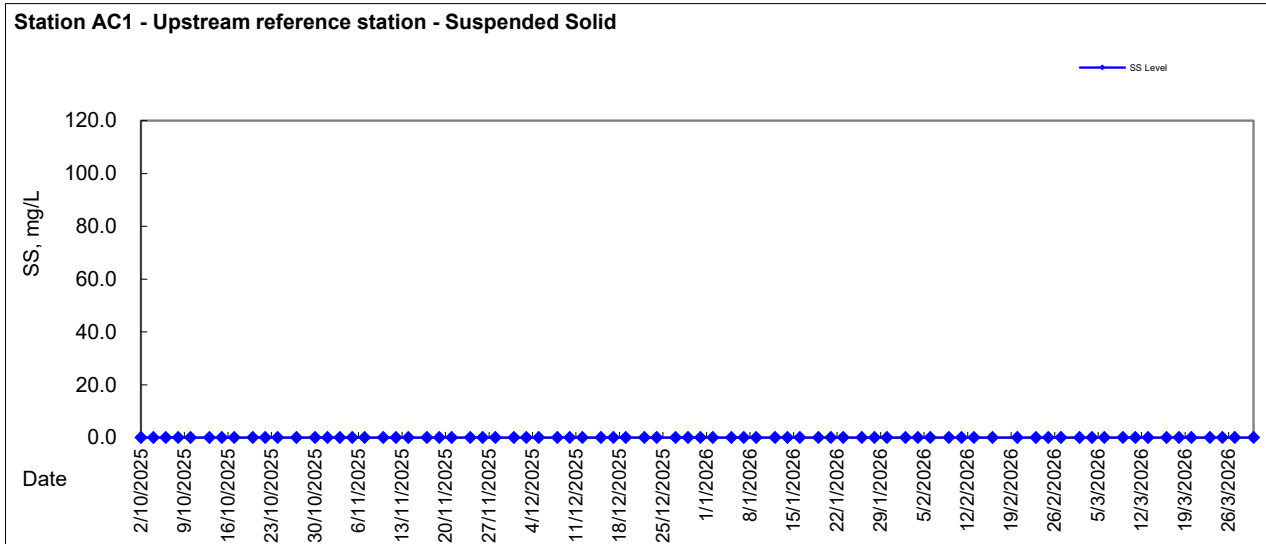
Graphic Presentation of WQM Result
