**ENVIRONMENTAL TEAM FOR  
DEVELOPMENT OF  
ANDERSON ROAD QUARRY SITE -  
ROAD IMPROVEMENT WORKS**

**UNDER ENVIRONMENTAL PERMIT NO. EP-513/2016**

**MONTHLY ENVIRONMENTAL MONITORING & AUDIT REPORT**

**[JULY 2026](#)**

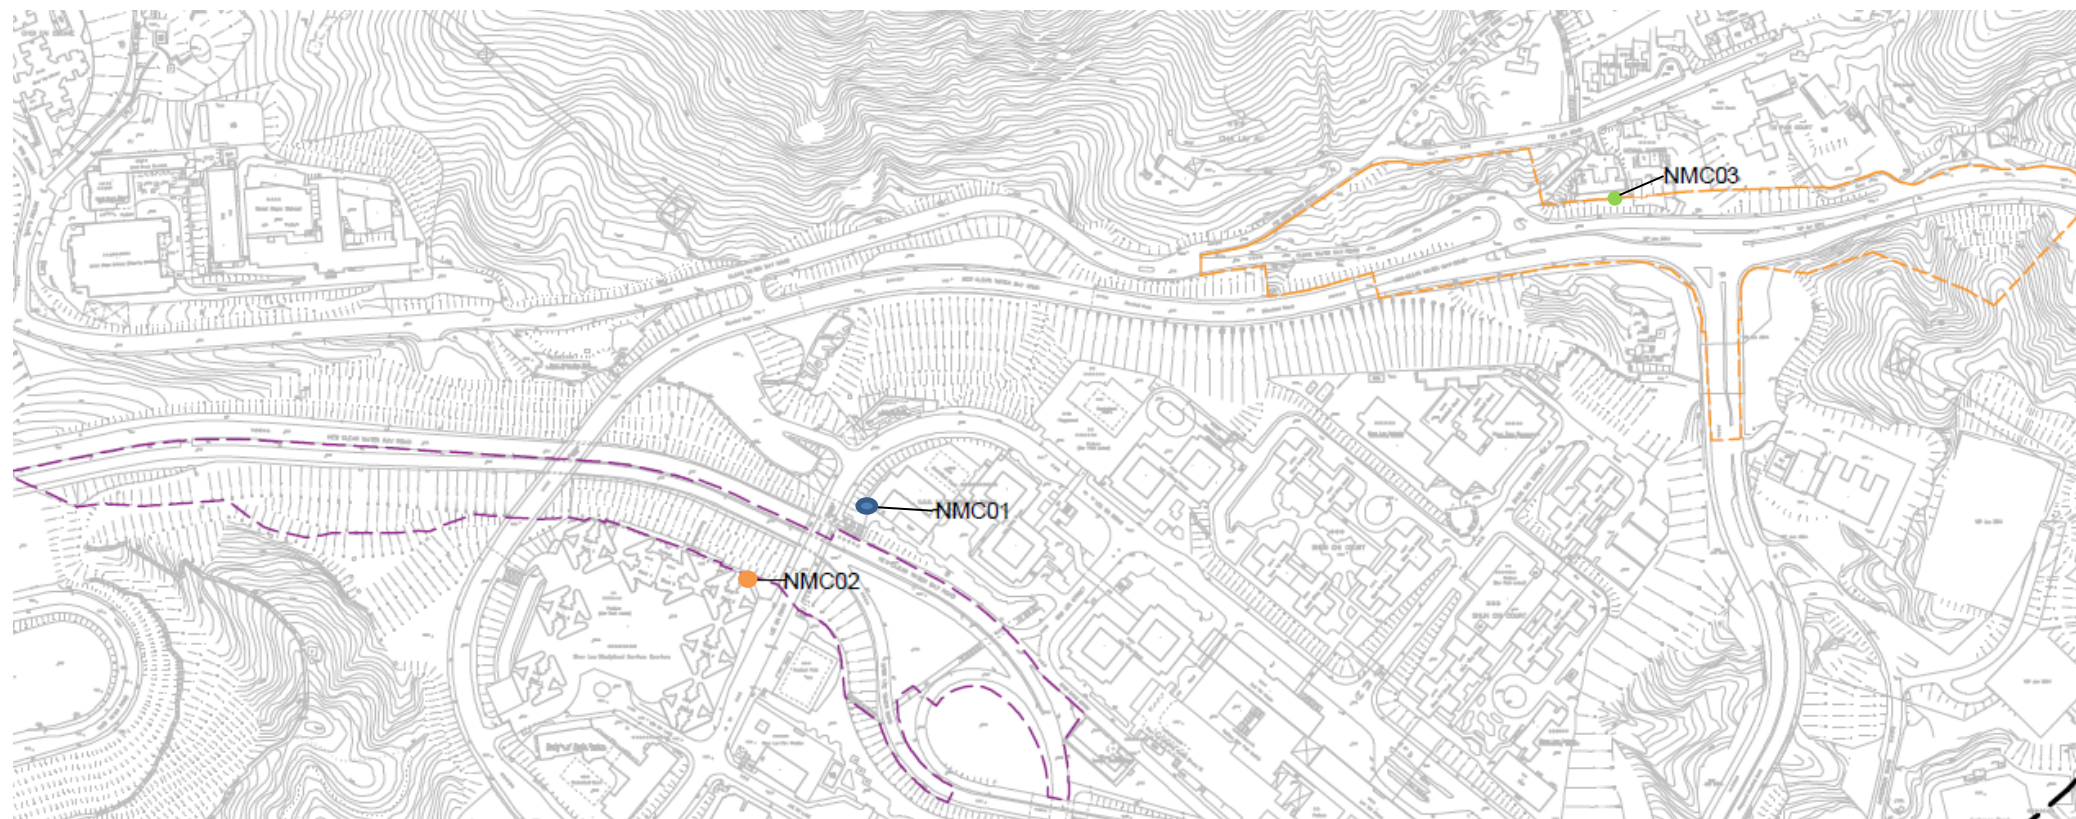
Figure 4.1  
Location of Noise Monitoring Station  
(Construction Phase)  
(for Road Improvement Work 1 & 2)

| Monitoring Location ID | Description |
|---|---|
| NMC03 | Sienna Garden Block 6 |

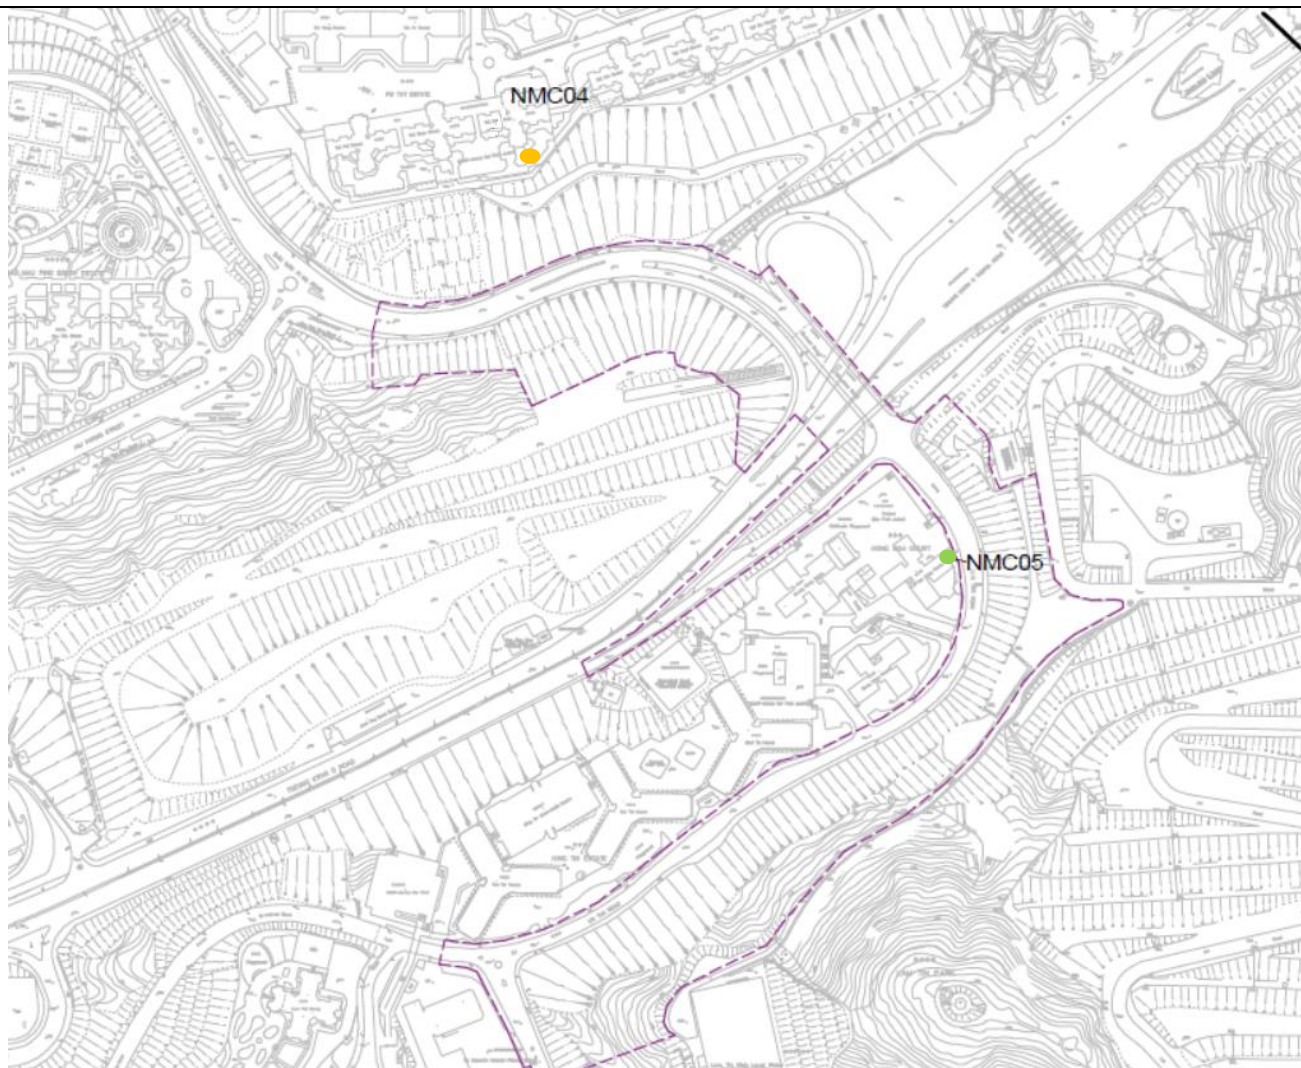
Figure 4.2  
Location of Noise Monitoring Station  
(Construction Phase)  
(for Road Improvement Work 3)

| Monitoring Location ID | Description |
|---|---|
| NMC04 | Po Tat Estate Tat Kai House |
| NMC05 | Hong Wah Court Block B Yee Hong House |

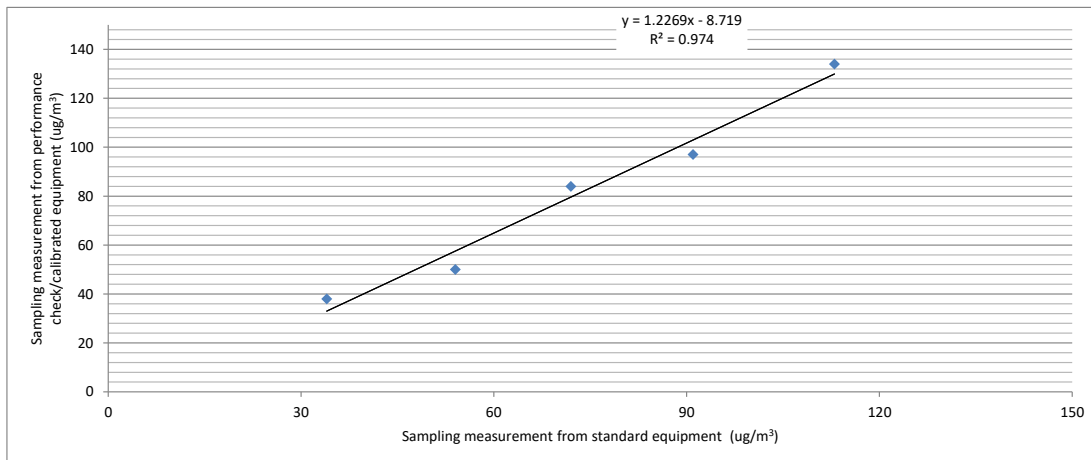
Slope (K- factor) : 0.8000  
 Correlation Coefficient : 0.9869  
 Validity of Performance Check / Calibration Record : 9/3/2027

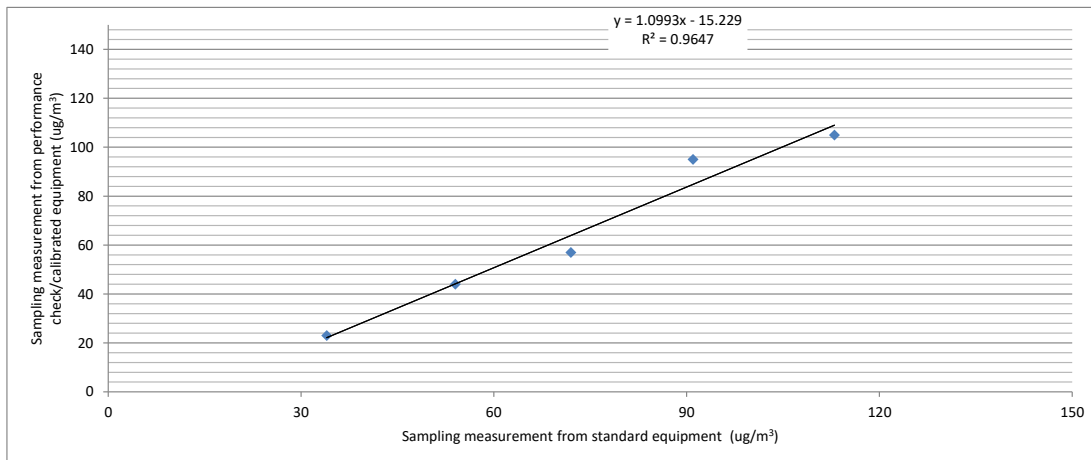
Slope (K- factor) : 0.9000  
 Correlation Coefficient : 0.9822  
 Validity of Performance Check / Calibration Record : 9/3/2027

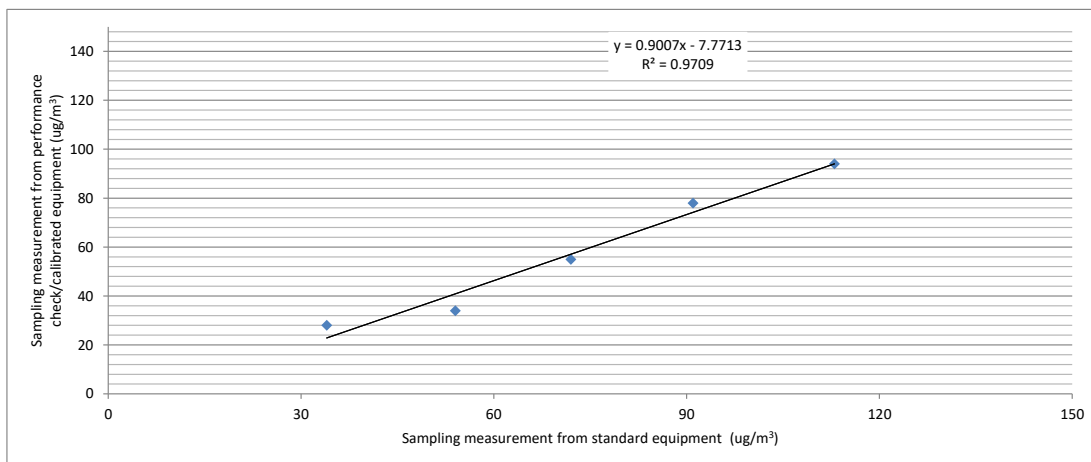
Slope (K- factor) : 1.1000  
 Correlation Coefficient : 0.9854  
 Validity of Performance Check / Calibration Record : 9/3/2027

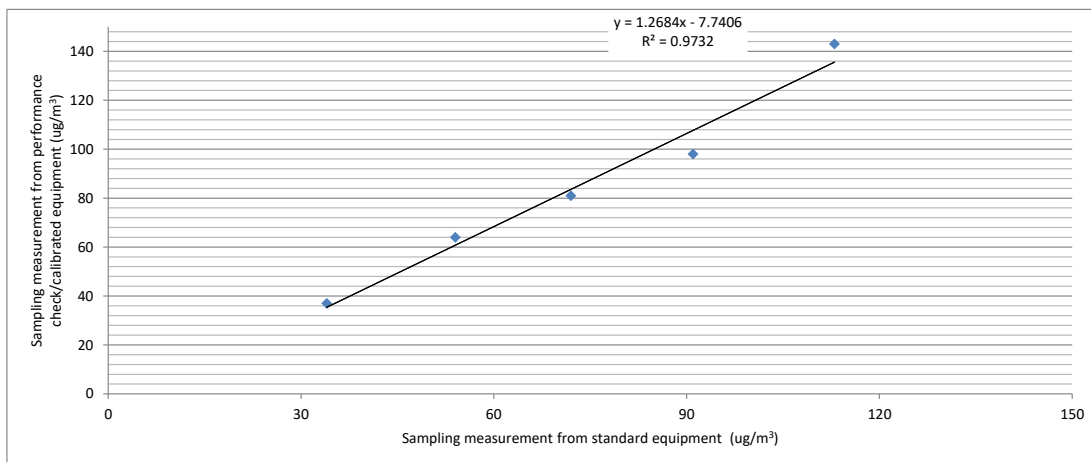
Slope (K- factor) : 0.8000  
 Correlation Coefficient : 0.9865  
 Validity of Performance Check / Calibration Record : 9/3/2027

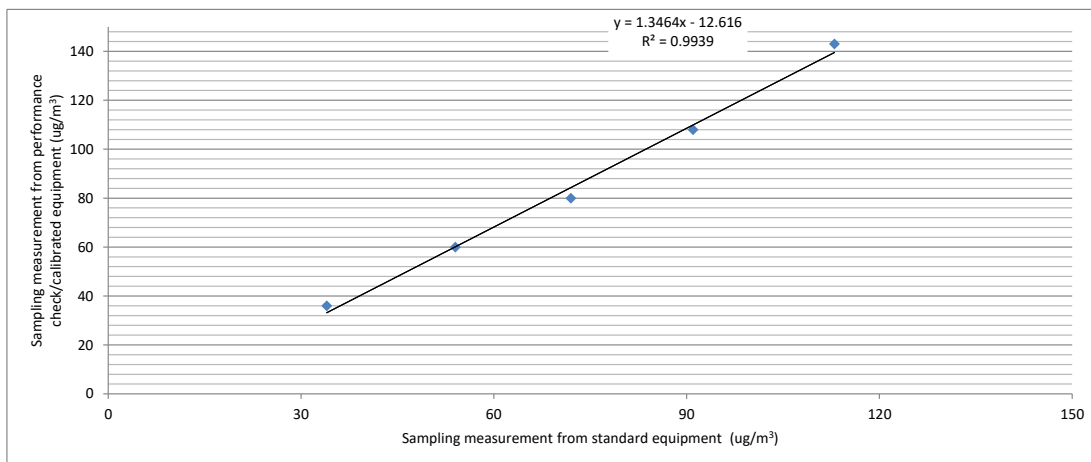
Slope (K- factor) : 0.8000  
 Correlation Coefficient : 0.9969  
 Validity of Performance Check / Calibration Record : 9/3/2027

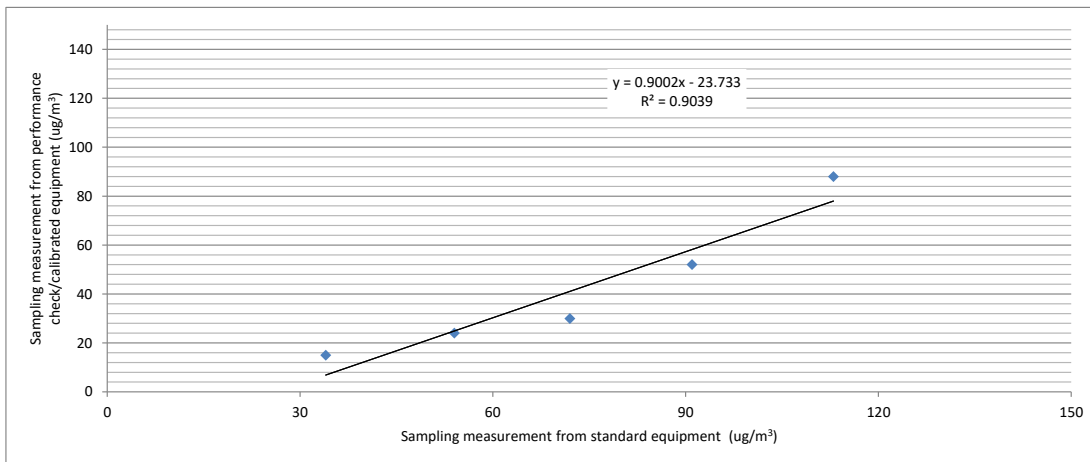
Slope (K- factor) : 1.1000  
 Correlation Coefficient : 0.9507  
 Validity of Performance Check / Calibration Record : 9/3/2027

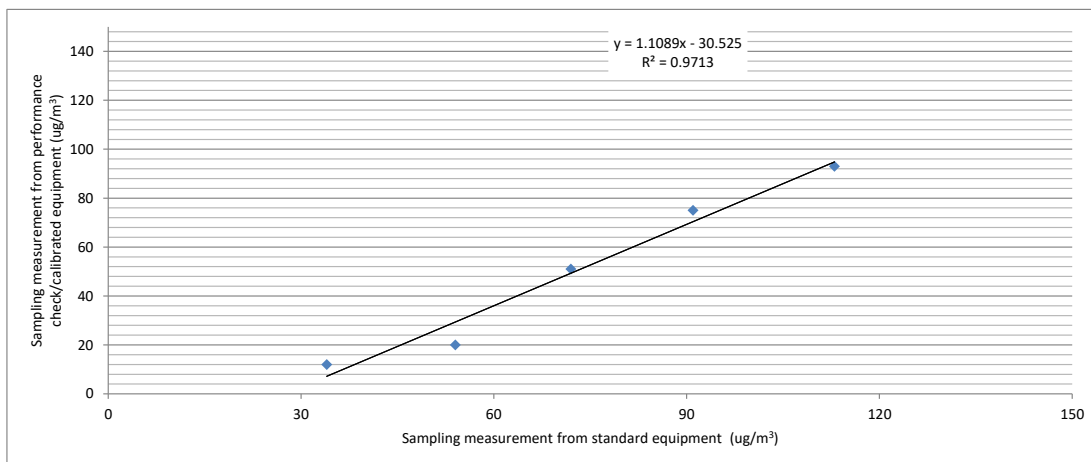
Slope (K- factor) : 0.9000  
 Correlation Coefficient : 0.9856  
 Validity of Performance Check / Calibration Record : 9/3/2027

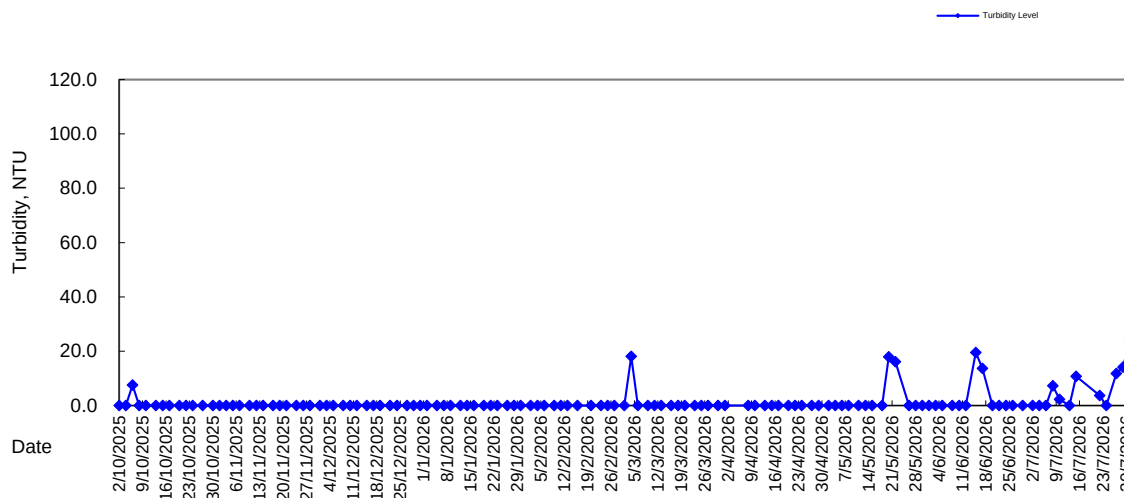
Station E - Channelized nullah across the Project site (Upstream Control Station) - Turbidity

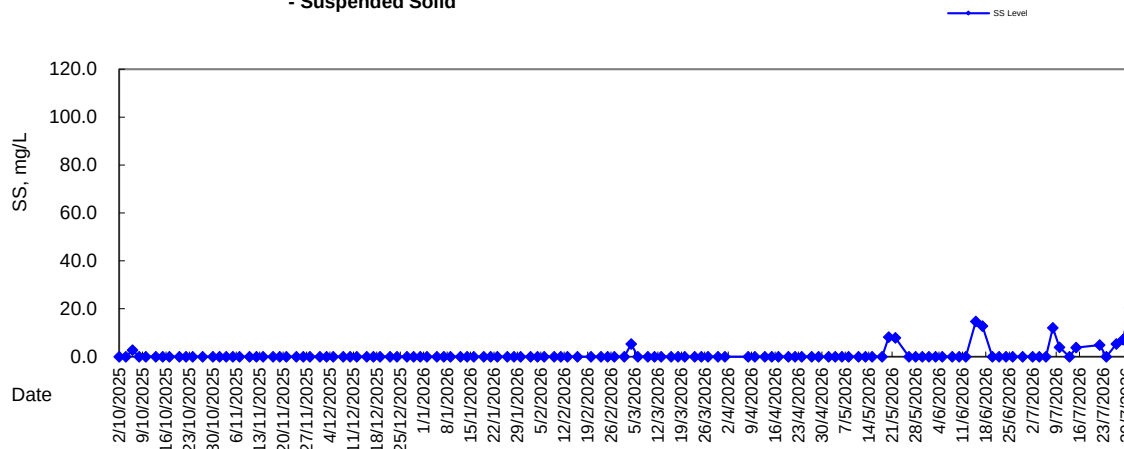
Station E - Channelized nullah across the Project site (Upstream Control Station) - Suspended Solid

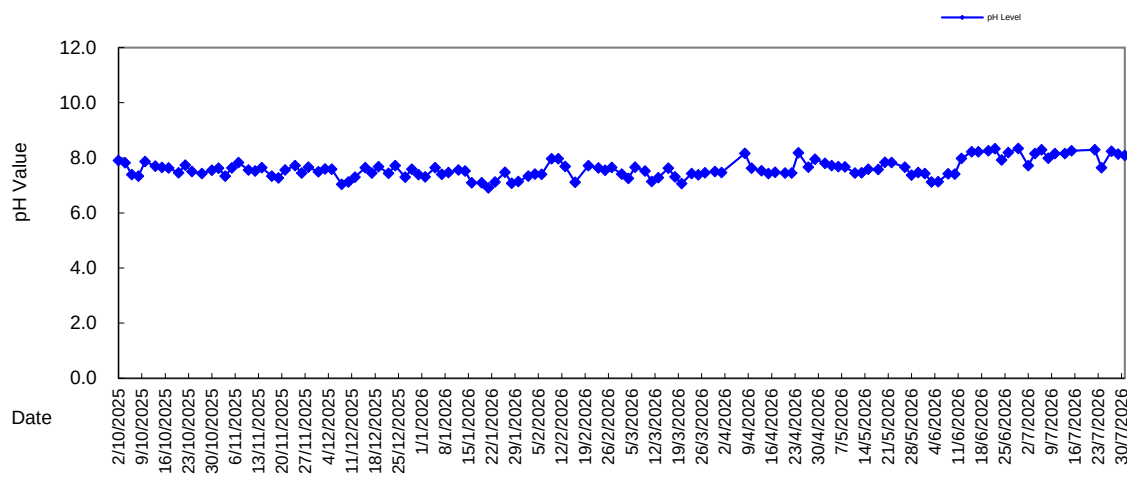
Station H - Ma Yau Tong Stream (Upstream Control Station) - pH

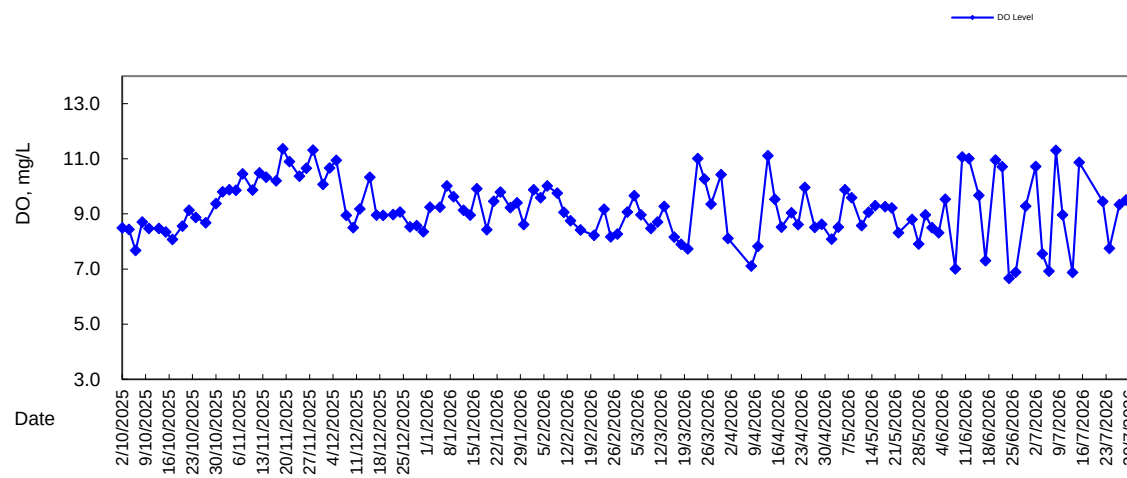
Station H - Ma Yau Tong Stream (Upstream Control Station) - DO

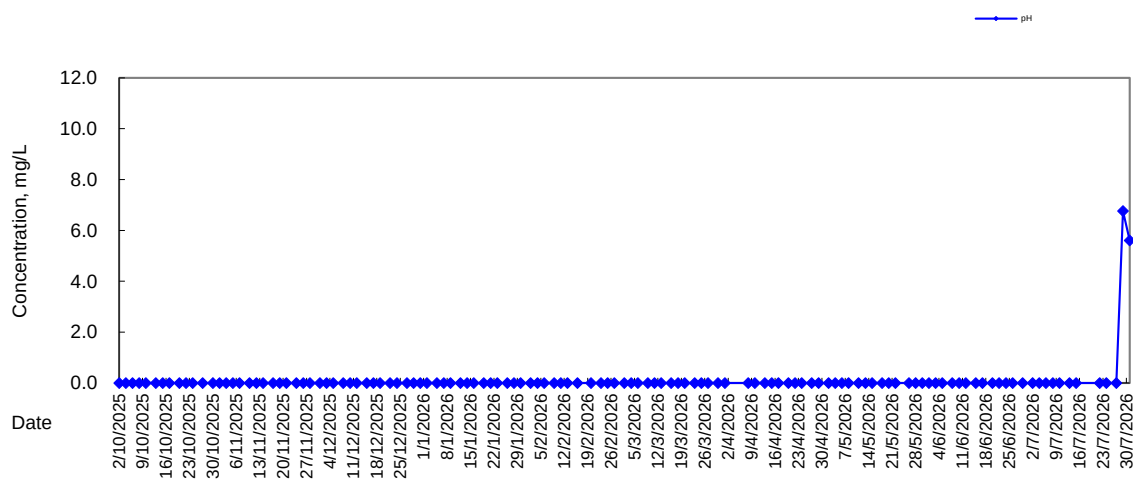
Station AC1 - Upstream reference station - pH

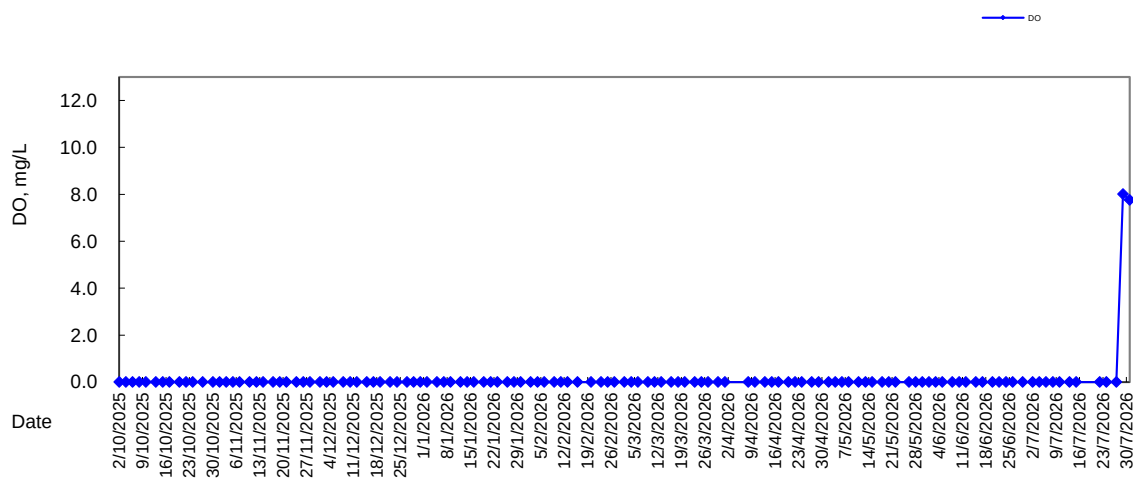
Station AC1 - Upstream reference station - DO
