Service Contract No: EDO/01/2017  
Environmental Team for  
Development of Anderson Road Quarry Site  
Road Improvement Works  
Monthly EM&A Report (March 2019)

**ENVIRONMENTAL TEAM FOR  
DEVELOPMENT OF  
ANDERSON ROAD QUARRY SITE -  
ROAD IMPROVEMENT WORKS**

**MONTHLY ENVIRONMENTAL MONITORING & AUDIT REPORT**

**MARCH 2019**

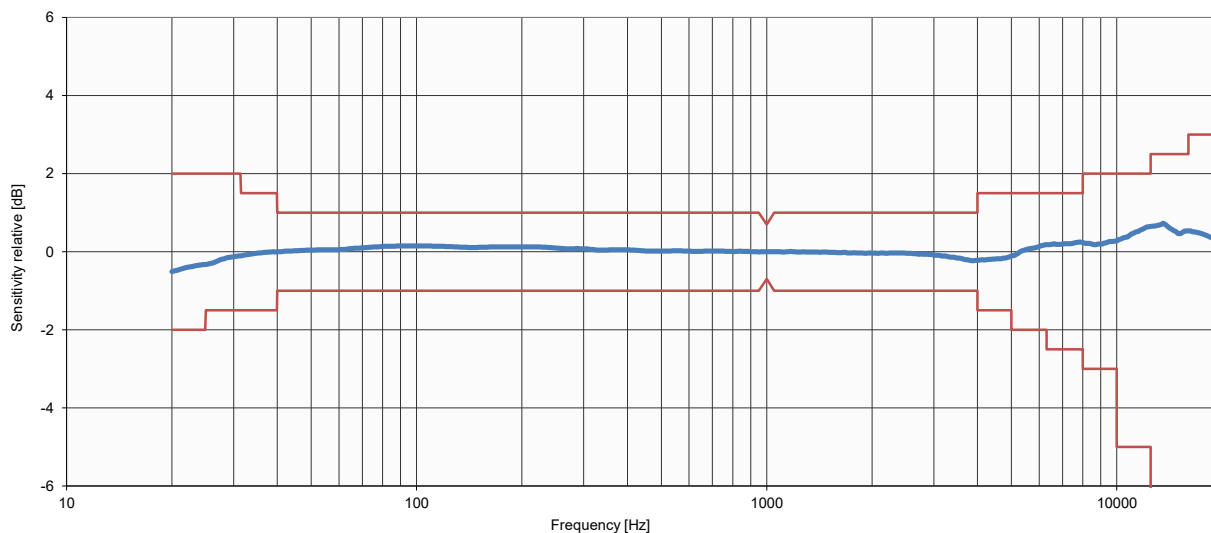
Frequency response: **Class 1 acc. IEC 61672**

actual	tolerance	calibration uncertainty <sup>1</sup>
Sensitivity @ 1 kHz, 114 dB SPL	<b>42.8 mV/Pa</b>	34-53 mV/Pa	±2.85%

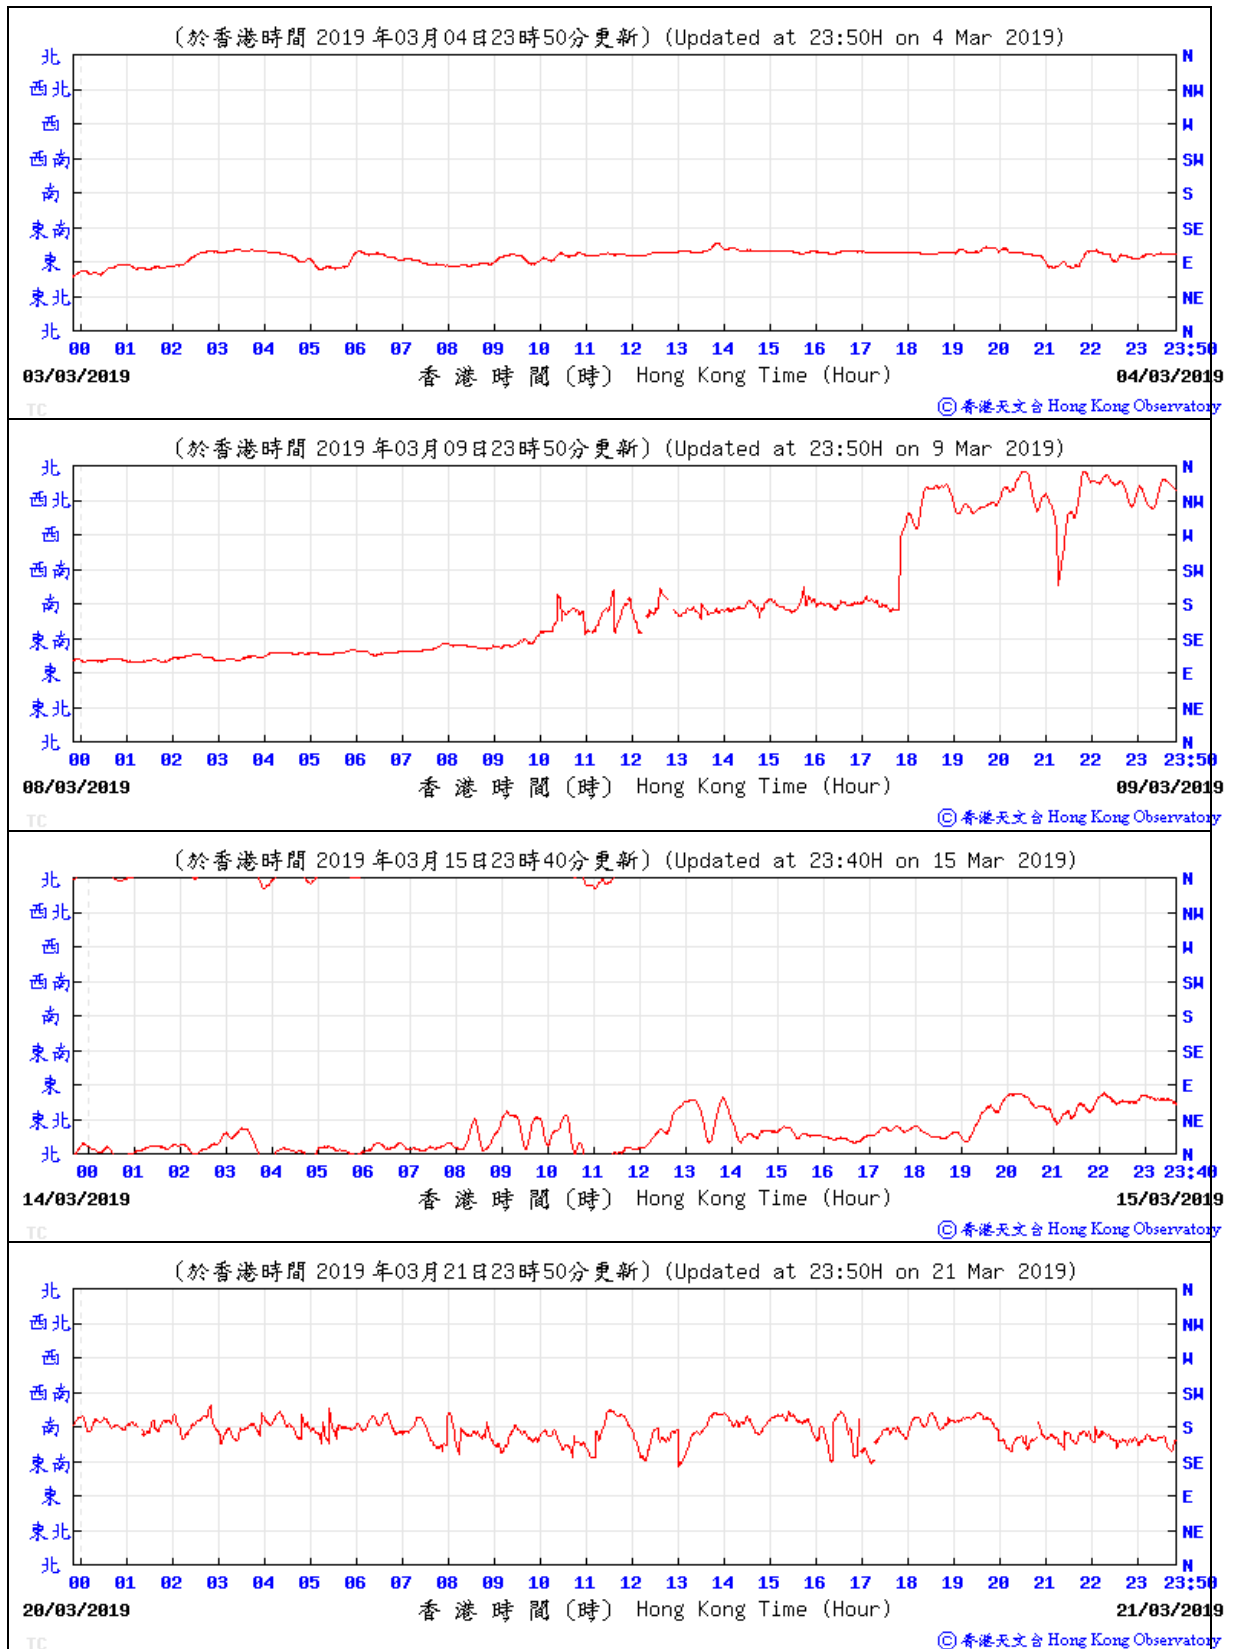
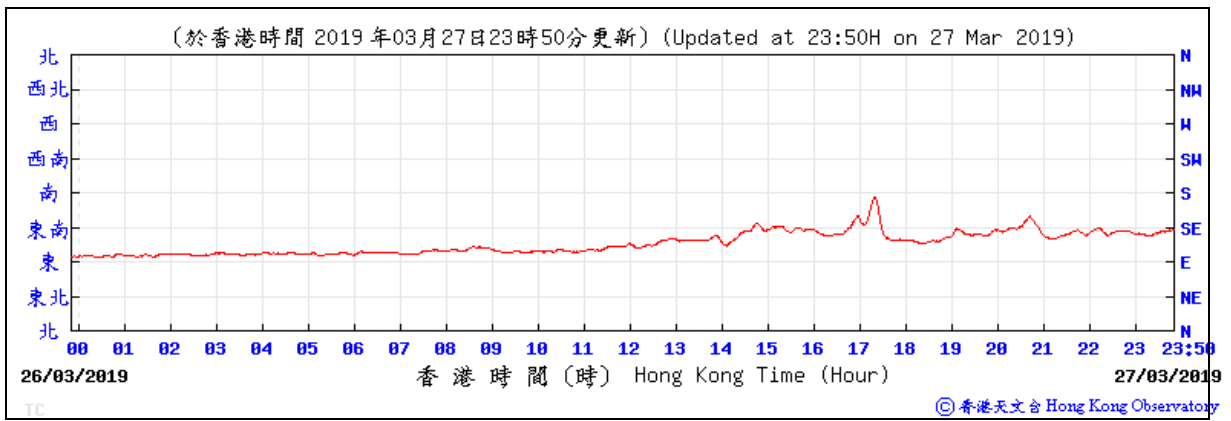
# A. Wind Direction extracted from Tate's Cairn HKO Automatic Weather Station

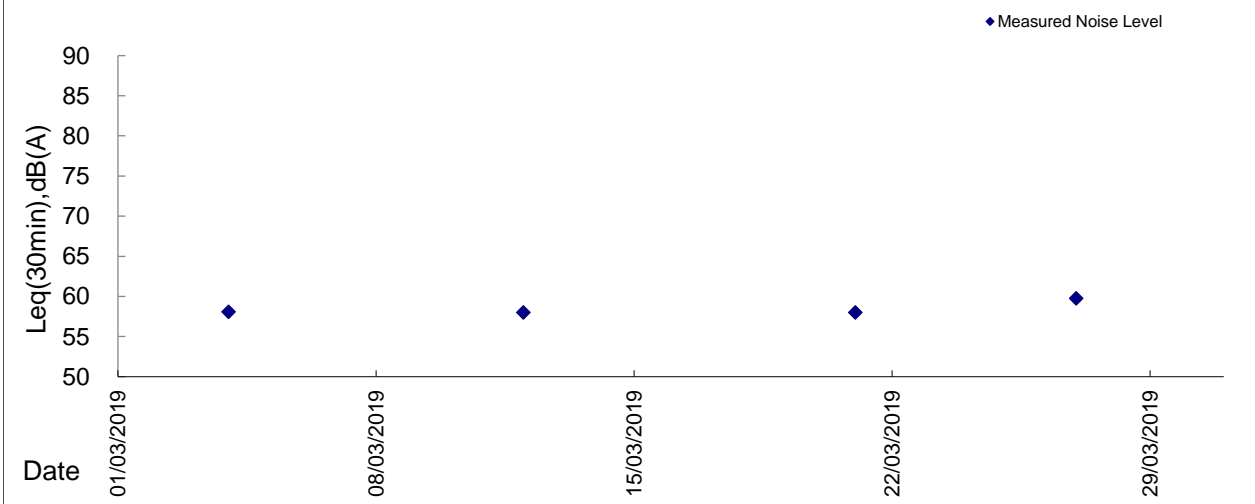
**Graphic Presentation of Noise Monitoring Result**  
**Day Time (0700 - 1900hrs on normal weekdays)**

**NMC-05 - G/F, Hong Wah Court Block B Yee Hong House**
