**CEDD SERVICE CONTRACT NO. EDO 12/2023
ENVIRONMENTAL TEAM FOR DEVELOPMENT OF
ANDERSON ROAD QUARRY SITE – SITE FORMATION
AND ASSOCIATED INFRASTRUCTURE WORKS**

**MONTHLY ENVIRONMENTAL MONITORING AND AUDIT
REPORT (DECEMBER 2025)**

**PREPARED FOR
CIVIL ENGINEERING AND DEVELOPMENT DEPARTMENT
(CEDD)**

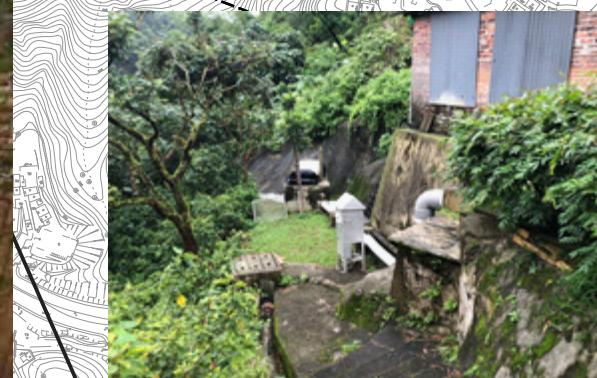
HVS in AMS-1 for 24-Hour TSP

3.6.4 For HVS for 24-hour TSP monitoring, the HVS is mounted in a metallic cage with a top for protection and also it is sat on the existing ground or the roof of building. The flow rate of the HVS between $0.6\text{m}^3/\text{min}$ and $1.7\text{m}^3/\text{min}$ will be properly set in accordance with the manufacturer's instruction to within the range recommended in *EPA Code of Federal Regulation, Appendix B to Part 50*. Glass Fiber Filter 8" x 10" of TE-653 will be used for 24-Hour TSP monitoring and would be supplied by laboratory. The general procedures of sampling are described as below:-

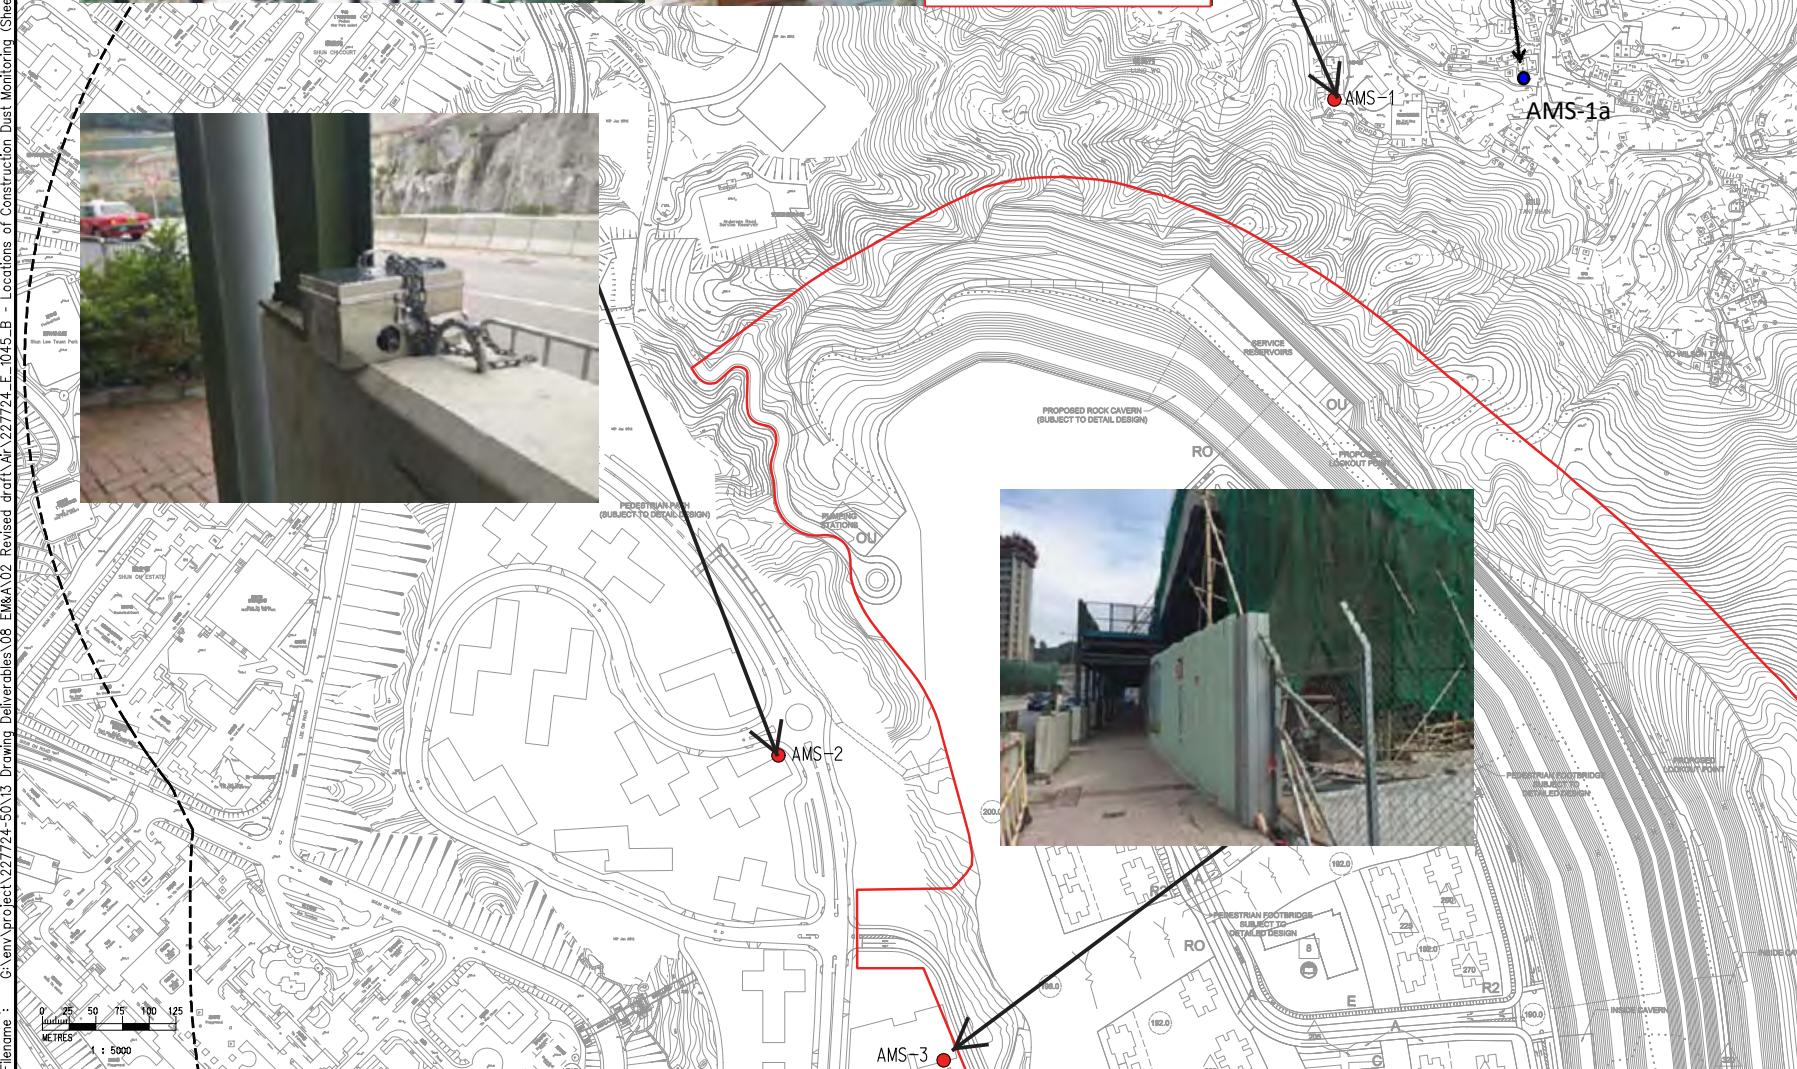
**Monitoring Locations
for
Contract 1 (NE/2016/01)**

- Study Area (Red Box)
- 500m Assessment Area (Dashed Box)
- Dust Monitoring Locations (Red Dot)

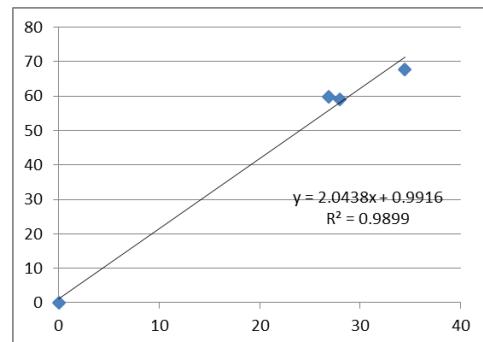
Correlation Coefficient (R) 0.9949

- Strong Correlation ($R > 0.8$)
- Factor 2.0438 ($\mu\text{g}/\text{m}^3$)/CPM should be apply for TSP monitoring

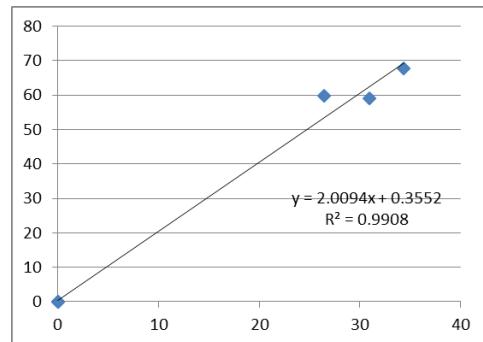
Correlation Coefficient (R) 0.9953

- Strong Correlation ($R > 0.8$)
- Factor 2.0094 ($\mu\text{g}/\text{m}^3$)/CPM should be apply for TSP monitoring

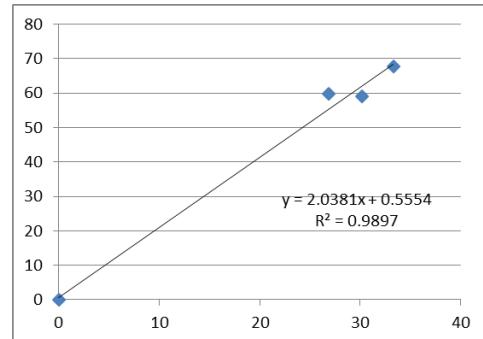
Correlation Coefficient (R) 0.9948

- Strong Correlation (R>0.8)
- Factor 2.0381 ($\mu\text{g}/\text{m}^3$)/CPM should be apply for TSP monitoring

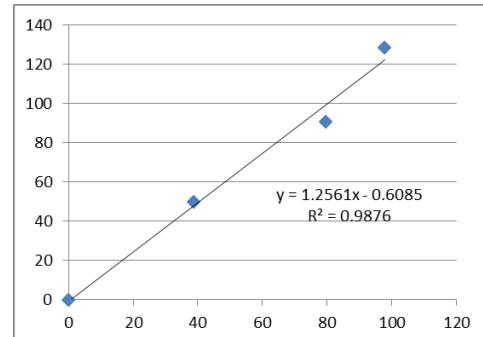
Slope (K-factor): 1.2561 (µg/m³)/CPM
Correlation Coefficient (R) 0.9938
Date of Issue 10 September 2025

- Strong Correlation ($R > 0.8$)
- Factor 1.2561 (µg/m³)/CPM should be apply for TSP monitoring

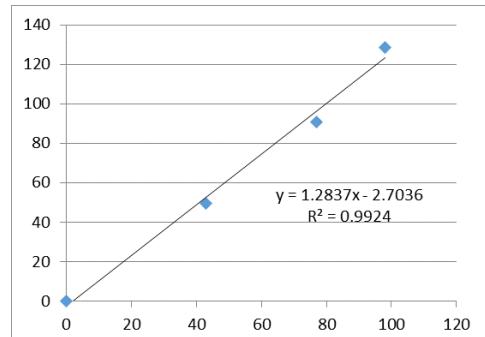
Slope (K-factor): 1.2837 ($\mu\text{g}/\text{m}^3$)/CPM
Correlation Coefficient (R) 0.9962
Date of Issue 10 September 2025

- Strong Correlation ($R > 0.8$)
- Factor 1.2837 ($\mu\text{g}/\text{m}^3$)/CPM should be apply for TSP monitoring

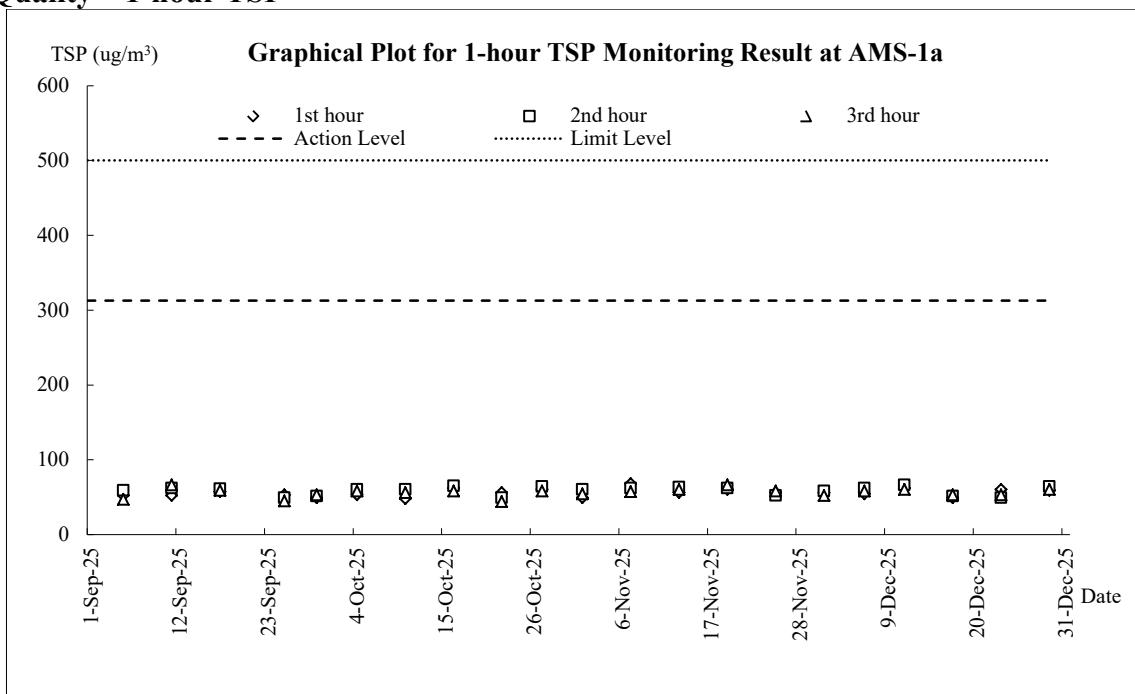
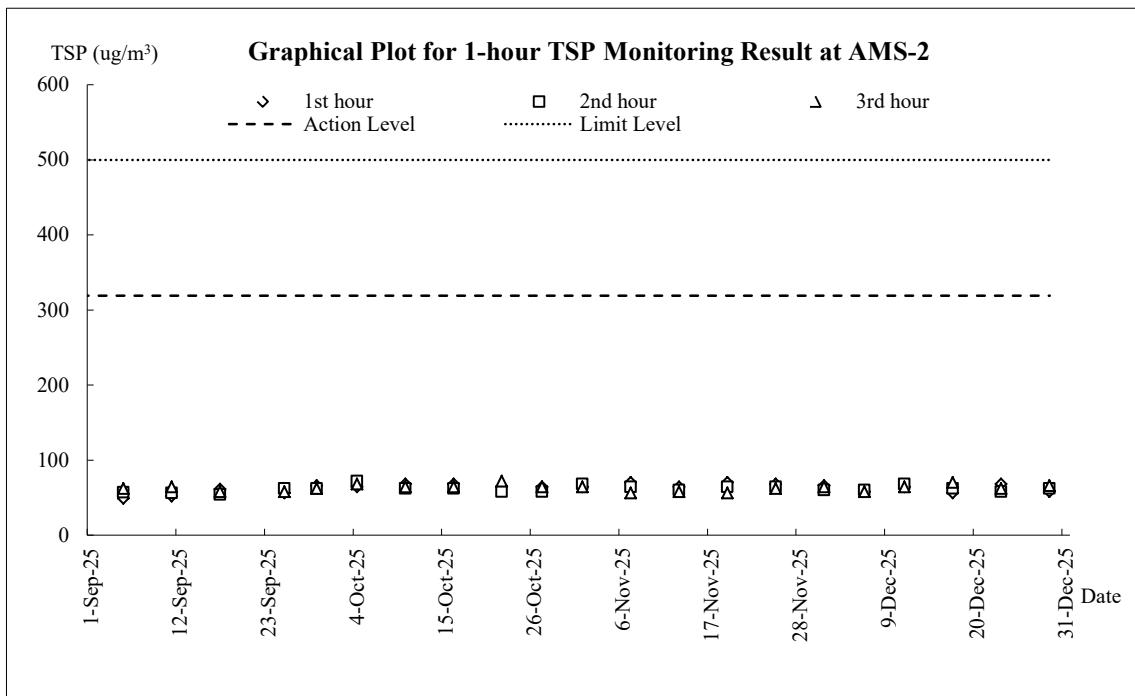
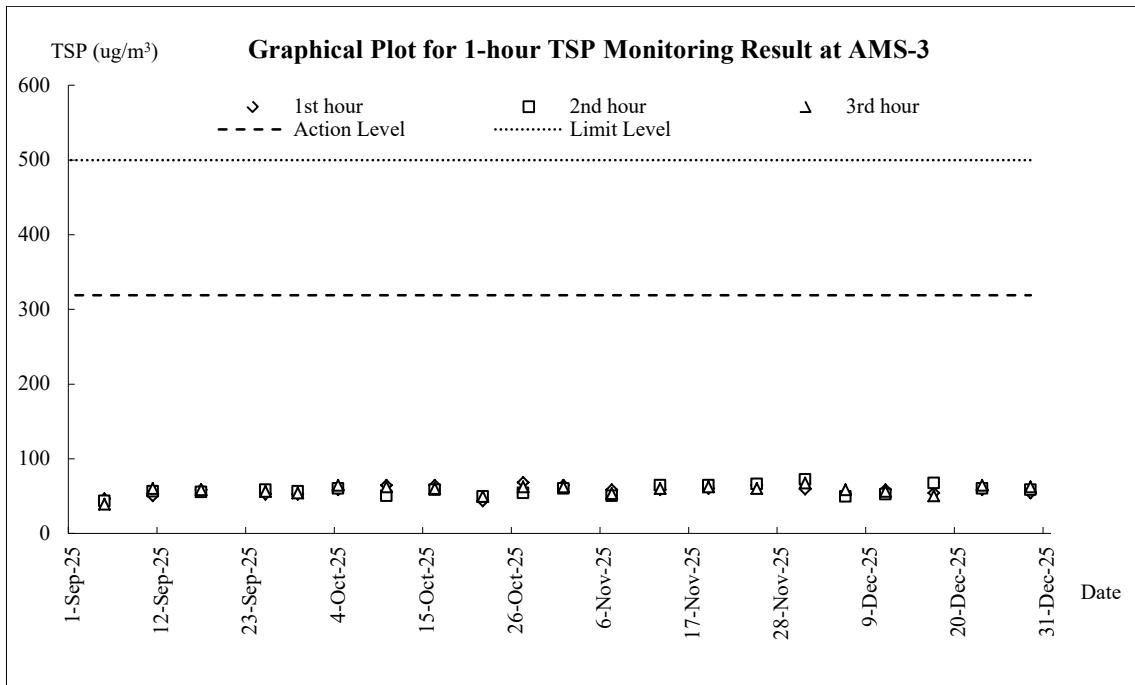
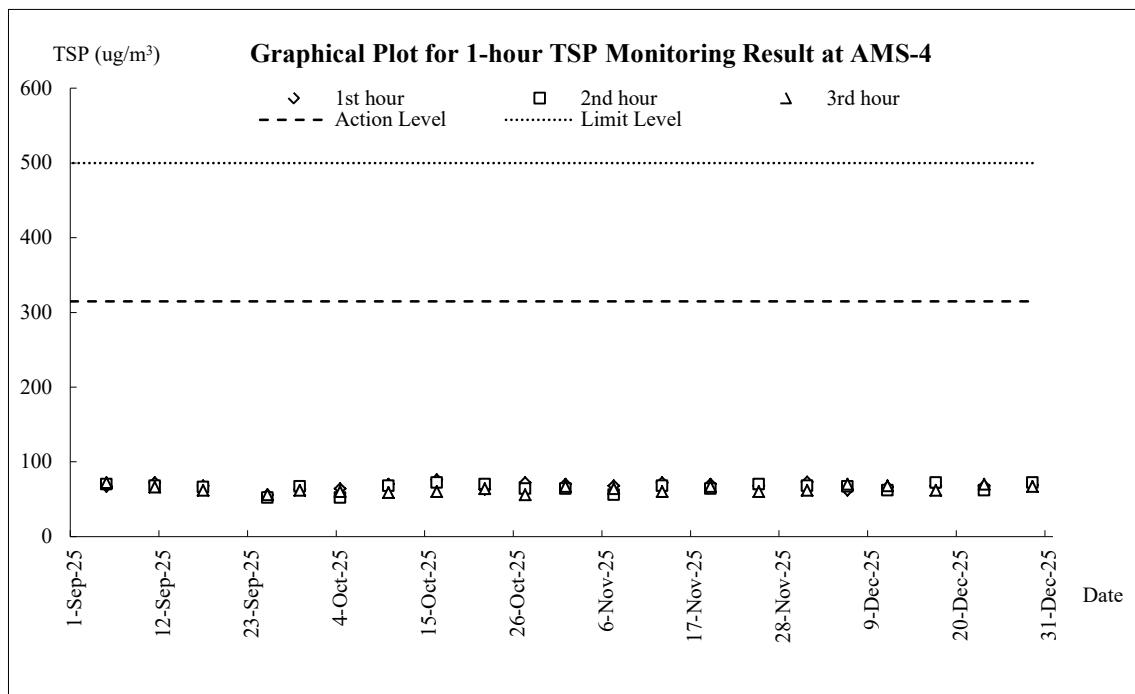
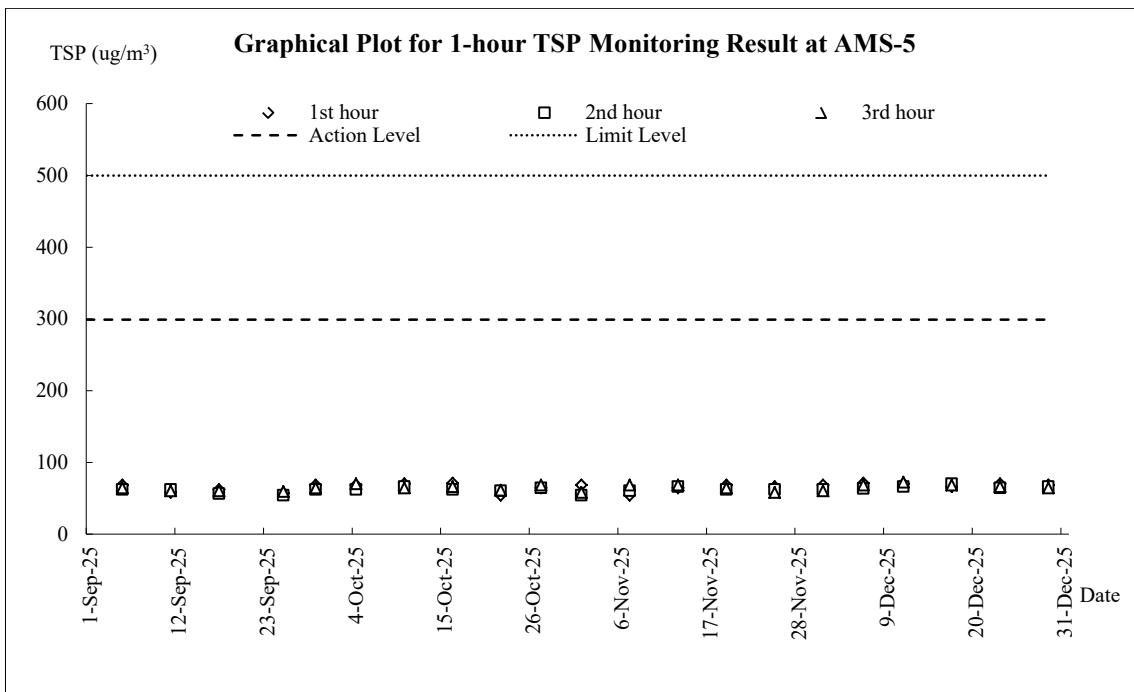
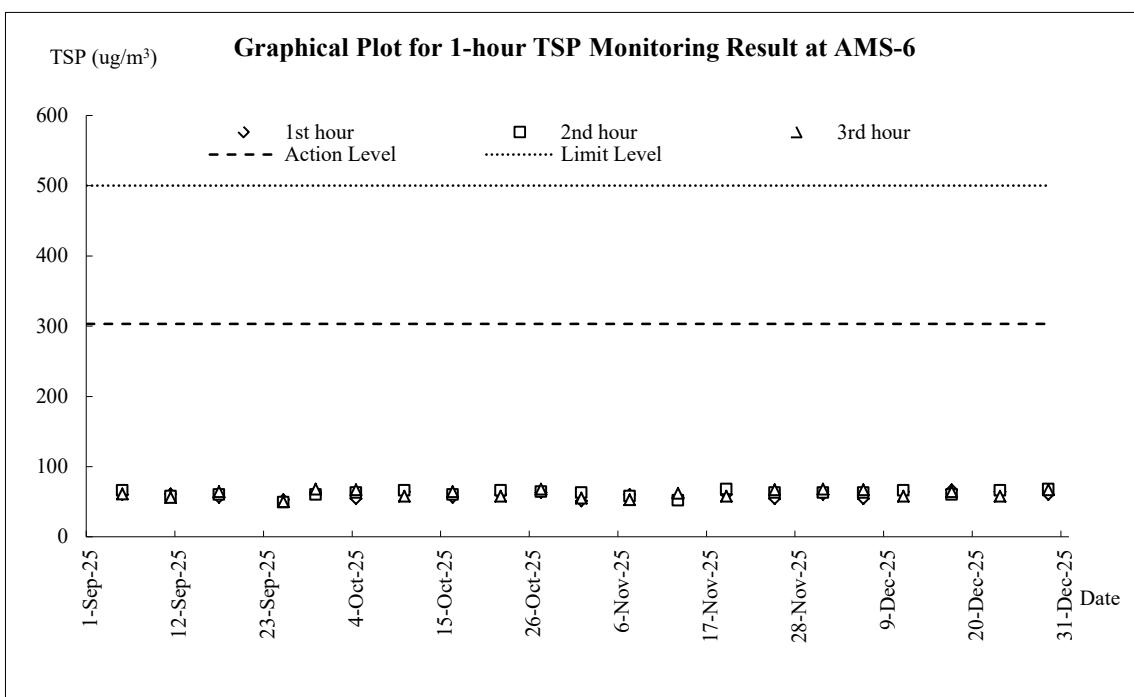
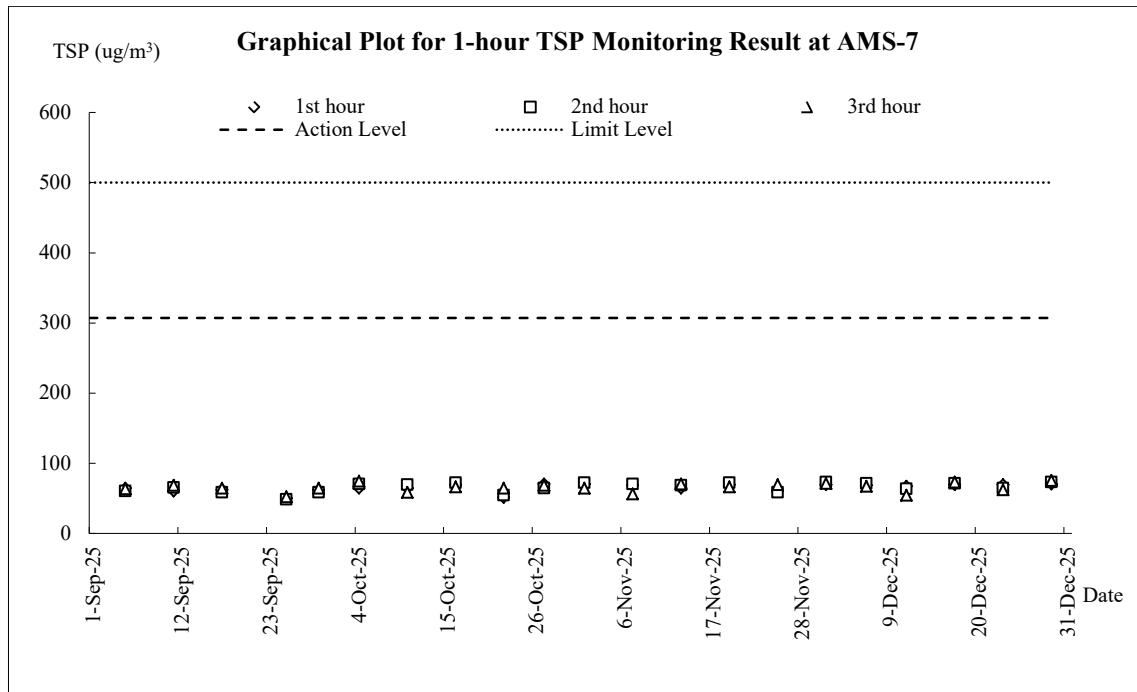
Air Quality – 1-hour TSP

Graphical Plots for Monitoring Result
