Service Contract No. NTE/07/2016

Environmental Team for Development of Anderson Road Quarry Site - Site Formation and Associated Infrastructure Works

Submission of Monthly Environmental Monitoring and Audit (EM&A) Report for September 2018

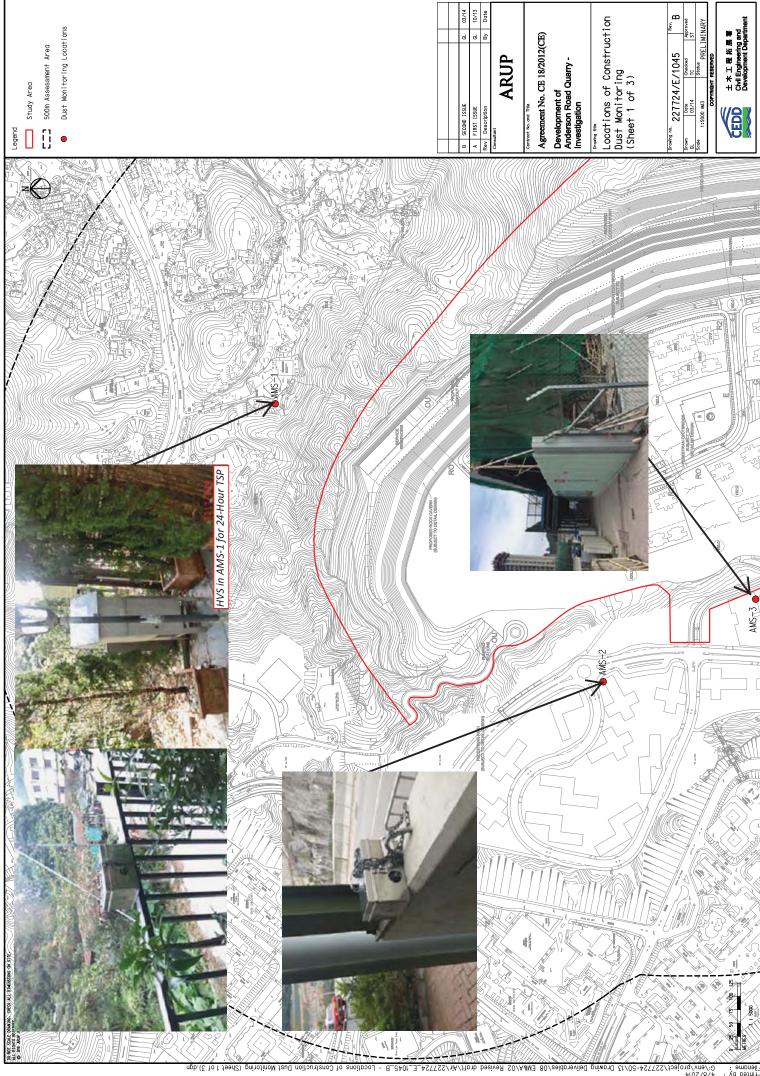
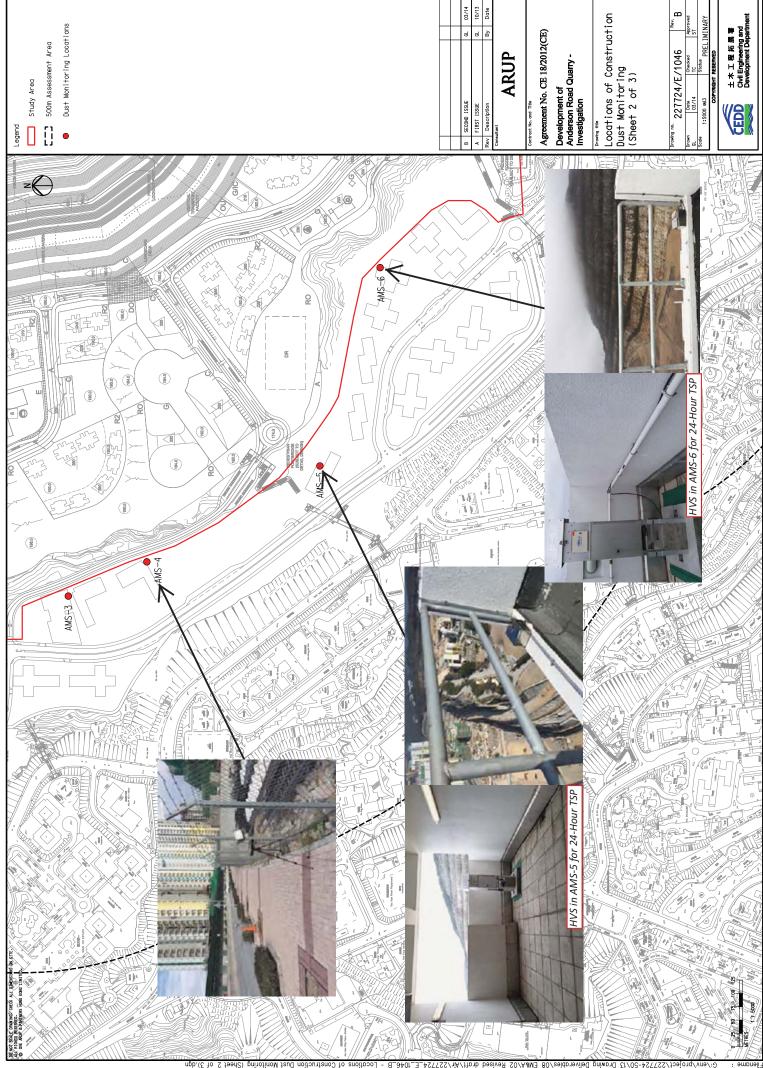
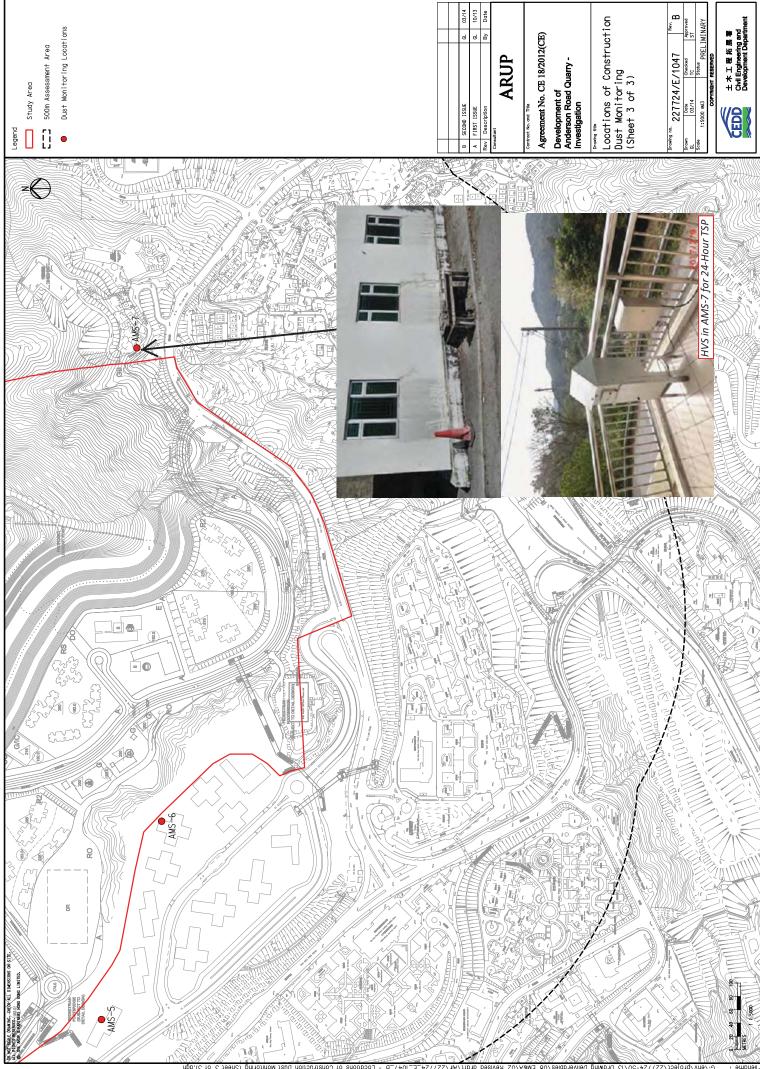
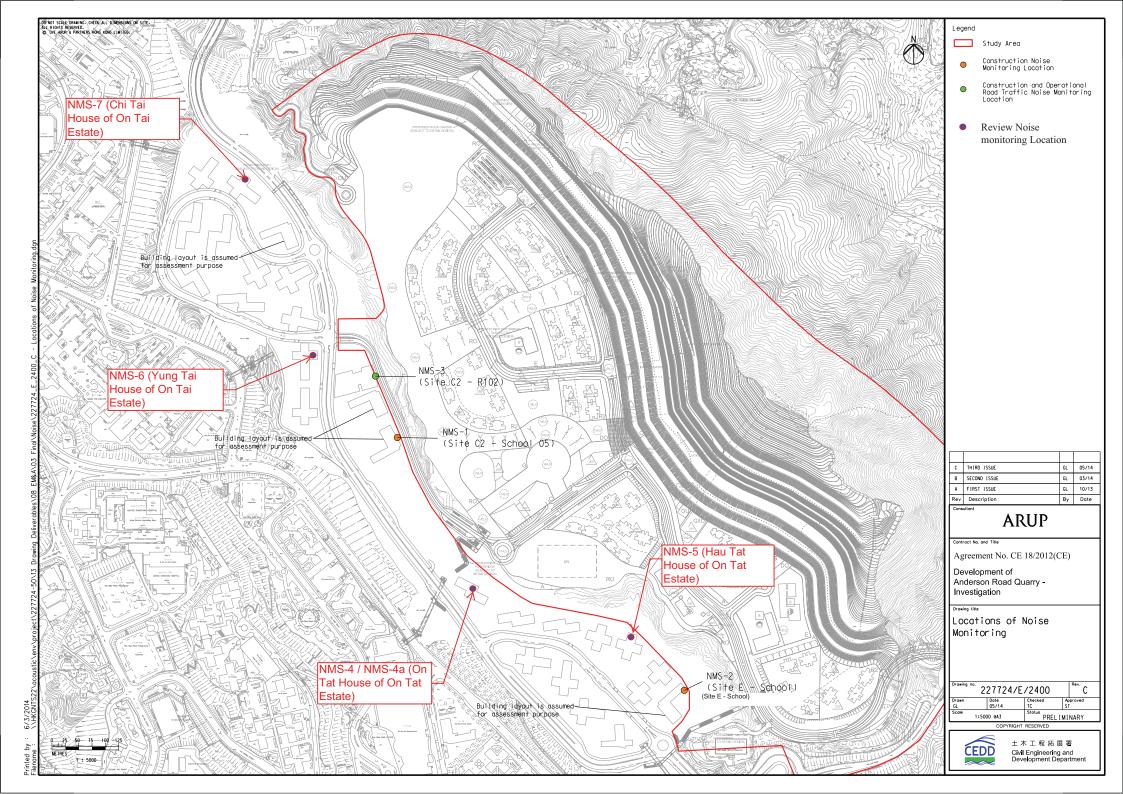
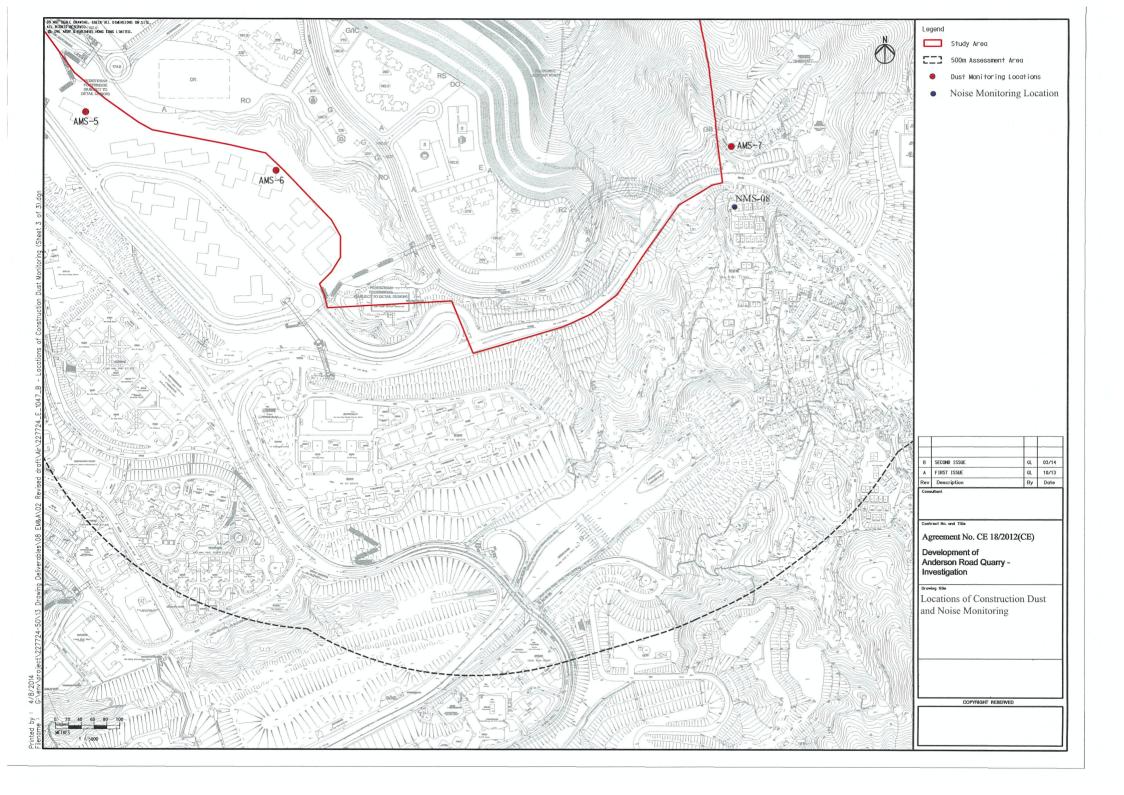
Monitoring Locations for Impact Monitoring

3.3.4 According to the EM&A Manual Section 5.5, three (3) most representative and affected noise sensitive receivers (NSR) were selected as monitoring stations. As recommended by the RE and agreed by IEC, one (1) additional noise monitoring location is proposed to add in Oi Tat House of On Tat Estate (hereafter "NMS-4") to oversee the possible noise impact pose to the resident in On Tat Estate, which is an existing NSR close to the major works activities. Moreover, review of impact monitoring location was proposed to IEC in view of the current site condition and it was agreed by all parties. The details of noise monitoring location are listed in *Table* 2-3 and illustrated in *Appendix D*.
